Asbestos Survey Report

Report Reference: J007189

Client	The Redstart Learning Partnership
UPRN	-
Address	Winsham Primary School 10 Church Street Winsham TA20 4HY
Survey Date	11 August 2021
Report Issue Date	23 August 2021
Report Reference	J007189
Survey Type	Management Survey

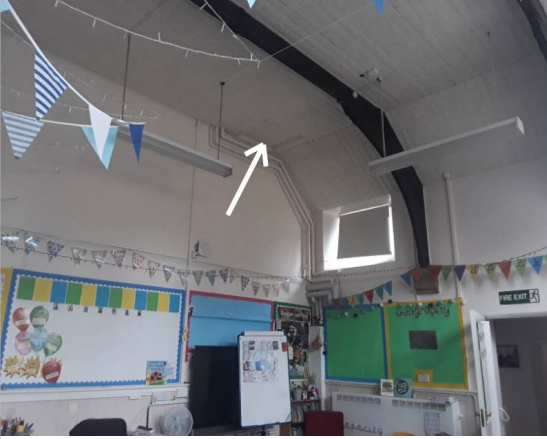
Item	Level	Location / Room Number	Survey Type	Sample Reference	Asbestos Present	Quantity			
6	Ground Floor	Main Bldg - Woodpecker Class - Loft	Management	Presumed	PRESUMED	-

Material Description		Material Risk				
			Inaccessible. Height Restrictions Apply		Product Type	Extent of Damage	Surface Treatment	Asbestos Type	
					3	3	3	3	
			Additional Information		Score - Material Risk				
			N/A		12	High			
			Recommendations		Action Date				
Presume Asbestos Is Present Until Accessed And/Or A Bulk Sample Is Taken		November 2021							
Ceilings		Ceiling Soffits		Walls		Flooring		Other	
No Access		No Access		No Access		No Access		No Access

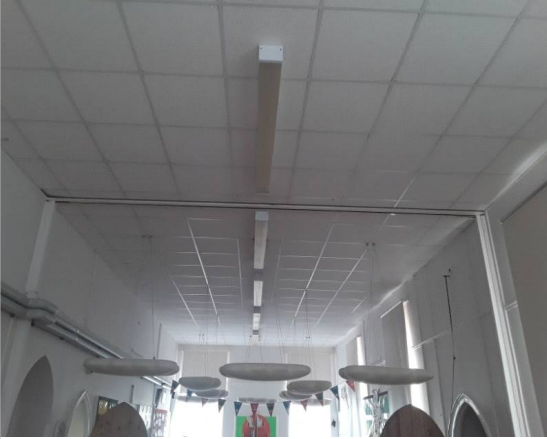
Item	Level	Location / Room Number	Survey Type	Sample Reference	Asbestos Present	Quantity			
10	Ground Floor	Main Bldg - Hall - Ceiling Void	Management	Presumed	PRESUMED	-

Material Description		Material Risk				
			Inaccessible. Height Restrictions Apply		Product Type	Extent of Damage	Surface Treatment	Asbestos Type	
					3	3	3	3	
			Additional Information		Score - Material Risk				
			N/A		12	High			
			Recommendations		Action Date				
Presume Asbestos Is Present Until Accessed And/Or A Bulk Sample Is Taken		November 2021							
Ceilings		Ceiling Soffits		Walls		Flooring		Other	
No Access		No Access		No Access		No Access		No Access

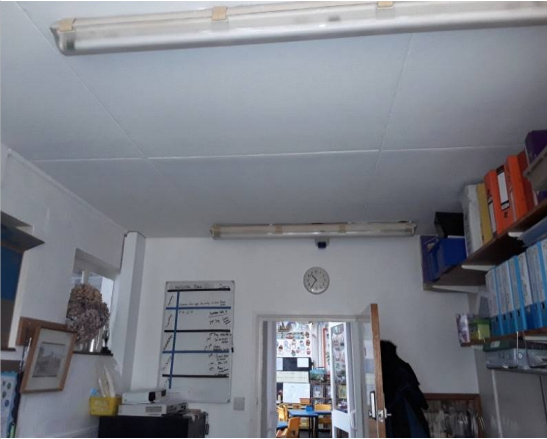
Item	Level	Location / Room Number	Survey Type	Sample Reference	Asbestos Present	Quantity			
13	Ground Floor	Main Bldg - Heads Office	Management	AT001751	YES	12 m ²

Material Description		Material Risk				
			Asbestos Textured Coating To Fixed Fibreboard Ceiling Panels		Product Type	Extent of Damage	Surface Treatment	Asbestos Type	
					1	0	1	1	
			Additional Information		Score - Material Risk				
			Timber Doors. Timber Architraves And Skirting Boards. Modern Electrical Installations		3		Very Low		
			Recommendations		Accessibility				
			Re-Inspect Periodically (Manage)		Medium				
Recommendations		Action Date							
		August 2022							
Ceilings		Ceiling Soffits		Walls		Flooring		Other	
No Access		Fixed Fibreboard		Plastered Brick		Concrete/Fixed Carpet		N/A

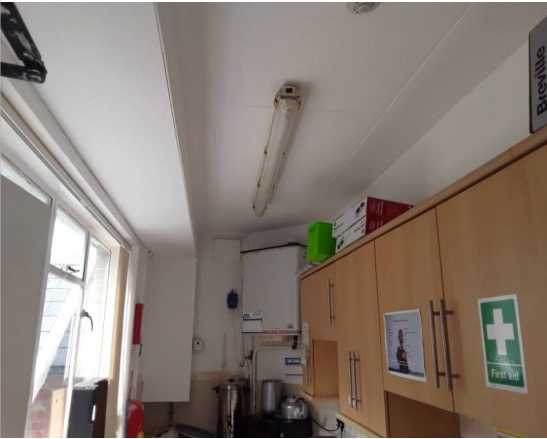
Item	Level	Location / Room Number	Survey Type	Sample Reference	Asbestos Present	Quantity			
14	Ground Floor	Main Bldg - Staff Kitchen	Management	AT001752	NO	-

Material Description		Material Risk				
			Non Asbestos Textured Coating To Fixed Fibreboard Ceiling Panels		Product Type	Extent of Damage	Surface Treatment	Asbestos Type	
					-	-	-	-	
			Additional Information		Score - Material Risk				
			Timber Door. Timber Architraves. Modern Electrical Installations. Modern Damper Pad To Underside Of Sink Basin		-		-		
			Recommendations		Accessibility				
			No Asbestos Detected In Sample		-				
Recommendations		Action Date							
Ceilings		Ceiling Soffits		Walls		Flooring		Other	
No Access		Fixed Fibreboard		Plastered Brick		Concrete/Fixed Vinyl		N/A

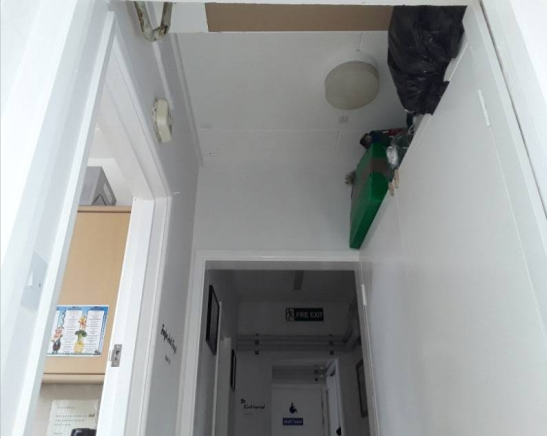
Item	Level	Location / Room Number	Survey Type	Sample Reference	Asbestos Present	Quantity		
15	Ground Floor	Main Bldg - Staff Kitchen Lobby	Management	As AT001752	NO	-

Material Description		Material Risk			
			Non Asbestos Textured Coating To Fixed Fibreboard Ceiling Panels		Product Type	Extent of Damage	Surface Treatment	Asbestos Type
					-	-	-	-
			Additional Information		Score - Material Risk			
			N/A		-	-		
					Accessibility			
					-			
Recommendations			Action Date					
No Asbestos Detected In Sample			-					
Ceilings		Ceiling Soffits	Walls	Flooring	Other			
No Access		Fixed Fibreboard	Plastered Brick	Concrete/Fixed Vinyl	N/A

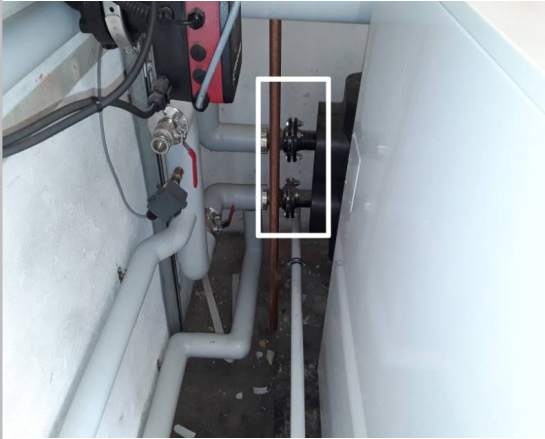
Item	Level	Location / Room Number	Survey Type	Sample Reference	Asbestos Present	Quantity		
17	Ground Floor	Main Bldg - Boiler Rm	Management	AT001754	YES	4 no.

Material Description		Material Risk			
			Asbestos Compressed Gaskets To Four Flanges Located To Rear Of Modern Boiler		Product Type	Extent of Damage	Surface Treatment	Asbestos Type
					1	0	1	1
			Additional Information		Score - Material Risk			
			Modern Mechanical And Electrical Installations		3	Very Low		
					Accessibility			
		Low						
Recommendations			Action Date					
Re-Inspect Periodically (Manage)			August 2022					
Ceilings		Ceiling Soffits	Walls	Flooring	Other			
No Access		Asbestos Board	Plastered Brick	Concrete	N/A

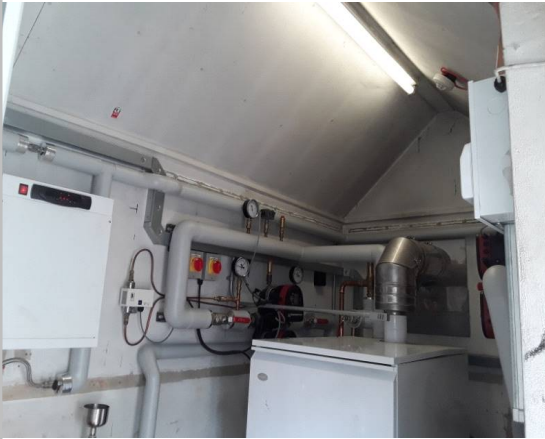
Item	Level	Location / Room Number	Survey Type	Sample Reference	Asbestos Present	Quantity		
18	Ground Floor	Main Bldg - Boiler Rm	Management	AT001755	YES	5 m ²

Material Description		Material Risk			
			Asbestos Insulating Board Ceiling Panels		Product Type	Extent of Damage	Surface Treatment	Asbestos Type
					2	0	1	2
			Additional Information		Score - Material Risk			
			N/A		5	Low		
					Accessibility			
		Medium						
Recommendations			Action Date					
Re-Inspect Periodically (Manage)			August 2022					
Ceilings		Ceiling Soffits	Walls	Flooring	Other			
No Access		Asbestos Board	Plastered Brick	Concrete	N/A

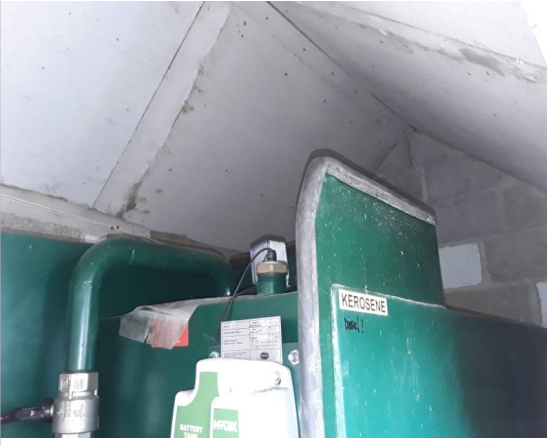
Item	Level	Location / Room Number	Survey Type	Sample Reference	Asbestos Present	Quantity		
19	Ground Floor	Main Bldg - Oil Tank Rm	Management	AT001756	YES	6 m ²

Material Description		Material Risk			
			Asbestos Insulating Board Ceiling Panels		Product Type	Extent of Damage	Surface Treatment	Asbestos Type
					2	0	1	2
			Additional Information		Score - Material Risk			
			N/A		5	Low		
					Accessibility			
					Medium			
Recommendations			Action Date					
Re-Inspect Periodically (Manage)			August 2022					
Ceilings		Ceiling Soffits	Walls	Flooring	Other			
No Access		Asbestos Board	Plastered Brick	Concrete	N/A

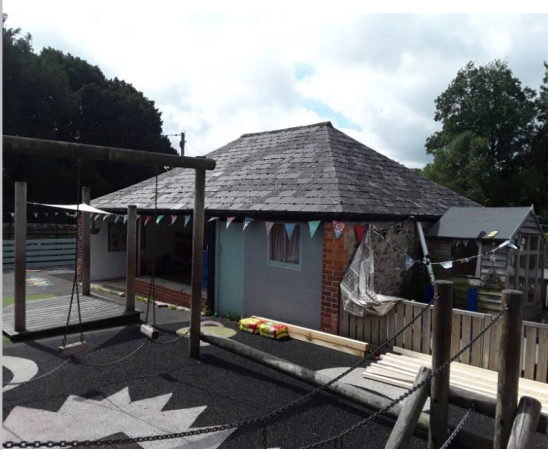
Item	Level	Location / Room Number	Survey Type	Sample Reference	Asbestos Present	Quantity			
22	External	Open Play Structure	Management	AT001757	NO	-

Material Description		Material Risk				
			Non Asbestos Cement Roof Tile Slates Intermittently Mixed With Non Asbestos Roof Tile Slates		Product Type	Extent of Damage	Surface Treatment	Asbestos Type	
					-	-	-	-	
			Additional Information		Score - Material Risk				
			N/A		-	-			
					Accessibility				
					-				
Recommendations		Action Date							
		No Asbestos Detected In Sample							
Ceilings		Ceiling Soffits		Walls		Flooring		Other	
N/A		N/A		N/A		N/A		N/A

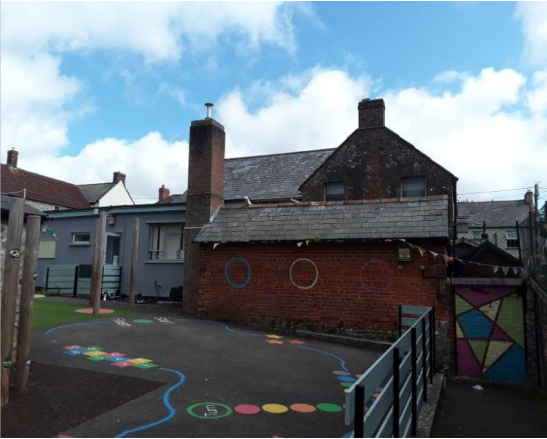
Item	Level	Location / Room Number	Survey Type	Sample Reference	Asbestos Present	Quantity		
23	External	Main Building	Management	AT001758	NO	-

Material Description		Material Risk			
			Non Asbestos Cement Roof Tile Slates Intermittently Mixed With Non Asbestos Roof Tile Slates. Inspection Includes The Boiler/Tank Rm		Product Type	Extent of Damage	Surface Treatment	Asbestos Type
					-	-	-	-
			Additional Information		Score - Material Risk			
			N/A		-	-		
					Accessibility			
					-			
Recommendations			Action Date					
No Asbestos Detected In Sample			-					
Ceilings		Ceiling Soffits		Walls		Flooring		Other
N/A		N/A		N/A		N/A		N/A

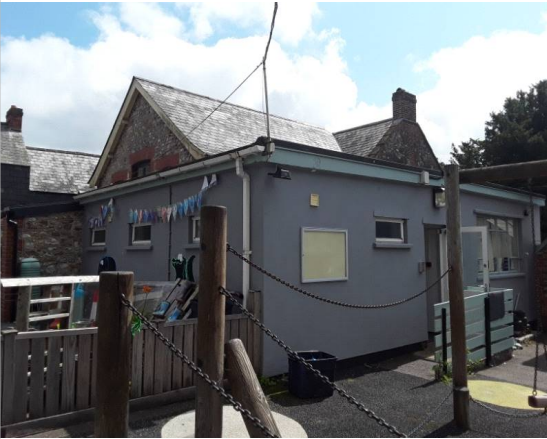
Item	Level	Location / Room Number	Survey Type	Sample Reference	Asbestos Present	Quantity		
24	External	Main Building	Management	AT001759	YES	18 lm

Material Description		Material Risk			
			Asbestos Cement Soffits To The Rear Elevation Of The Main Building		Product Type	Extent of Damage	Surface Treatment	Asbestos Type
					1	0	1	1
			Additional Information		Score - Material Risk			
			N/A		3	Very Low		
					Accessibility			
					Medium			
Recommendations			Action Date					
Re-Inspect Periodically (Manage)			August 2022					
Ceilings		Ceiling Soffits		Walls		Flooring		Other
N/A		N/A		N/A		N/A		N/A
