ASBESTOS REGISTER

053801 : NEWTOWN PRIMARY SCHOOL

NEWTOWN
EXETER
DEVON
EX1 2ES

NPS Property Consultants

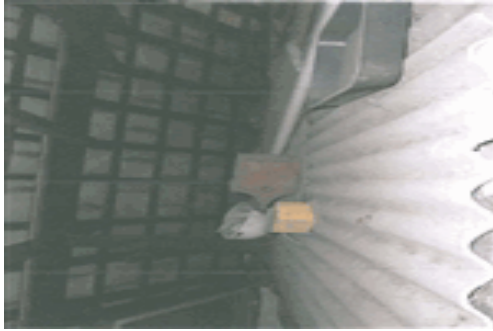
Room:
Location: Inner roof sheet over store GD-0026
Use: Reefs
Reference: 633056
Sample number: HRP0905114
Presumed: No
REMOVED (See ASB3 20/05/2013)

Product type: AIB,textiles,gaskets,ropes,paper(2)
Damage: Low damage (1)
Surface treatment: Enclosed sprays or lagging/bare-
cement (1)
Asbestos type: Chrysotile (1)
Extent: <=10m2 or <=10m pipe run
Material score:
Priority score:
Banding:

REMOVED

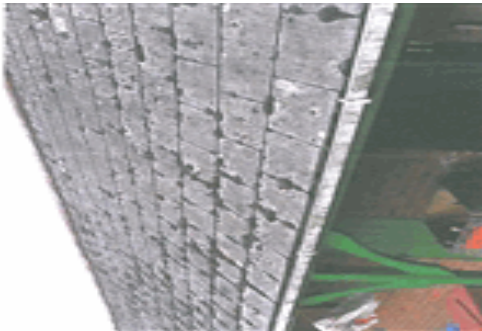
Room:
Location: Roof tile over store rooms GD-0025-28
Use: Reefs
Reference: 633057
Sample number: HRP0905113
Presumed: No
REMOVED (See ASB3 20/05/2013)

Product type: AIB,textiles,gaskets,ropes,paper(2)
Damage: Low damage (1)
Surface treatment: Enclosed sprays or lagging/bare-
cement (1)
Asbestos type: Chrysotile (1)
Extent: 10 to 50m2 or 10 to 50m pipe run
Material score:
Priority score:
Banding:

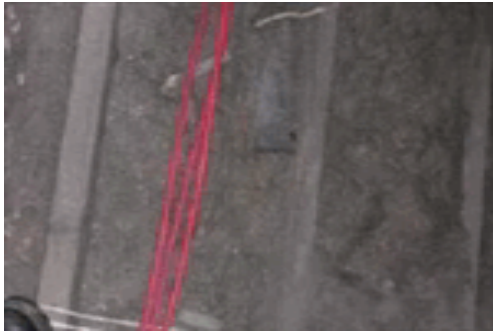
Room:
Location: Room 1 (High level Roofspace over hall) -
Cement roof tiles and associated debris
Use: Roof
Reference: 633100
Sample number: EH002916
Presumed: No

Materials can be removed by a non-licensed
contractor in accordance with the Control of
Asbestos Regulations 2012.
No access during annual inspection

Product type: Composites(1)
Damage: Good-no damage (0)
Surface treatment: Enclosed sprays or lagging/bare
cement (1)
Asbestos type: Chrysotile (1)
Extent: >50m2 or >50m pipe run

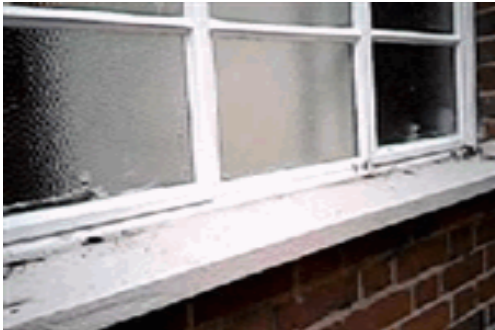
Room: External
Location: Putty to windows throughout

Use: External walls, windows and doors
Reference: 633085
Sample number: EE000879
Presumed: No

Product type: Composites(1)
Damage: Good no damage (0)
Surface treatment: Non friable composite asbestos (0)

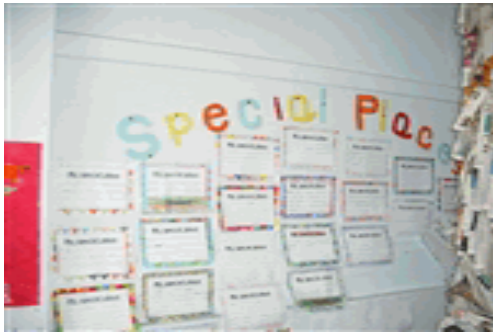
Room: GD.0021 Classroom
Location: ~~Wall panel on chimney breast~~
~~Position :-~~
~~Wall~~
~~Quantity :- 0 to 10 m² :- Cement~~
Use: ~~Walls and partitions~~
Reference: 41281
Sample number: 068
Presumed: ~~No~~

REMOVED (See ASB3 19/10/2011)

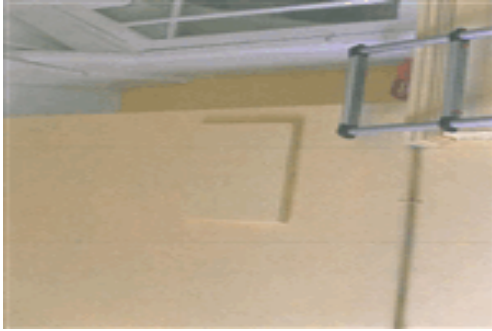
Room: GD.0021 Classroom
Location: Panel at high level
Use: Walls and partitions
Reference: 633052
Sample number: HRP0905144
Presumed: No
REMOVED (See ASB3 20/05/2013)

Product type: AIB,textiles,gaskets,ropes,paper(2)
Damage: Low damage (1)
Surface treatment: Enclosed sprays or lagging/bare-
cement (1)
Asbestos type: Chrysotile (1)
Extent: <=10m2 or <=10m pipe run
Material score:
Priority score:
Banding:

REMOVED

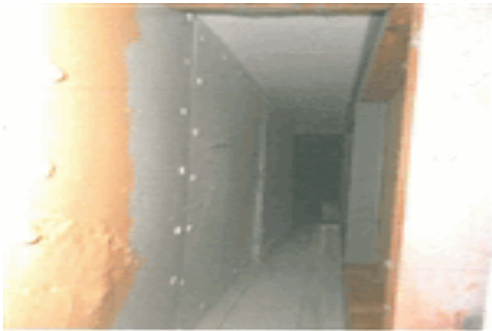
Room: GD.0021 Classroom
Location: Infill panel adj. boxed water tank
Use: Walls and partitions
Reference: 633053
Sample number: HRP0905142
Presumed: No
REMOVED (See ASB3 20/05/2013)

Product type: AIB,textiles,gaskets,ropes,paper(2)
Damage: Low damage (1)
Surface treatment: Enclosed sprays or lagging/bare-
cement (1)
Asbestos type: Chrysotile (1)
Extent: <=10m2 or <=10m pipe run
Material score:
Priority score:
Banding:

REMOVED

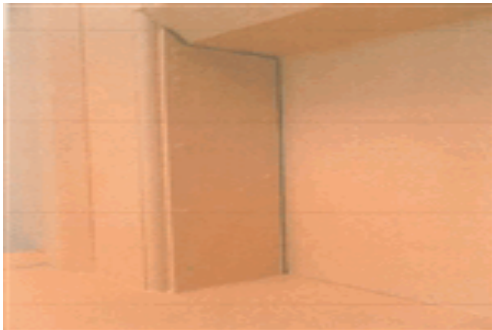
Room: GD.0021 Classroom
Location: Panel covering lintel
Use: Ceiling
Reference: 633054
Sample number:
Presumed: Yes
REMOVED (See ASB3 20/05/2013)

Product type: AIB,textiles,gaskets,ropes,paper(2)
Damage: Low damage (1)
Surface treatment: Enclosed sprays or lagging/bare-
cement (1)
Asbestos type: Chrysotile (1)
Extent: <=10m2 or <=10m pipe run
Material score:
Priority score:
Banding:

REMOVED

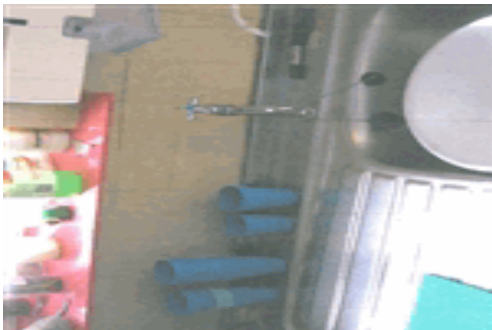
Room: GD.0021 Classroom
Location: Floor tile (on wall)
Use: Floors and stairs
Reference: 633055
Sample number: HRP1506403
Presumed: No
REMOVED (See ASB3 19/10/2011)

Product type: AIB,textiles,gaskets,ropes,paper(2)
Damage: Low damage (1)
Surface treatment: Enclosed sprays or lagging/bare-
cement (1)
Asbestos type: Chrysotile (1)
Extent: <=10m2 or <=10m pipe run
Material score:
Priority score:
Banding:

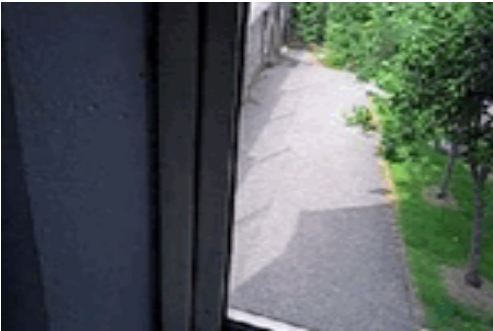
Room: GD.0021 Classroom
Location: Putty to all window surrounds of large metal-framed windows
Use: External walls, windows and doors
Reference: 633078
Sample number: EE000878
Presumed: No
REMOVED (See annual site check 07/01/2014)

Product type: Composites(1)
Damage: Good-no damage (0)
Surface treatment: Non friable composite asbestos (0)
Asbestos type: Chrysotile (1)
Extent: >50m2 or >50m pipe run
Material score:
Priority score:
Banding:
REMOVED

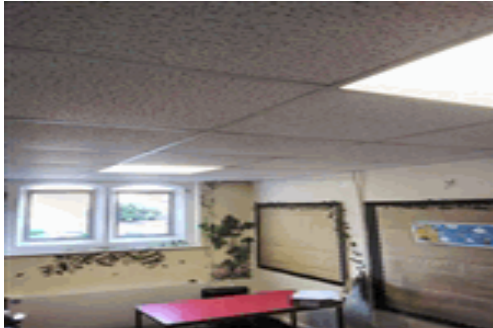
Room:	GD.0007 Special Educational Needs	Product type:	Composites(1)
Location:	Textured coating above ceiling tiles	Damage:	Low damage (1)
Use:	Ceiling	Surface treatment:	Enclosed sprays or lagging/bare cement (1)
Reference:	633116	Asbestos type:	Chrysotile (1)
Sample number:	11	Extent:	10 to 50m2 or 10 to 50m pipe run
Presumed:	No	Material score:	4
Work with this material to be carried out in accordance with the Control of Asbestos Regulations 2012		Priority score:	6
No access during annual inspection		Banding:	Low
		Monitor & Manage

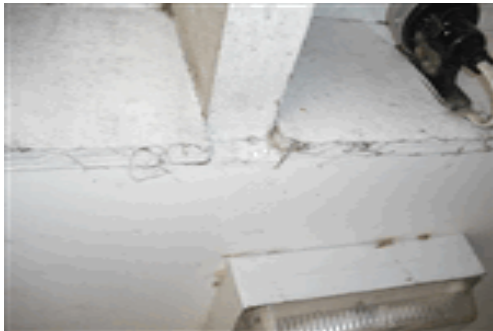
Room: GD.0026 Entrance Step Area
Location: Soffit
Use: Roofs
Reference: 621609
Sample number:
Presumed: Yes
Exercise caution until content established

Product type: AIB,textiles,gaskets,ropes,paper(2)
Damage: Low damage (1)
Surface treatment: Non friable composite asbestos (0)
Asbestos type: Crocidolite (3)
Extent: <=10m2 or <=10m pipe run
Material score: 6
Priority score: 4
Banding: Low

Monitor & Manage

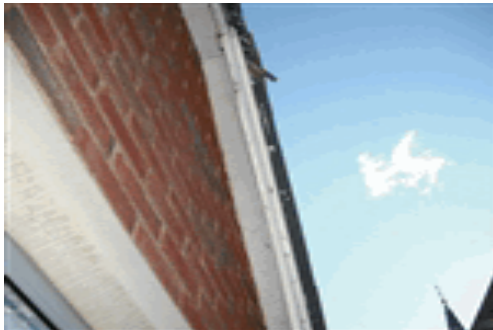
Room: GD.0027 Access Ramp
Location: Soffit
Use: Roofs
Reference: 621610
Sample number:
Presumed: Yes
Exercise caution until content established

Product type: AIB,textiles,gaskets,ropes,paper(2)
Damage: Low damage (1)
Surface treatment: Enclosed sprays or lagging/bare cement (1)
Asbestos type: Crocidolite (3)
Extent: 10 to 50m2 or 10 to 50m pipe run
Material score: 7
Priority score: 4
Banding: Low

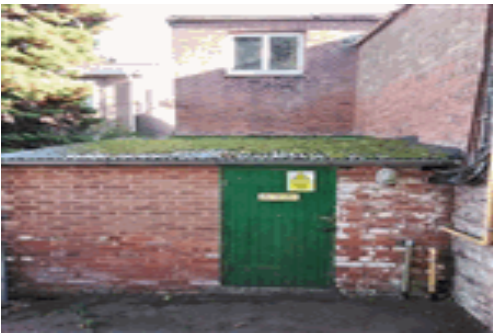
Room:	CW - GD.0002 Roof only	Product type:	Composites(1)
Location:		Damage:	Good-no damage (0)
Use:	Roofs	Surface treatment:	Non friable composite asbestos (0)
Reference:	604136	Asbestos type:	Chrysotile (1)
Sample number:	076	Extent:	>50m2 or >50m pipe run
Presumed:	No	Material score:	2
Moss covered		Priority score:	6
		Banding:	Very Low
			Monitor & Manage

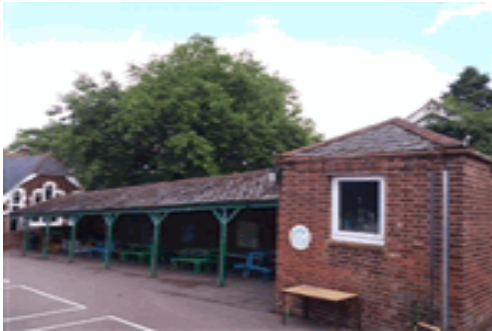
Room: External
Location: Cement roof tiles
Use: Roofs
Reference: 633122
Sample number: 47
Presumed: No
PE Shed roof REMOVED (See ASB3 14/10/2020)

Product type: Composites(1)
Damage: Low damage (1)
Surface treatment: Enclosed sprays or lagging/bare cement (1)
Asbestos type: Chrysotile (1)
Extent: >50m2 or >50m pipe run
Material score:
Priority score:
Banding:

REMOVED

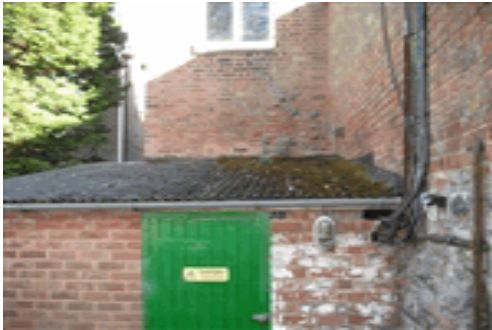
Room: GD.0002 Meter Room
Location: Corrugated sheets Position : Roof and ceiling Quantity : 0 to 10 m² : Cement
Use: Ceilings
Reference: 41289
Sample number: 080
Presumed: No
REMOVED (See ASB3 19/10/2011)

Product type: Composites(1)
Damage: Medium damage (2)
Surface treatment: Non friable composite asbestos (0)
Asbestos type: Chrysotile (1)
Extent: <=10m2 or <=10m pipe run
Material score:
Priority score:
Banding:

REMOVED

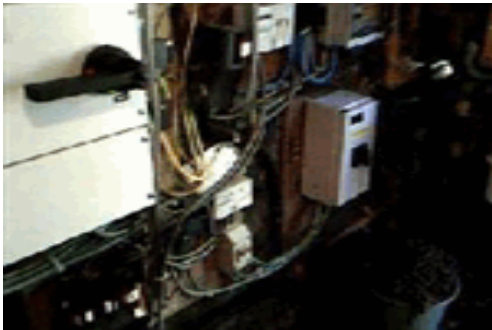
Room: GD.0002 Meter Room
Location: Bitumen coated textile wrapped mains cable - No sample as live.
Use: Electrical Services
Reference: 633058
Sample number:
Presumed: Yes
Materials can be removed by a non-licensed contractor in accordance with the Control of Asbestos Regulations 2012.

Product type: AIB,textiles,gaskets,ropes,paper(2)
Damage: Good-no damage (0)
Surface treatment: Enclosed sprays or lagging/bare cement (1)
Asbestos type: Chrysotile (1)
Extent: <=10m2 or <=10m pipe run
Material score: 4
Priority score: 4
Banding: Very Low

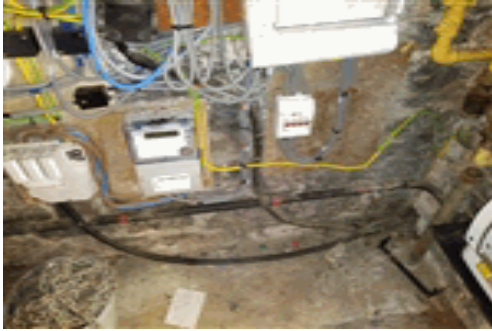
Room: GD.0002 Meter Room
Location: Electrical intake wrapping
Use: Other
Reference: 633137
Sample number: P1
Presumed: No

Not safe to sample. Presumed to contain asbestos. Work with this material to be carried out in accordance with the Control of Asbestos Regulations 2012

Product type: Composites(1)
Damage: Low damage (1)
Surface treatment: Non friable composite asbestos (0)
Asbestos type: Chrysotile (1)
Extent: <=10m2 or <=10m pipe run
Material score: 3
Priority score: 3
Banding: Very Low

Monitor & Manage

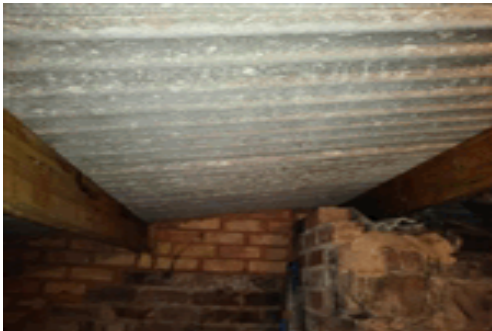
Room: GD.0002 Meter Room
Location: Proiled roof sheets
Use: Roofs
Reference: 633138
Sample number: SP1 (prev EC002141)
Presumed: No

Strongly presumed to contain asbestos. Work with this material to be carried out in accordance with the Control of Asbestos Regulations 2012
Moss covered (See annual site check)

Product type: Composites(1)
Damage: Medium damage (2)
Surface treatment: Enclosed sprays or lagging/bare cement (1)
Asbestos type: Chrysotile (1)
Extent: 10 to 50m2 or 10 to 50m pipe run
Material score: 5
Priority score: 4
Banding: Low

Monitor & Manage

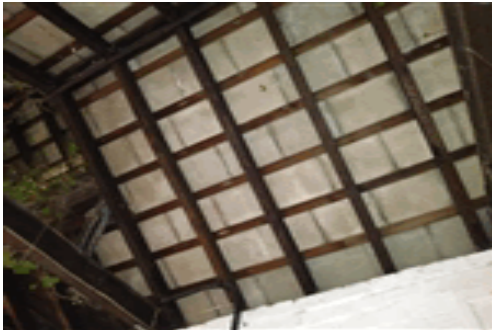
Room: GD.0004 P E Store
Location: Cement roof tiles
Use: Roofs
Reference: 633125
Sample number: as 47
Presumed: Yes

REMOVED (See annual site check 2019)
