ASBESTOS RE-INSPECTION SURVEY REPORT

Site Name and Address	Stoberry Park Primary School, North Road, Wells, BA5 2TJ	
Client Name and Address	Somerset Council, Strategic Asset Management, County Hall, Taunton, Somerset, TA1 4DY	
Client Contact & Phone No.	Oliver Woodhams 07977400667	
Job No.	J006176	
Date of Re-inspection	9th January 2025 to 10th January 2025	
Next Inspection due	09/01/2026	
Report Date	27 Feb 2025	
Report Revision No.	1	
Inspector/Surveyor	Name: Tracy Chulk	Signature:

Report Issue Date	27 Feb 2025

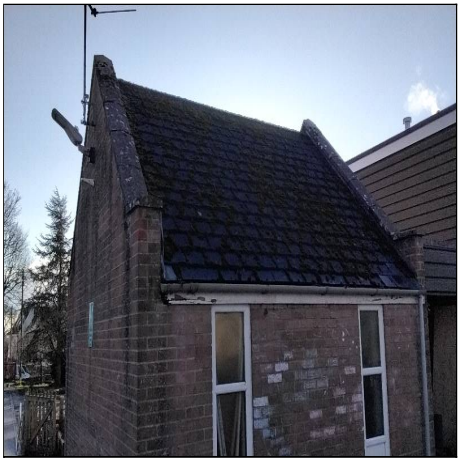
Re-inspection Date:	Lead Surveyor	Survey Type	Floor	Analysis
	9 Jan 2025 to 10 Jan 2025	Tracy Chulk	Reinspection Survey	External	Chrysotile (1)
	Building	Room	Item	Quantity	
	Block A	External Block A	Slates to roof above A058/A059	40m ²	
	Sample No (S,SP,P,As)	Product Type	Surface Treatment	Condition	Accessibility
	20761329 {AB000292}* (S)	Asbestos Cement (1)	Surface Sealed (1)	Good Condition (0)	Usually inaccessible or unlikely to be disturbed (0)

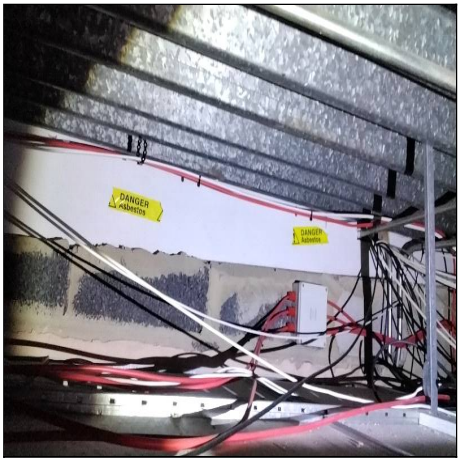
Re-inspection Date:	Lead Surveyor	Survey Type	Floor	Analysis
	9 Jan 2025 to 10 Jan 2025	Tracy Chulk	Reinspection Survey	Ground	Amosite (2)
	Building	Room	Item	Quantity	
	Block A	Lobby A001	Firebreak adjacent wall to A008	2m	
	Sample No (S,SP,P,As)	Product Type	Surface Treatment	Condition	Accessibility
	20761319 {AB000282}* (S)	Asbestos Insulating Board (2)	Surface Sealed (1)	Good Condition (0)	Usually inaccessible or unlikely to be disturbed (0)

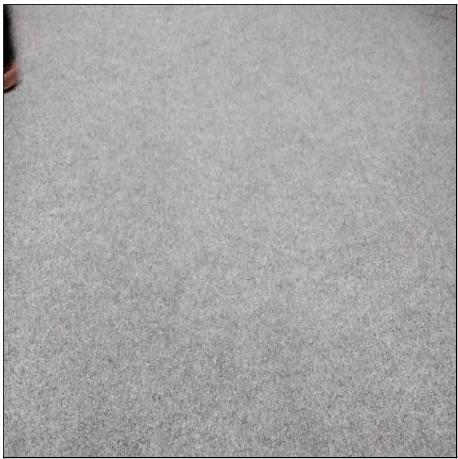
Re-inspection Date:	Lead Surveyor	Survey Type	Floor	Analysis
	9 Jan 2025 to 10 Jan 2025	Tracy Chulk	Reinspection Survey	Ground	Chrysotile (1)
	Building	Room	Item	Quantity	
	Block A	LRC A002	Floor tile adhesive beneath carpet	20m ²	
	Sample No (S,SP,P,As)	Product Type	Surface Treatment	Condition	Accessibility
	As 20761321 {AB000275}* (SP)	Well Bound Material (1)	Completely Sealed (0)	Good Condition (0)	Usually inaccessible or unlikely to be disturbed (0)

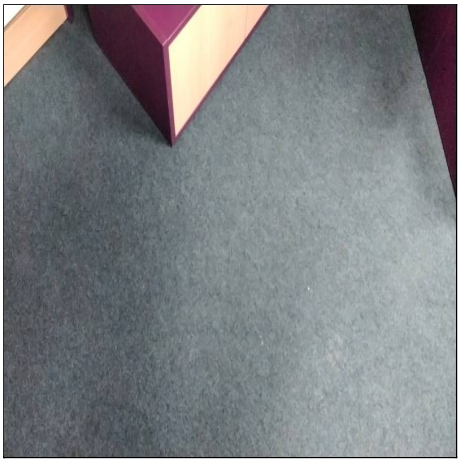
Re-inspection Date:	Lead Surveyor	Survey Type	Floor	Analysis
	9 Jan 2025 to 10 Jan 2025	Tracy Chulk	Reinspection Survey	Ground	Chrysotile (1)
	Building	Room	Item	Quantity	
	Block A	Library A002A	Floor tile adhesive beneath carpet	20m ²	
	Sample No (S,SP,P,As)	Product Type	Surface Treatment	Condition	Accessibility
	As 20761321 {AB000275}* (SP)	Well Bound Material (1)	Completely Sealed (0)	Good Condition (0)	Usually inaccessible or unlikely to be disturbed (0)

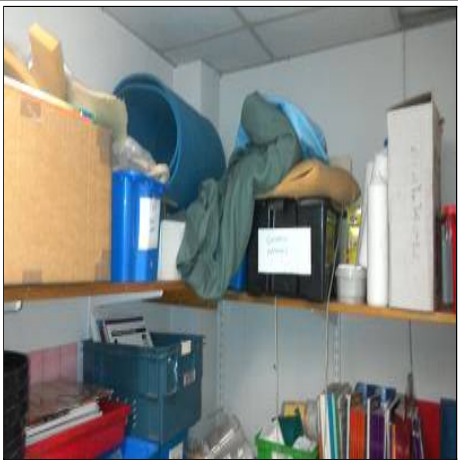
Re-inspection Date:	Lead Surveyor	Survey Type	Floor	Analysis
	9 Jan 2025 to 10 Jan 2025	Tracy Chulk	Reinspection Survey	Ground	N/A
	Building	Room	Item	Quantity	
	Block A	Store A002B	Vertical boxing NW corner	N/A	
	Sample No (S,SP,P,As)	Product Type	Surface Treatment	Condition	Accessibility
	Visual (P)	N/A	N/A	N/A	N/A

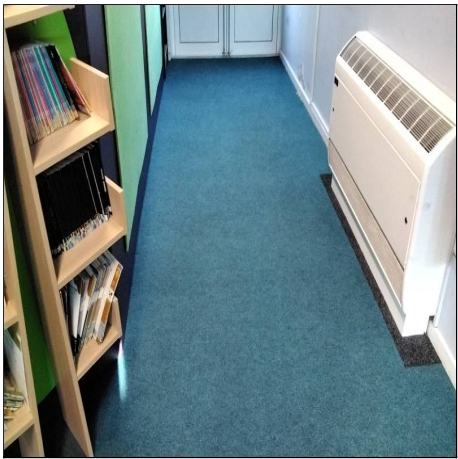
Re-inspection Date:	Lead Surveyor	Survey Type	Floor	Analysis
	9 Jan 2025 to 10 Jan 2025	Tracy Chulk	Reinspection Survey	Ground	Chrysotile (1)
	Building	Room	Item	Quantity	
	Block A	Circulation A002C	Floor tile adhesive beneath carpet	15m ²	
	Sample No (S,SP,P,As)	Product Type	Surface Treatment	Condition	Accessibility
	20761321 {AB000275} * (S)	Well Bound Material (1)	Completely Sealed (0)	Good Condition (0)	Usually inaccessible or unlikely to be disturbed (0)

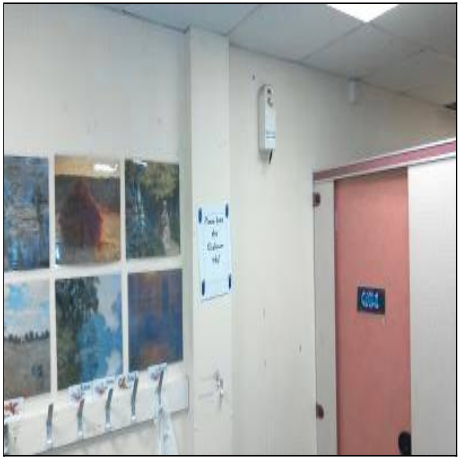
Re-inspection Date:	Lead Surveyor	Survey Type	Floor	Analysis
	9 Jan 2025 to 10 Jan 2025	Tracy Chulk	Reinspection Survey	Ground	N/A
	Building	Room	Item	Quantity	
	Block A	Pupils cloak A003	Vertical wooden boxing West wall	N/A	
	Sample No (S,SP,P,As)	Product Type	Surface Treatment	Condition	Accessibility
	Visual (P)	N/A	N/A	N/A	N/A

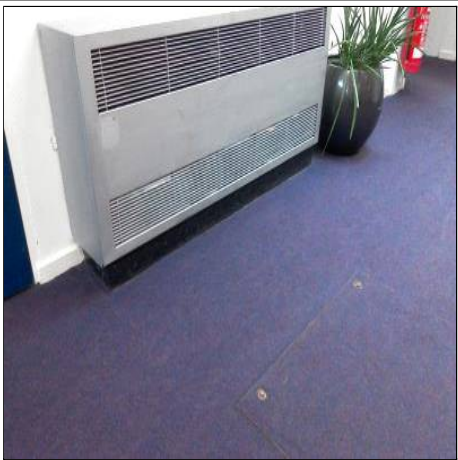
Re-inspection Date:	Lead Surveyor	Survey Type	Floor	Analysis
	9 Jan 2025 to 10 Jan 2025	Tracy Chulk	Reinspection Survey	Ground	N/A
	Building	Room	Item	Quantity	
	Block A	Circulation A004	Beneath fan convector unit	N/A	
	Sample No (S,SP,P,As)	Product Type	Surface Treatment	Condition	Accessibility
	Visual (P)	N/A	N/A	N/A	N/A

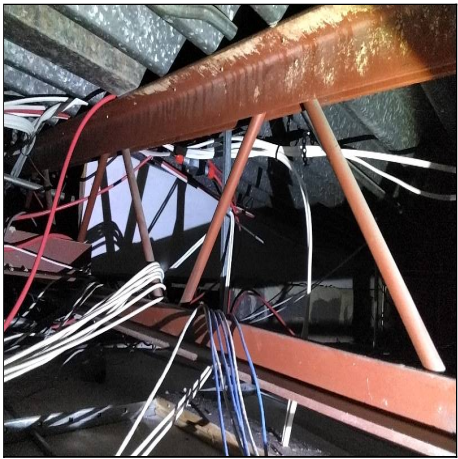
Re-inspection Date:	Lead Surveyor	Survey Type	Floor	Analysis
	9 Jan 2025 to 10 Jan 2025	Tracy Chulk	Reinspection Survey	Ground	Chrysotile + Amosite (2)
	Building	Room	Item	Quantity	
	Block A	Circulation A004	Firebreak adjacent wall to A001	2m	
	Sample No (S,SP,P,As)	Product Type	Surface Treatment	Condition	Accessibility
	20761319 {AB000280}* (S)	Asbestos Insulating Board (2)	Surface Sealed (1)	Good Condition (0)	Usually inaccessible or unlikely to be disturbed (0)

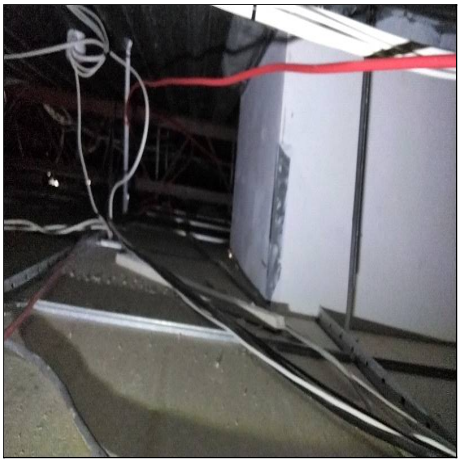
Re-inspection Date:	Lead Surveyor	Survey Type	Floor	Analysis
	9 Jan 2025 to 10 Jan 2025	Tracy Chulk	Reinspection Survey	Ground	Amosite (2)
	Building	Room	Item	Quantity	
	Block A	Circulation A004	Skylight cheeks (sealed both sides)	2m ²	
	Sample No (S,SP,P,As)	Product Type	Surface Treatment	Condition	Accessibility
	9506917 {AB000281}* (S)	Asbestos Insulating Board (2)	Surface Sealed (1)	Good Condition (0)	Usually inaccessible or unlikely to be disturbed (0)

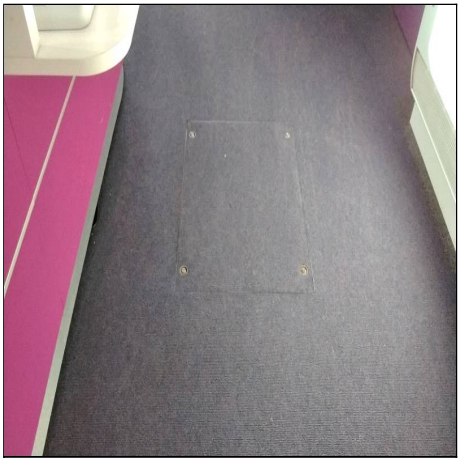
Re-inspection Date:	Lead Surveyor	Survey Type	Floor	Analysis
	9 Jan 2025 to 10 Jan 2025	Tracy Chulk	Reinspection Survey	Ground	Chrysotile (1)
	Building	Room	Item	Quantity	
	Block A	Circulation A004	Shuttering in soil waste floor ducts	1m ²	
	Sample No (S,SP,P,As)	Product Type	Surface Treatment	Condition	Accessibility
	AB000288* (S)	Asbestos Cement (1)	Surface Sealed (1)	Good Condition (0)	Usually inaccessible or unlikely to be disturbed (0)

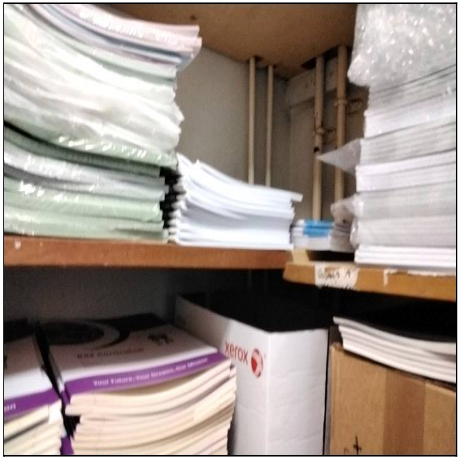
Re-inspection Date:	Lead Surveyor	Survey Type	Floor	Analysis
	9 Jan 2025 to 10 Jan 2025	Tracy Chulk	Reinspection Survey	Ground	N/A
	Building	Room	Item	Quantity	
	Block A	Store A005	Void where pipes enter the floor construction	N/A	
	Sample No (S,SP,P,As)	Product Type	Surface Treatment	Condition	Accessibility
	Visual (P)	N/A	N/A	N/A	N/A

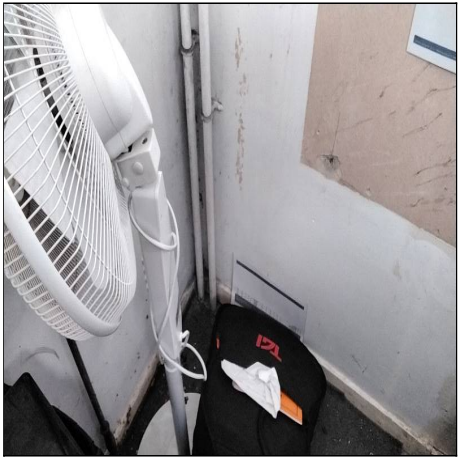
Re-inspection Date:	Lead Surveyor	Survey Type	Floor	Analysis
	9 Jan 2025 to 10 Jan 2025	Tracy Chulk	Reinspection Survey	Ground	N/A
	Building	Room	Item	Quantity	
	Block A	Cleaner A006	Void where pipes enter floor construction	N/A	
	Sample No (S,SP,P,As)	Product Type	Surface Treatment	Condition	Accessibility
	Visual (P)	N/A	N/A	N/A	N/A

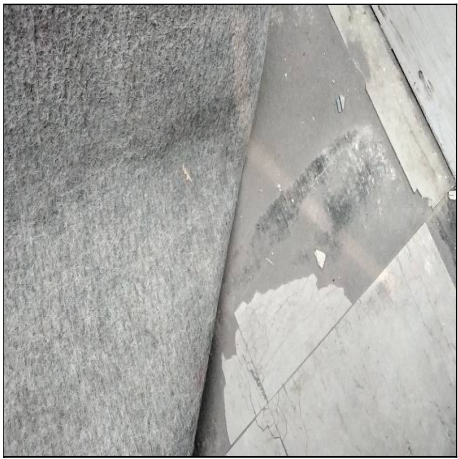
Re-inspection Date:	Lead Surveyor	Survey Type	Floor	Analysis
	9 Jan 2025 to 10 Jan 2025	Tracy Chulk	Reinspection Survey	Ground	Chrysotile (1)
	Building	Room	Item	Quantity	
	Block A	Cleaner A006	Vinyl floor tiles beneath carpet	3m ²	
	Sample No (S,SP,P,As)	Product Type	Surface Treatment	Condition	Accessibility
	20761327 {AB000284}* (S)	Well Bound Material (1)	Completely Sealed (0)	Low Damage (1)	Usually inaccessible or unlikely to be disturbed (0)

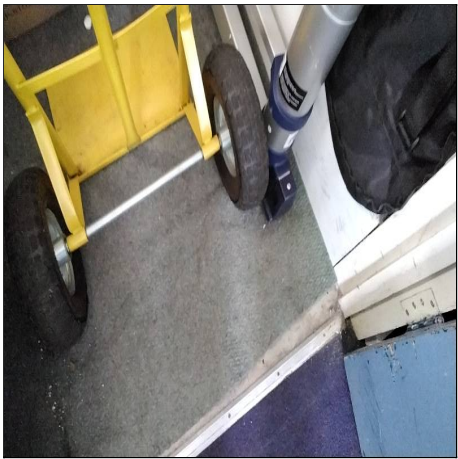
Re-inspection Date:	Lead Surveyor	Survey Type	Floor	Analysis
	9 Jan 2025 to 10 Jan 2025	Tracy Chulk	Reinspection Survey	Ground	Chrysotile (1)
	Building	Room	Item	Quantity	
	Block A	Cleaner A006	Floor tile adhesive beneath carpet	3m ²	
	Sample No (S,SP,P,As)	Product Type	Surface Treatment	Condition	Accessibility
	20761327 {AB000285}* (S)	Well Bound Material (1)	Completely Sealed (0)	Good Condition (0)	Usually inaccessible or unlikely to be disturbed (0)

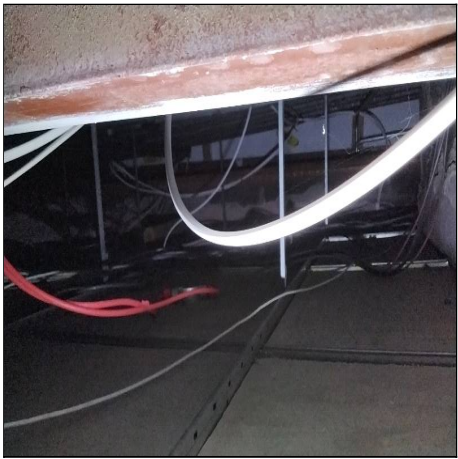
Re-inspection Date:	Lead Surveyor	Survey Type	Floor	Analysis
	9 Jan 2025 to 10 Jan 2025	Tracy Chulk	Reinspection Survey	Ground	Crocidolite (or unknown) (3)
	Building	Room	Item	Quantity	
	Block A	Office A008	Firebreak above wall to A001	2m	
	Sample No (S,SP,P,As)	Product Type	Surface Treatment	Condition	Accessibility
	Visual (P)	Asbestos Insulating Board (2)	Surface Sealed (1)	Good Condition (0)	Usually inaccessible or unlikely to be disturbed (0)

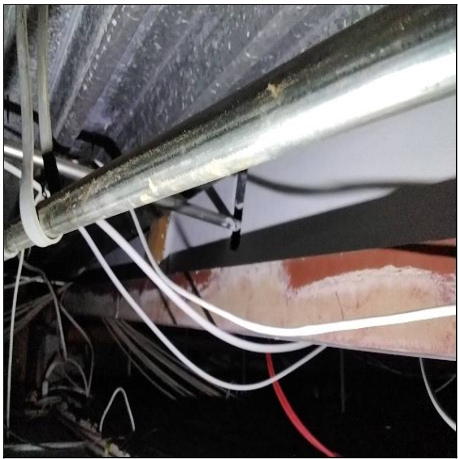
Re-inspection Date:	Lead Surveyor	Survey Type	Floor	Analysis
	9 Jan 2025 to 10 Jan 2025	Tracy Chulk	Reinspection Survey	Ground	Crocidolite (or unknown) (3)
	Building	Room	Item	Quantity	
	Block A	Office A008	Firebreak across centre of room	3m	
	Sample No (S,SP,P,As)	Product Type	Surface Treatment	Condition	Accessibility
	Visual (P)	Asbestos Insulating Board (2)	Surface Sealed (1)	Good Condition (0)	Usually inaccessible or unlikely to be disturbed (0)

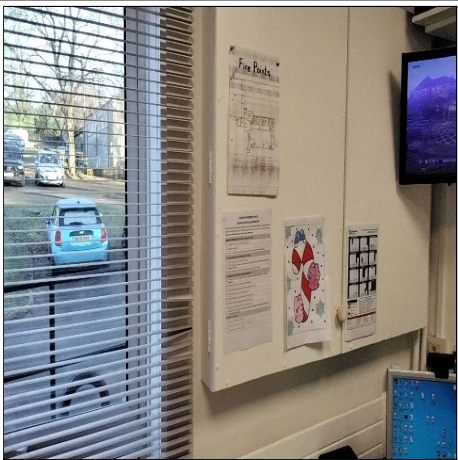
Re-inspection Date:	Lead Surveyor	Survey Type	Floor	Analysis
	9 Jan 2025 to 10 Jan 2025	Tracy Chulk	Reinspection Survey	Ground	N/A
	Building	Room	Item	Quantity	
	Block A	Office A008	Wall safe to North East corner	N/A	
	Sample No (S,SP,P,As)	Product Type	Surface Treatment	Condition	Accessibility
	Visual (P)	N/A	N/A	N/A	N/A

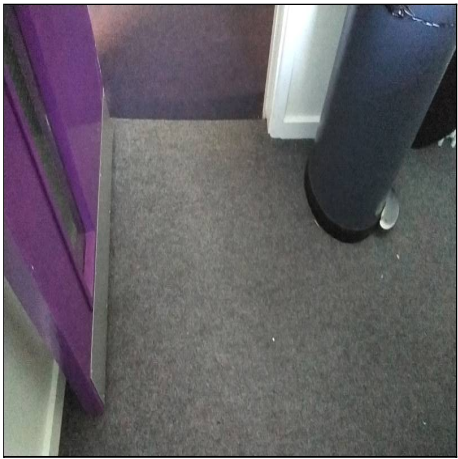
Re-inspection Date:	Lead Surveyor	Survey Type	Floor	Analysis
	9 Jan 2025 to 10 Jan 2025	Tracy Chulk	Reinspection Survey	Ground	Chrysotile (1)
	Building	Room	Item	Quantity	
	Block A	Office A009	Vinyl floor tiles beneath carpet	8m ²	
	Sample No (S,SP,P,As)	Product Type	Surface Treatment	Condition	Accessibility
	20761320 {AB000289}* (S)	Well Bound Material (1)	Completely Sealed (0)	Good Condition (0)	Usually inaccessible or unlikely to be disturbed (0)

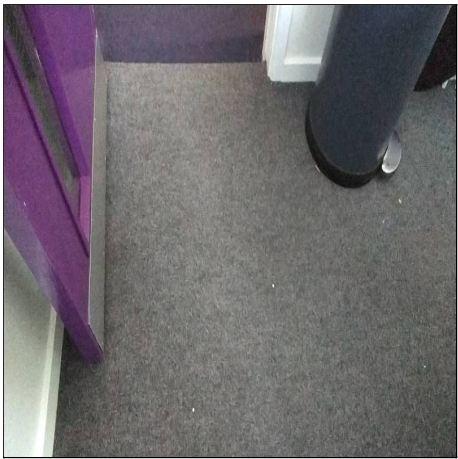
Re-inspection Date:	Lead Surveyor	Survey Type	Floor	Analysis
	9 Jan 2025 to 10 Jan 2025	Tracy Chulk	Reinspection Survey	Ground	Chrysotile (1)
	Building	Room	Item	Quantity	
	Block A	Office A009	Floor tile adhesive beneath carpet	8m ²	
	Sample No (S,SP,P,As)	Product Type	Surface Treatment	Condition	Accessibility
	20761320 {AB000290}* (S)	Well Bound Material (1)	Completely Sealed (0)	Good Condition (0)	Usually inaccessible or unlikely to be disturbed (0)

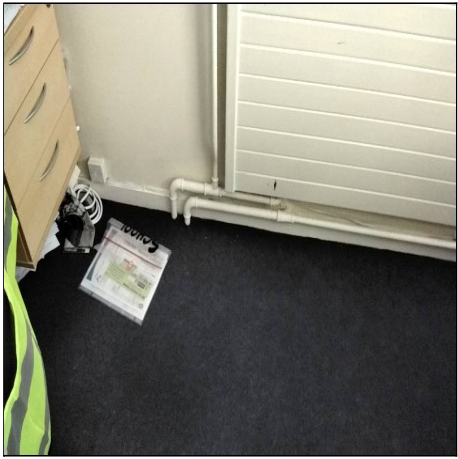
Re-inspection Date:	Lead Surveyor	Survey Type	Floor	Analysis
	9 Jan 2025 to 10 Jan 2025	Tracy Chulk	Reinspection Survey	Ground	N/A
	Building	Room	Item	Quantity	
	Block A	Head A010	Void where pipes enter floor construction	N/A	
	Sample No (S,SP,P,As)	Product Type	Surface Treatment	Condition	Accessibility
	Visual (P)	N/A	N/A	N/A	N/A

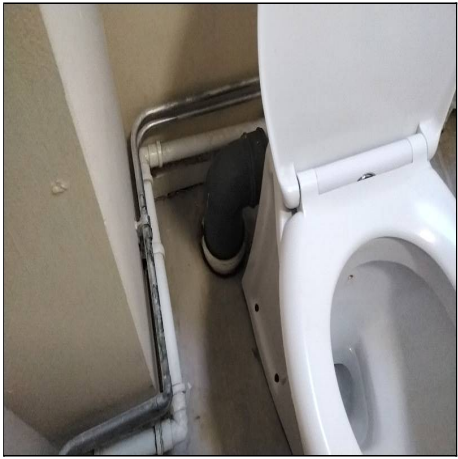
Re-inspection Date:	Lead Surveyor	Survey Type	Floor	Analysis
	9 Jan 2025 to 10 Jan 2025	Tracy Chulk	Reinspection Survey	Ground	N/A
	Building	Room	Item	Quantity	
	Block A	Staff WC A012	Void where pipe enters floor construction	N/A	
	Sample No (S,SP,P,As)	Product Type	Surface Treatment	Condition	Accessibility
	Visual (P)	N/A	N/A	N/A	N/A

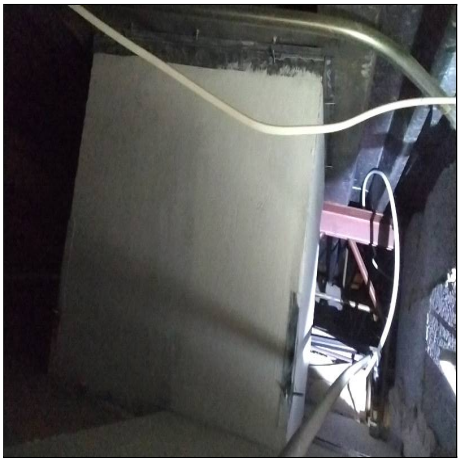
Re-inspection Date:	Lead Surveyor	Survey Type	Floor	Analysis
	9 Jan 2025 to 10 Jan 2025	Tracy Chulk	Reinspection Survey	Ground	Amosite (2)
	Building	Room	Item	Quantity	
	Block A	Staff WC A012	Skylight cheeks South end of room (sealed both sides)	2m ²	
	Sample No (S,SP,P,As)	Product Type	Surface Treatment	Condition	Accessibility
	As 9506917 {AB000281}* (SP)	Asbestos Insulating Board (2)	Surface Sealed (1)	Good Condition (0)	Usually inaccessible or unlikely to be disturbed (0)

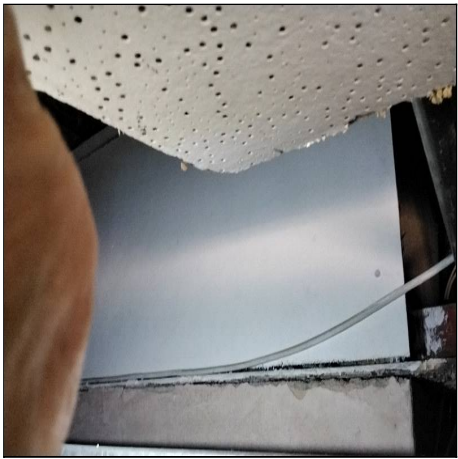
Re-inspection Date:	Lead Surveyor	Survey Type	Floor	Analysis
	9 Jan 2025 to 10 Jan 2025	Tracy Chulk	Reinspection Survey	Ground	Crocidolite (or unknown) (3)
	Building	Room	Item	Quantity	
	Block A	Circulation A014A	Firebreak above wall to A031	2m	
	Sample No (S,SP,P,As)	Product Type	Surface Treatment	Condition	Accessibility
	Visual (P)	Asbestos Insulating Board (2)	Surface Sealed (1)	Good Condition (0)	Usually inaccessible or unlikely to be disturbed (0)

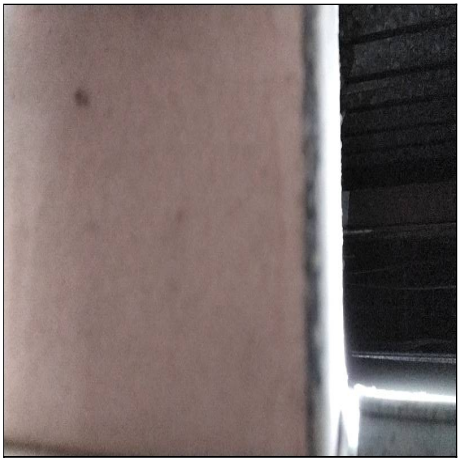
Re-inspection Date:	Lead Surveyor	Survey Type	Floor	Analysis
	9 Jan 2025 to 10 Jan 2025	Tracy Chulk	Reinspection Survey	Ground	Crocidolite (or unknown) (3)
	Building	Room	Item	Quantity	
	Block A	Circulation A014A	Firebreak above wall to A037	2m	
	Sample No (S,SP,P,As)	Product Type	Surface Treatment	Condition	Accessibility
	Visual (P)	Asbestos Insulating Board (2)	Surface Sealed (1)	Good Condition (0)	Usually inaccessible or unlikely to be disturbed (0)

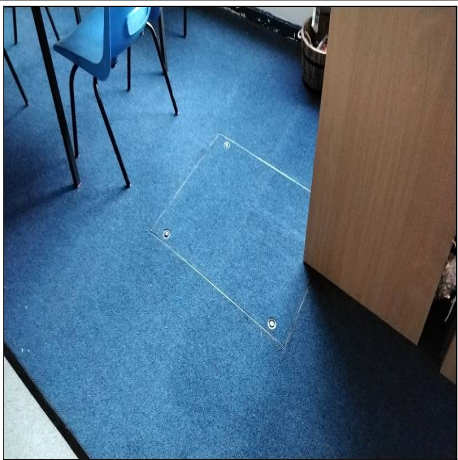
Re-inspection Date:	Lead Surveyor	Survey Type	Floor	Analysis
	9 Jan 2025 to 10 Jan 2025	Tracy Chulk	Reinspection Survey	Ground	N/A
	Building	Room	Item	Quantity	
	Block A	Circulation A014A	Floor void	N/A	
	Sample No (S,SP,P,As)	Product Type	Surface Treatment	Condition	Accessibility
	Visual (P)	N/A	N/A	N/A	N/A

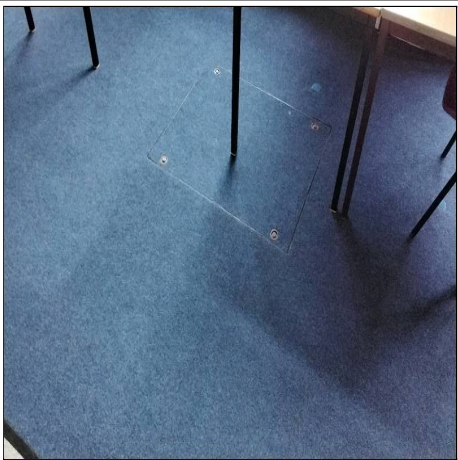
Re-inspection Date:	Lead Surveyor	Survey Type	Floor	Analysis
	9 Jan 2025 to 10 Jan 2025	Tracy Chulk	Reinspection Survey	Ground	N/A
	Building	Room	Item	Quantity	
	Block A	Circulation A014B	Floor void	N/A	
	Sample No (S,SP,P,As)	Product Type	Surface Treatment	Condition	Accessibility
	Visual (P)	N/A	N/A	N/A	N/A

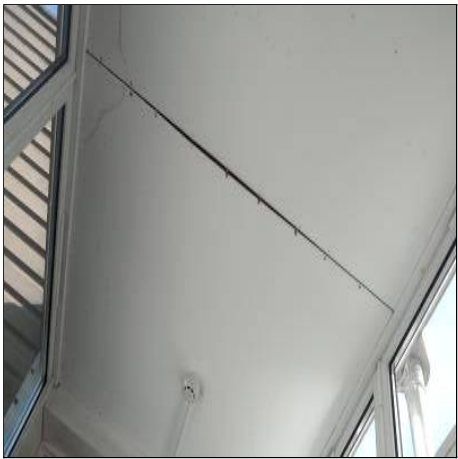
Re-inspection Date:	Lead Surveyor	Survey Type	Floor	Analysis
	9 Jan 2025 to 10 Jan 2025	Tracy Chulk	Reinspection Survey	Ground	No Asbestos Detected (0)
	Building	Room	Item	Quantity	
	Block A	Circulation A014B	Fixed fibreboard ceiling panels	6m ²	
	Sample No (S,SP,P,As)	Product Type	Surface Treatment	Condition	Accessibility
	21361194 {AB000276} * (S)	Not applicable (No asbestos detected) (0)	Completely Sealed (0)	Good Condition (0)	Usually inaccessible or unlikely to be disturbed (0)

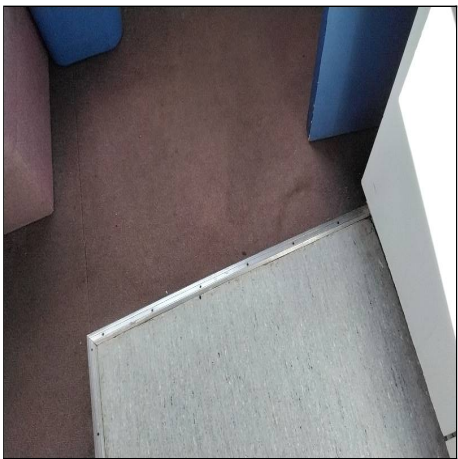
Re-inspection Date:	Lead Surveyor	Survey Type	Floor	Analysis
	9 Jan 2025 to 10 Jan 2025	Tracy Chulk	Reinspection Survey	Ground	Chrysotile (1)
	Building	Room	Item	Quantity	
	Block A	Staff room A015	Bitumen adhesive to floor where tiles removed, beneath carpet, screed and modern vinyl sheet.	35-40m ²	
	Sample No (S,SP,P,As)	Product Type	Surface Treatment	Condition	Accessibility
	BF000352* (S)	Reinforced Composite (1)	Completely Sealed (0)	Good Condition (0)	Usually inaccessible or unlikely to be disturbed (0)

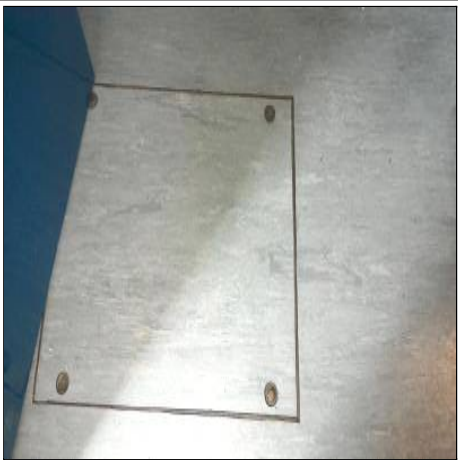
Re-inspection Date:	Lead Surveyor	Survey Type	Floor	Analysis
	9 Jan 2025 to 10 Jan 2025	Tracy Chulk	Reinspection Survey	Ground	N/A
	Building	Room	Item	Quantity	
	Block A	Staff cloak A016	Floor void	N/A	
	Sample No (S,SP,P,As)	Product Type	Surface Treatment	Condition	Accessibility
	Visual (P)	N/A	N/A	N/A	N/A

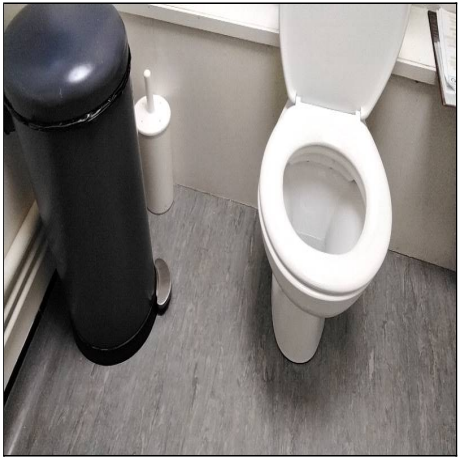
Re-inspection Date:	Lead Surveyor	Survey Type	Floor	Analysis
	9 Jan 2025 to 10 Jan 2025	Tracy Chulk	Reinspection Survey	Ground	N/A
	Building	Room	Item	Quantity	
	Block A	Staff WC A017	Void where soil pipe enters floor construction	N/A	
	Sample No (S,SP,P,As)	Product Type	Surface Treatment	Condition	Accessibility
	Visual (P)	N/A	N/A	N/A	N/A

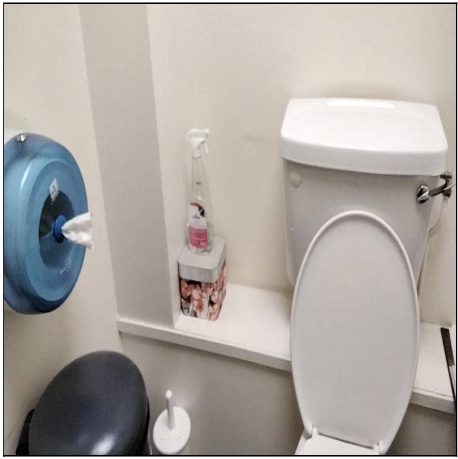
Re-inspection Date:	Lead Surveyor	Survey Type	Floor	Analysis
	9 Jan 2025 to 10 Jan 2025	Tracy Chulk	Reinspection Survey	Ground	N/A
	Building	Room	Item	Quantity	
	Block A	Staff WC A017	Horizontal and vertical boxing behind WC	N/A	
	Sample No (S,SP,P,As)	Product Type	Surface Treatment	Condition	Accessibility
	Visual (P)	N/A	N/A	N/A	N/A

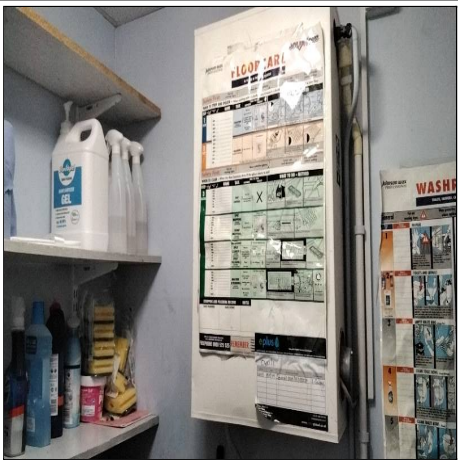
Re-inspection Date:	Lead Surveyor	Survey Type	Floor	Analysis
	9 Jan 2025 to 10 Jan 2025	Tracy Chulk	Reinspection Survey	Ground	N/A
	Building	Room	Item	Quantity	
	Block A	Cleaner A018A	Water heater	N/A	
	Sample No (S,SP,P,As)	Product Type	Surface Treatment	Condition	Accessibility
	Visual (P)	N/A	N/A	N/A	N/A

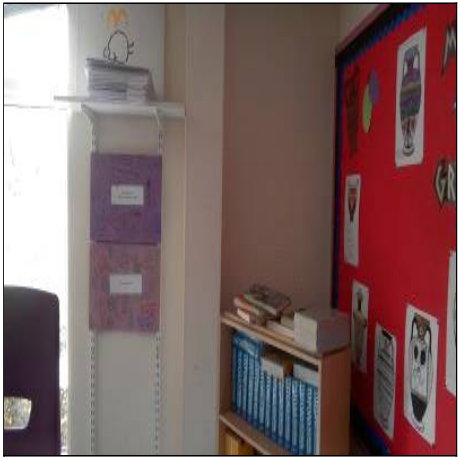
Re-inspection Date:	Lead Surveyor	Survey Type	Floor	Analysis
	9 Jan 2025 to 10 Jan 2025	Tracy Chulk	Reinspection Survey	Ground	N/A
	Building	Room	Item	Quantity	
	Block A	Classroom A019	Vertical wooden boxing NW corner	N/A	
	Sample No (S,SP,P,As)	Product Type	Surface Treatment	Condition	Accessibility
	Visual (P)	N/A	N/A	N/A	N/A

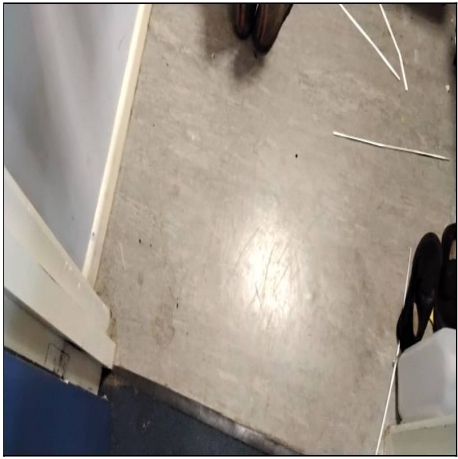
Re-inspection Date:	Lead Surveyor	Survey Type	Floor	Analysis
	9 Jan 2025 to 10 Jan 2025	Tracy Chulk	Reinspection Survey	Ground	N/A
	Building	Room	Item	Quantity	
	Block A	Store A019A	Beneath modern vinyl floor sheet	N/A	Accessibility
	Sample No (S,SP,P,As)	Product Type	Surface Treatment	Condition	
	Visual (P)	N/A	N/A	N/A	N/A

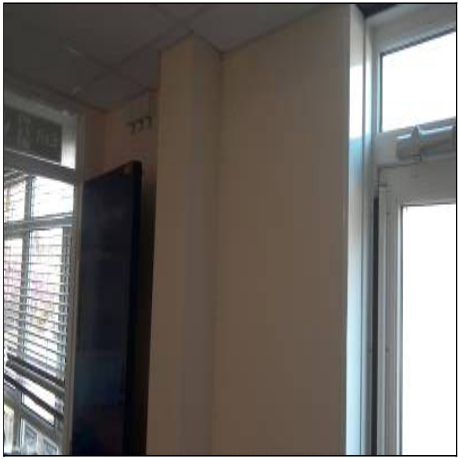
Re-inspection Date:	Lead Surveyor	Survey Type	Floor	Analysis
	9 Jan 2025 to 10 Jan 2025	Tracy Chulk	Reinspection Survey	Ground	N/A
	Building	Room	Item	Quantity	
	Block A	Circulation A022	Vertical wooden boxing West wall	N/A	
	Sample No (S,SP,P,As)	Product Type	Surface Treatment	Condition	Accessibility
	Visual (P)	N/A	N/A	N/A	N/A

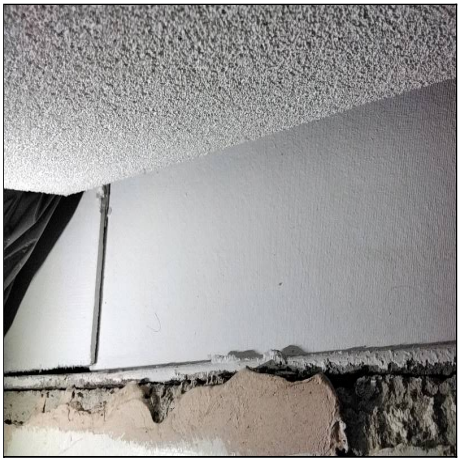
Re-inspection Date:	Lead Surveyor	Survey Type	Floor	Analysis
	9 Jan 2025 to 10 Jan 2025	Tracy Chulk	Reinspection Survey	Ground	Amosite (2)
	Building	Room	Item	Quantity	
	Block A	Circulation A022	Firebreak above wall to A019	5m	
	Sample No (S,SP,P,As)	Product Type	Surface Treatment	Condition	Accessibility
	As DD000841 (SP)	Asbestos Insulating Board (2)	Surface Sealed (1)	Good Condition (0)	Usually inaccessible or unlikely to be disturbed (0)

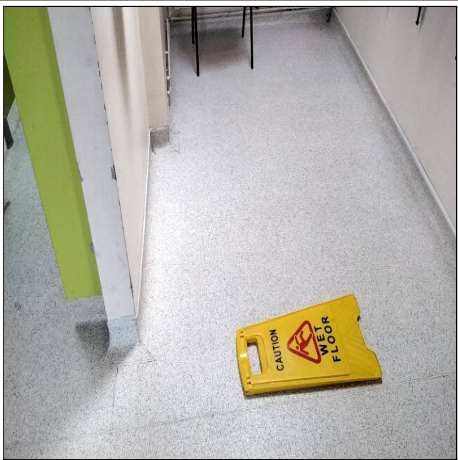
Re-inspection Date:	Lead Surveyor	Survey Type	Floor	Analysis
	9 Jan 2025 to 10 Jan 2025	Tracy Chulk	Reinspection Survey	Ground	N/A
	Building	Room	Item	Quantity	
	Block A	Pupils cloak A022A	Floor void	N/A	N/A
	Sample No (S,SP,P,As)	Product Type	Surface Treatment	Condition	
	Visual (P)	N/A	N/A	N/A

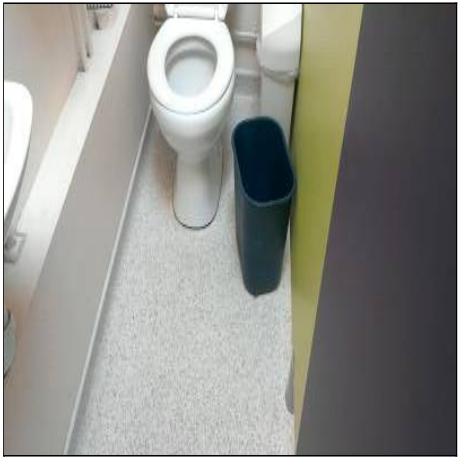
Re-inspection Date:	Lead Surveyor	Survey Type	Floor	Analysis
	9 Jan 2025 to 10 Jan 2025	Tracy Chulk	Reinspection Survey	Ground	N/A
	Building	Room	Item	Quantity	
	Block A	Girls WC A023	Void where pipe enters floor construction	N/A	
	Sample No (S,SP,P,As)	Product Type	Surface Treatment	Condition	Accessibility
	Visual (P)	N/A	N/A	N/A	N/A

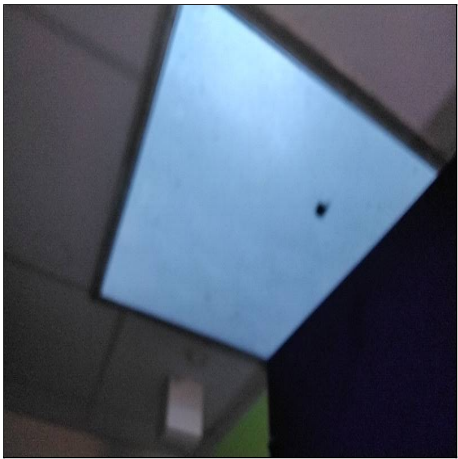
Re-inspection Date:	Lead Surveyor	Survey Type	Floor	Analysis
	9 Jan 2025 to 10 Jan 2025	Tracy Chulk	Reinspection Survey	Ground	Crocidolite (or unknown) (3)
	Building	Room	Item	Quantity	
	Block A	Girls WC A023	Skylight cheeks (sealed both sides)	2m ²	
	Sample No (S,SP,P,As)	Product Type	Surface Treatment	Condition	Accessibility
	Visual (P)	Asbestos Insulating Board (2)	Surface Sealed (1)	Good Condition (0)	Usually inaccessible or unlikely to be disturbed (0)

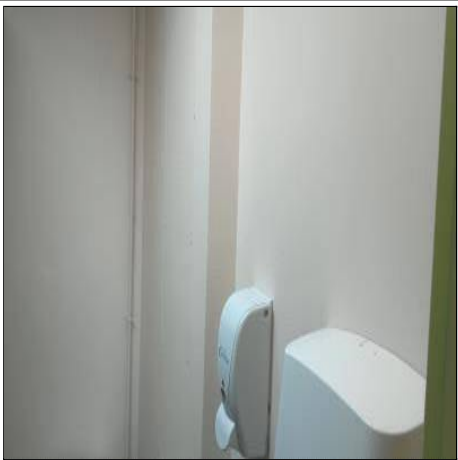
Re-inspection Date:	Lead Surveyor	Survey Type	Floor	Analysis
	9 Jan 2025 to 10 Jan 2025	Tracy Chulk	Reinspection Survey	Ground	N/A
	Building	Room	Item	Quantity	
	Block A	Girls WC A023	Wall void	N/A	
	Sample No (S,SP,P,As)	Product Type	Surface Treatment	Condition	Accessibility
	Visual (P)	N/A	N/A	N/A	N/A

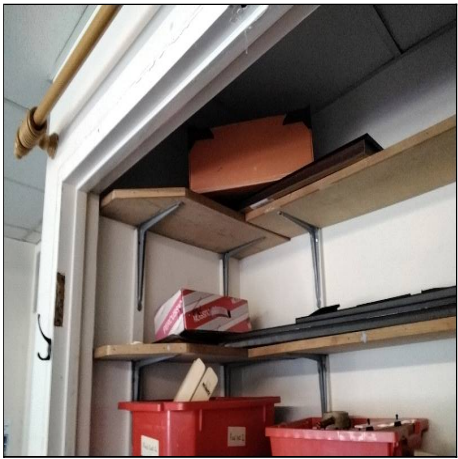
Re-inspection Date:	Lead Surveyor	Survey Type	Floor	Analysis
	9 Jan 2025 to 10 Jan 2025	Tracy Chulk	Reinspection Survey	Ground	Crocidolite (or unknown) (3)
	Building	Room	Item	Quantity	
	Block A	Store A027	Firebreak above wall to A025	2m ²	
	Sample No (S,SP,P,As)	Product Type	Surface Treatment	Condition	Accessibility
	Visual (P)	Asbestos Insulating Board (2)	Surface Sealed (1)	Good Condition (0)	Usually inaccessible or unlikely to be disturbed (0)

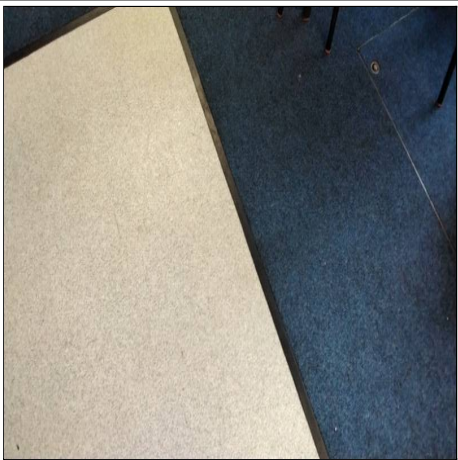
Re-inspection Date:	Lead Surveyor	Survey Type	Floor	Analysis
	9 Jan 2025 to 10 Jan 2025	Tracy Chulk	Reinspection Survey	Ground	N/A
	Building	Room	Item	Quantity	
	Block A	Practical A028	Floor void	N/A	
	Sample No (S,SP,P,As)	Product Type	Surface Treatment	Condition	Accessibility
	Visual (P)	N/A	N/A	N/A	N/A

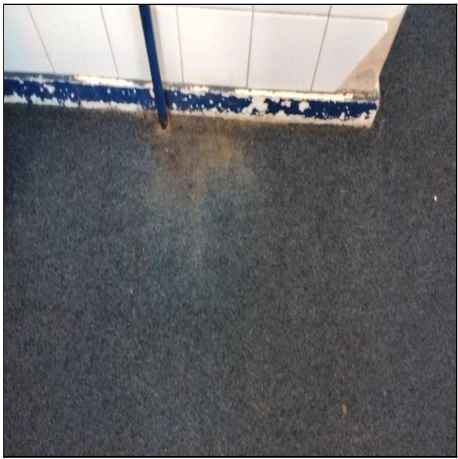
Re-inspection Date:	Lead Surveyor	Survey Type	Floor	Analysis
	9 Jan 2025 to 10 Jan 2025	Tracy Chulk	Reinspection Survey	Ground	Chrysotile (1)
	Building	Room	Item	Quantity	
	Block A	Practical A028B	Vinyl floor tiles beneath carpet	2m ²	
	Sample No (S,SP,P,As)	Product Type	Surface Treatment	Condition	Accessibility
	Visual (P)	Well-bound Material (1)	Completely Sealed (0)	Good Condition (0)	Usually inaccessible or unlikely to be disturbed (0)

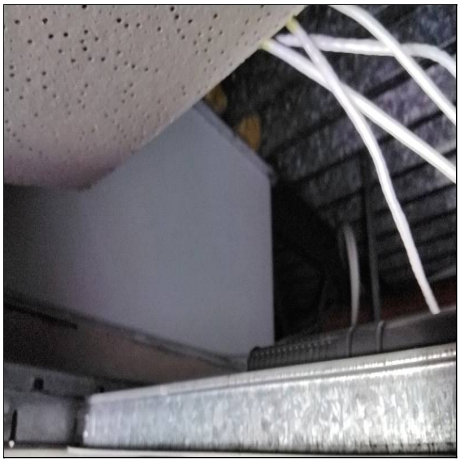
Re-inspection Date:	Lead Surveyor	Survey Type	Floor	Analysis
	9 Jan 2025 to 10 Jan 2025	Tracy Chulk	Reinspection Survey	Ground	Crocidolite (or unknown) (3)
	Building	Room	Item	Quantity	
	Block A	Classroom A029	Firebreak in ceiling void above East wall to A031	1m	
	Sample No (S,SP,P,As)	Product Type	Surface Treatment	Condition	Accessibility
	Visual (P)	Asbestos Insulating Board (2)	Surface Sealed (1)	Good Condition (0)	Usually inaccessible or unlikely to be disturbed (0)

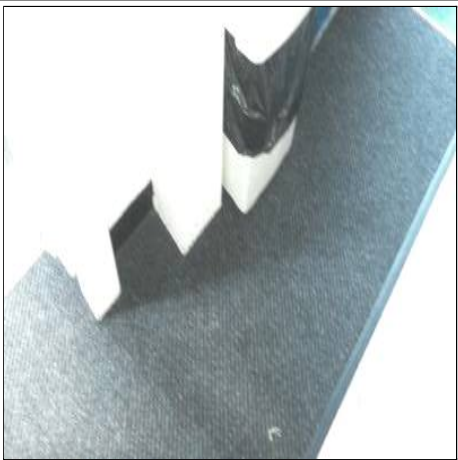
Re-inspection Date:	Lead Surveyor	Survey Type	Floor	Analysis
	9 Jan 2025 to 10 Jan 2025	Tracy Chulk	Reinspection Survey	Ground	N/A
	Building	Room	Item	Quantity	
	Block A	Circulation A032	Floor void	N/A	
	Sample No (S,SP,P,As)	Product Type	Surface Treatment	Condition	Accessibility
	Visual (P)	N/A	N/A	N/A	N/A

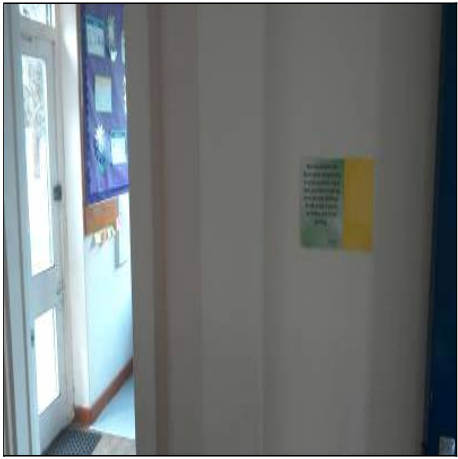
Re-inspection Date:	Lead Surveyor	Survey Type	Floor	Analysis
	9 Jan 2025 to 10 Jan 2025	Tracy Chulk	Reinspection Survey	Ground	N/A
	Building	Room	Item	Quantity	
	Block A	Circulation A032	Vertical wooden boxing South wall	N/A	
	Sample No (S,SP,P,As)	Product Type	Surface Treatment	Condition	Accessibility
	Visual (P)	N/A	N/A	N/A	N/A
