ASBESTOS REINSPECTION SURVEY
OF
GALMPTON C OF E PRIMARY SCHOOL, GREENWAY ROAD, BRIXHAM, TQ5 0LT

CLIENT: TORBAY DEVELOPMENT AGENCY
3RD FLOOR, TOR HILL HOUSE, UNION STREET, TORQUAY, TQ2 5QW

SITE UPRN NO: P3005
PROJECT NO: J826225
SURVEY START DATE: 26 Oct 2022
NUMBER OF ASBESTOS CONTAINING MATERIALS IDENTIFIED: 7

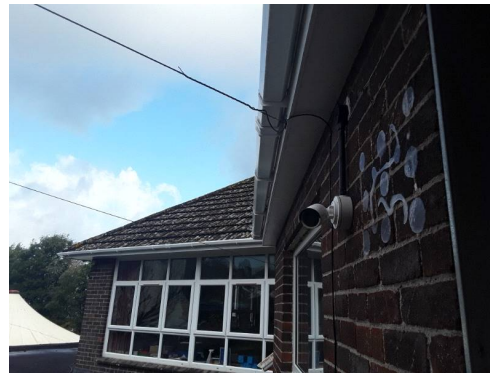
BUILDING NAME:	Main Building
FLOOR/LOCATION:	First Floor External
DESCRIPTION:	Soffits
RECOMMENDATIONS:	Manage, monitor and inform maintenance personnel prior to relevant works
EXTENT:	10 - 50 m ² or 10 - 50m pipe run
SAMPLE REF:	DJ221007/01 {CW009474}*
RESULT:	Chrysotile + Crocidolite

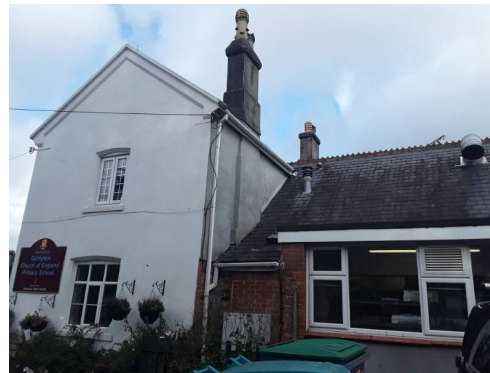
BUILDING NAME:	Main Building
FLOOR/LOCATION:	First Floor External
DESCRIPTION:	Presumed asbestos containing materials within cowl to roof - unable to sample due to height restrictions
RECOMMENDATIONS:	Conduct further investigation prior to relevant maintenance / refurbishment / demolition work
EXTENT:	<10m ² or <10m pipe run
SAMPLE REF:	Presumed
RESULT:	Presumed Crocidolite (or unknown)

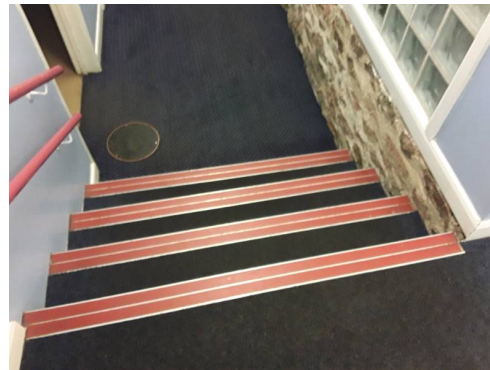
BUILDING NAME:	Main Building
FLOOR/LOCATION:	0024
DESCRIPTION:	Red Stair Nosings
RECOMMENDATIONS:	Manage, monitor and inform maintenance personnel prior to relevant works
EXTENT:	10 - 50 m ² or 10 - 50m pipe run
SAMPLE REF:	IW020806/02 {CW009471}*
RESULT:	Chrysotile

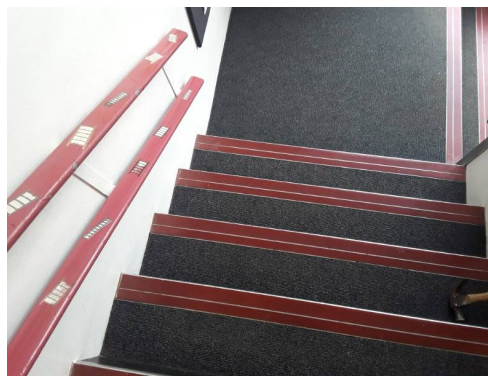
BUILDING NAME:	Main Building
FLOOR/LOCATION:	0070
DESCRIPTION:	Stair Nosings
RECOMMENDATIONS:	Manage, monitor and inform maintenance personnel prior to relevant works
EXTENT:	<10m ² or <10m pipe run
SAMPLE REF:	SPST IW020806/02 {CW009471}*
RESULT:	Chrysotile

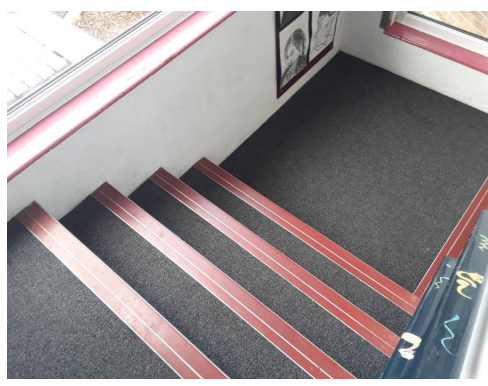
BUILDING NAME:	Main Building
FLOOR/LOCATION:	0072
DESCRIPTION:	Stair Nosings
RECOMMENDATIONS:	Manage, monitor and inform maintenance personnel prior to relevant works
EXTENT:	<10m ² or <10m pipe run
SAMPLE REF:	SPST IW020806/02 {CW009471}*
RESULT:	Chrysotile

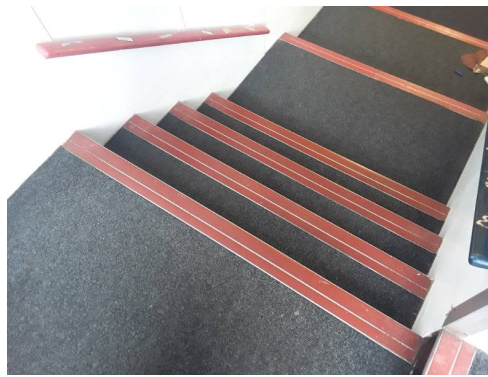
BUILDING NAME:	Main Building
FLOOR/LOCATION:	0070
DESCRIPTION:	Red Stair nosing
RECOMMENDATIONS:	Manage, monitor and inform maintenance personnel prior to relevant works
EXTENT:	<10m ² or <10m pipe run
SAMPLE REF:	IW020806/02 {EP004173}*
RESULT:	Chrysotile

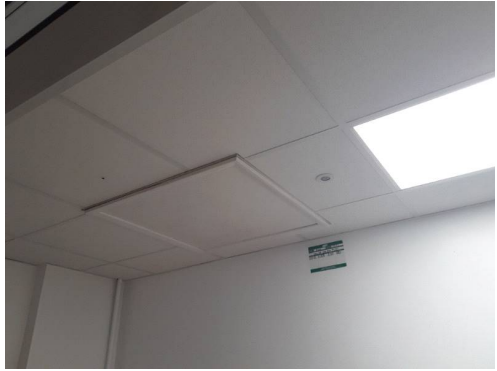
BUILDING NAME:	Main Building
FLOOR/LOCATION:	078
DESCRIPTION:	Presumed asbestos containing materials within felt - unable to safely access to sample (Unable to access during re-inspection 2022)
RECOMMENDATIONS:	Conduct further investigation prior to relevant maintenance / refurbishment / demolition work
EXTENT:	<10m ² or <10m pipe run
SAMPLE REF:	Presumed
RESULT:	Presumed Crocidolite (or unknown)
