**ASBESTOS REINSPECTION SURVEY
OF
REDHILLS SCHOOL, LANDHAYES ROAD, EXETER, DEVON, EX4 2BY**

**CLIENT: TORBAY DEVELOPMENT AGENCY
3RD FLOOR, TOR HILL HOUSE, UNION STREET, TORQUAY, TQ2 5QW**

**SITE UPRN NO: N/A
PROJECT NO: J617237
SURVEY START DATE: 22 Jul 2020
NUMBER OF ASBESTOS CONTAINING MATERIALS IDENTIFIED: 82**

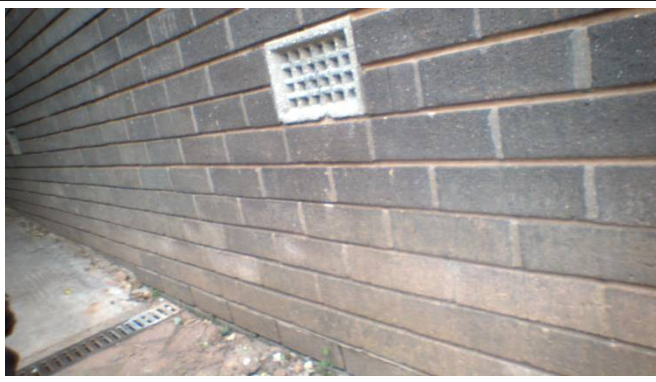
FLOOR/LOCATION:	External	
DESCRIPTION:	Damp proof course	
RECOMMENDATIONS:	Manage, monitor and inform maintenance personnel prior to relevant works	
EXTENT:	>50m ² or >50m pipe run	
SAMPLE REF:	EC002397 {GW003836}	
RESULT:	Chrysotile

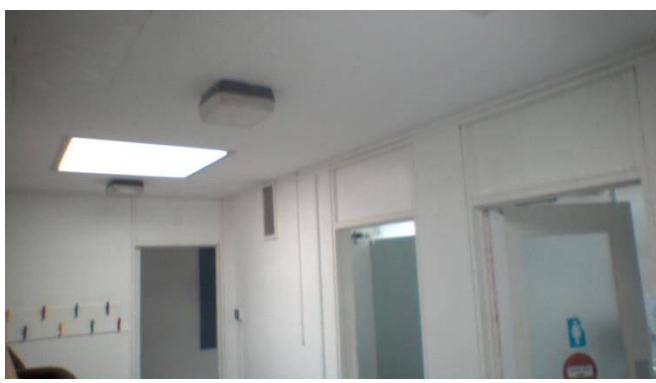
FLOOR/LOCATION:	0051	
DESCRIPTION:	Cement infill panels over doors to 0052, 0053, 0050, 0054	
RECOMMENDATIONS:	Manage, monitor and inform maintenance personnel prior to relevant works	
EXTENT:	<10m ² or <10m pipe run	
SAMPLE REF:	EC004646 {GW003837}	
RESULT:	Chrysotile

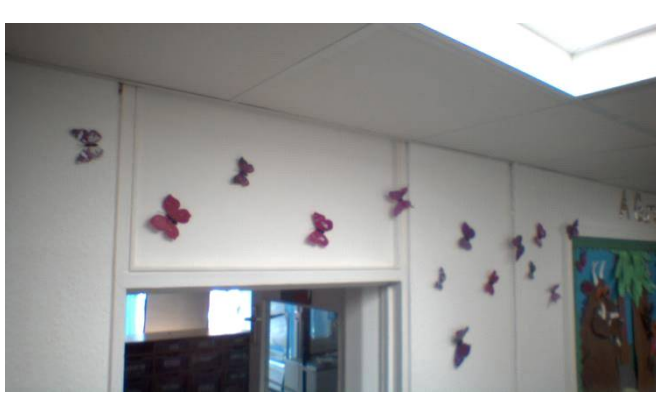
FLOOR/LOCATION:	0005	
DESCRIPTION:	Cement infill panels over doors to 0022, 0023, 0024	
RECOMMENDATIONS:	Manage, monitor and inform maintenance personnel prior to relevant works	
EXTENT:	<10m ² or <10m pipe run	
SAMPLE REF:	SPST EC004646 {GW003837}	
RESULT:	Chrysotile

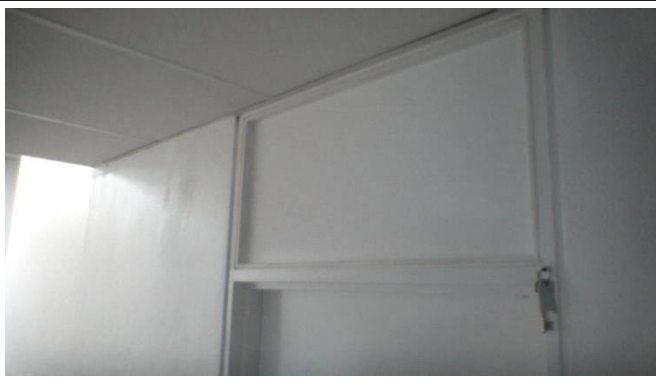
FLOOR/LOCATION:	0006	
DESCRIPTION:	Panel above door	
RECOMMENDATIONS:	Manage, monitor and inform maintenance personnel prior to relevant works	
EXTENT:	<10m ² or <10m pipe run	
SAMPLE REF:	123 {GW003838}	
RESULT:	Chrysotile

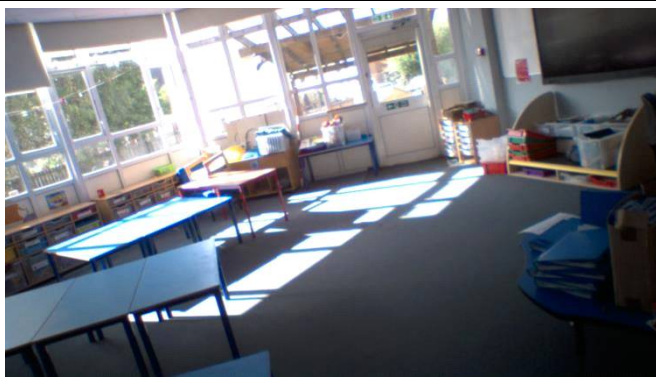
FLOOR/LOCATION:	0007	
DESCRIPTION:	Grey floor tiles	
RECOMMENDATIONS:	Manage, monitor and inform maintenance personnel prior to relevant works	
EXTENT:	>50m ² or >50m pipe run	
SAMPLE REF:	125 {GW003839}	
RESULT:	Chrysotile

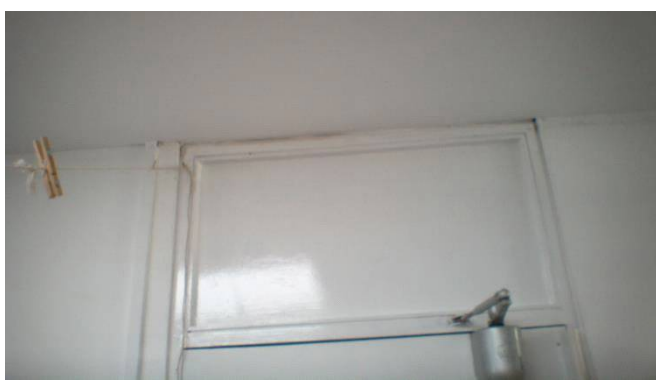
FLOOR/LOCATION:	0007	
DESCRIPTION:	Cement infill panels over door and below glazed wall	
RECOMMENDATIONS:	Manage, monitor and inform maintenance personnel prior to relevant works	
EXTENT:	<10m ² or <10m pipe run	
SAMPLE REF:	EC004654 {GW003840}	
RESULT:	Chrysotile

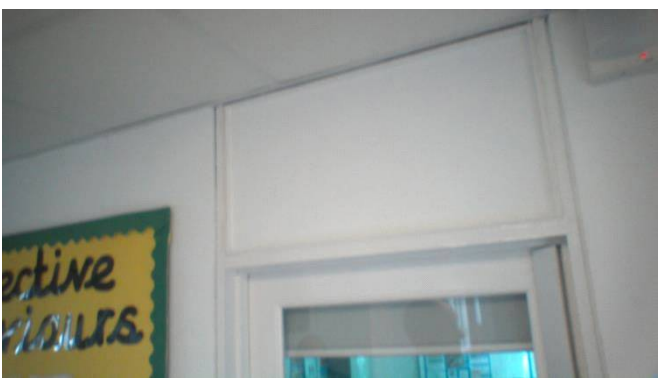
FLOOR/LOCATION:	0011	
DESCRIPTION:	Cement infill panels over door	
RECOMMENDATIONS:	Manage, monitor and inform maintenance personnel prior to relevant works	
EXTENT:	<10m ² or <10m pipe run	
SAMPLE REF:	SPST EC004646 {GW003837}	
RESULT:	Chrysotile

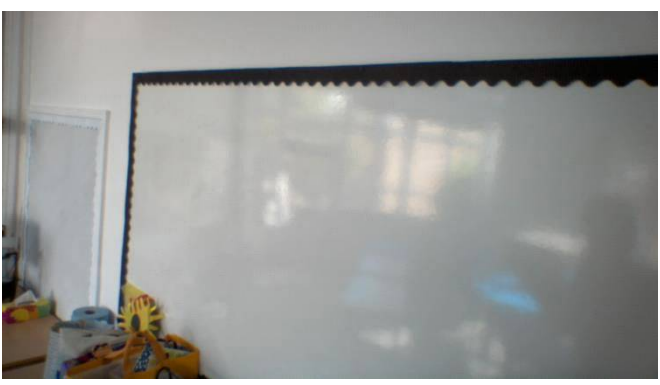
FLOOR/LOCATION:	0012	
DESCRIPTION:	Blackboard (coloured green), covered by new white board.	
RECOMMENDATIONS:	Manage, monitor and inform maintenance personnel prior to relevant works	
EXTENT:	<10m ² or <10m pipe run	
SAMPLE REF:	124 {GW003841}	
RESULT:	Chrysotile

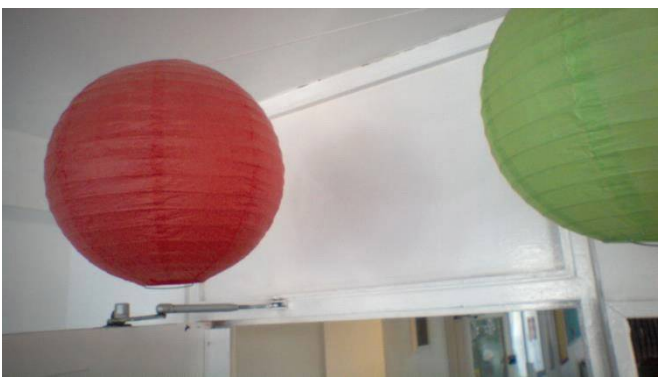
FLOOR/LOCATION:	0012	
DESCRIPTION:	Cement infill panel over door	
RECOMMENDATIONS:	Manage, monitor and inform maintenance personnel prior to relevant works	
EXTENT:	<10m ² or <10m pipe run	
SAMPLE REF:	SPST EC004654 {GW003840}	
RESULT:	Chrysotile

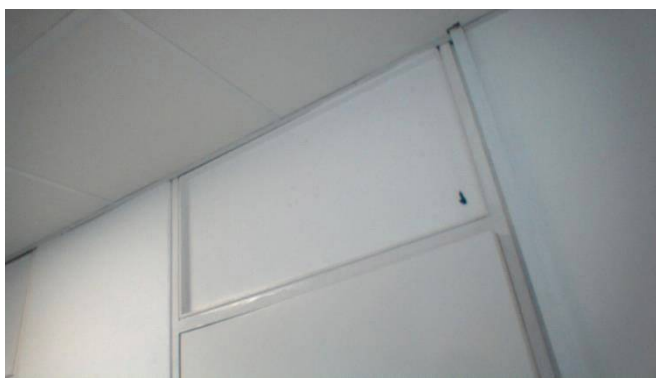
FLOOR/LOCATION:	0013	
DESCRIPTION:	Cement infill panel over door	
RECOMMENDATIONS:	Manage, monitor and inform maintenance personnel prior to relevant works	
EXTENT:	<10m ² or <10m pipe run	
SAMPLE REF:	SPST EC004646 {GW003837}	
RESULT:	Chrysotile

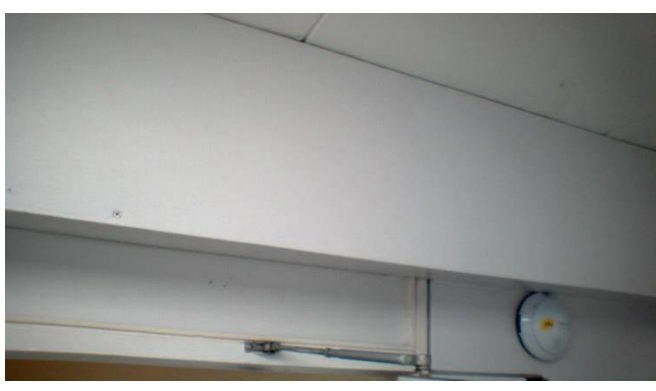
FLOOR/LOCATION:	0014	
DESCRIPTION:	Cement infill panel over door	
RECOMMENDATIONS:	Manage, monitor and inform maintenance personnel prior to relevant works	
EXTENT:	<10m ² or <10m pipe run	
SAMPLE REF:	SPST EC004646 {GW003837}	
RESULT:	Chrysotile

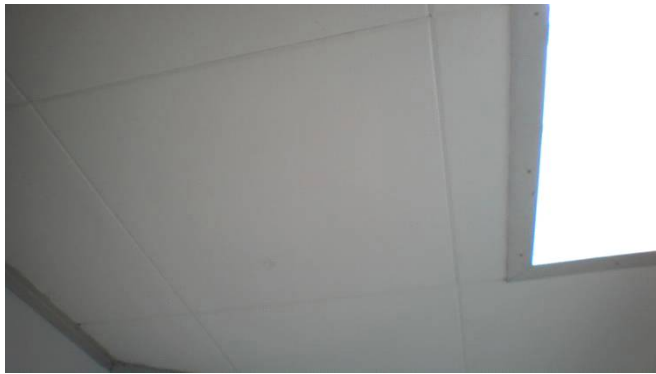
FLOOR/LOCATION:	0014	
DESCRIPTION:	Fixed ceiling tiles	
RECOMMENDATIONS:	Manage, monitor and inform maintenance personnel prior to relevant works	
EXTENT:	<10m ² or <10m pipe run	
SAMPLE REF:	EC004658 {GW003842}	
RESULT:	Amosite

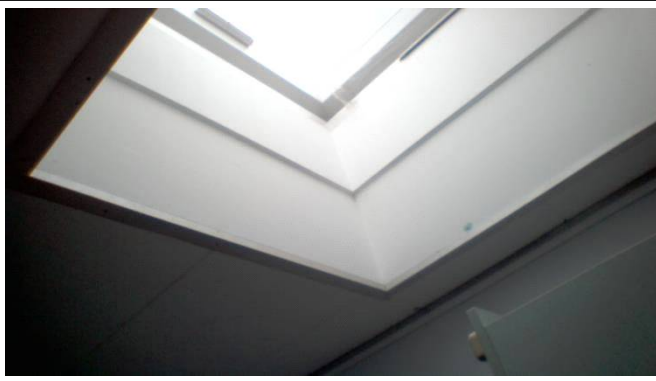
FLOOR/LOCATION:	0014	
DESCRIPTION:	Skylight upstands	
RECOMMENDATIONS:	Manage, monitor and inform maintenance personnel prior to relevant works	
EXTENT:	<10m ² or <10m pipe run	
SAMPLE REF:	EC004659 {GW003843}	
RESULT:	Amosite

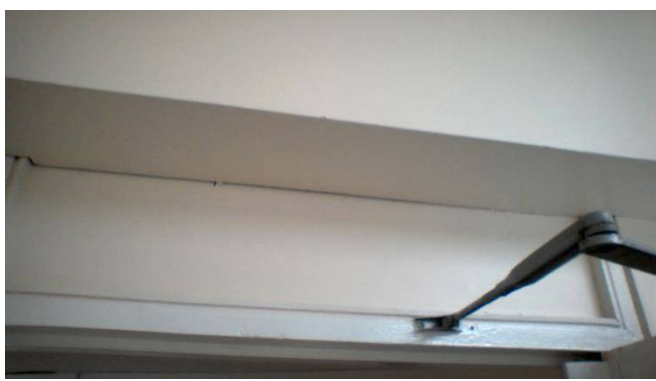
FLOOR/LOCATION:	0015	
DESCRIPTION:	Cement infill panel over door	
RECOMMENDATIONS:	Manage, monitor and inform maintenance personnel prior to relevant works	
EXTENT:	<10m ² or <10m pipe run	
SAMPLE REF:	SPST EC004646 {GW003837}	
RESULT:	Chrysotile

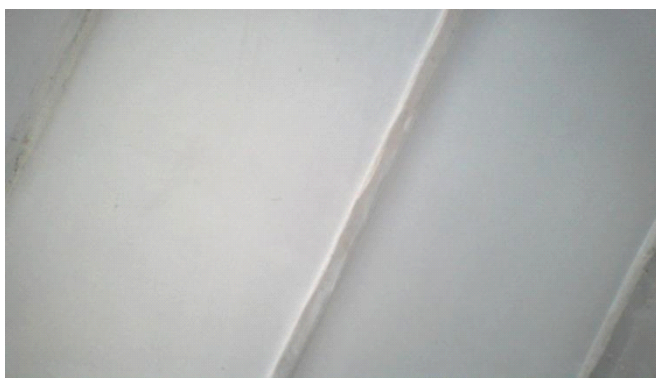
FLOOR/LOCATION:	0015	
DESCRIPTION:	Fixed ceiling tiles	
RECOMMENDATIONS:	Manage, monitor and inform maintenance personnel prior to relevant works	
EXTENT:	<10m ² or <10m pipe run	
SAMPLE REF:	SPST EC004658 {GW003842}	
RESULT:	Amosite

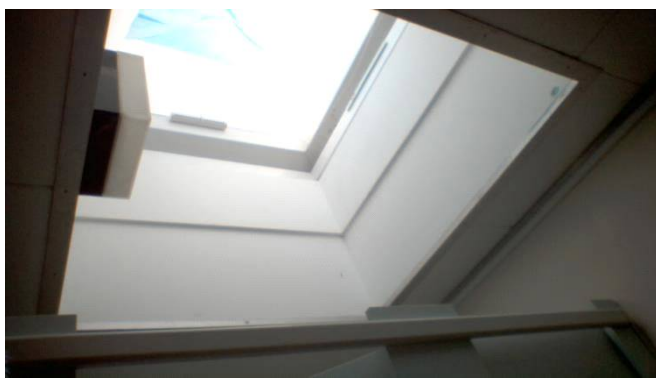
FLOOR/LOCATION:	0015	
DESCRIPTION:	Skylight upstands	
RECOMMENDATIONS:	Manage, monitor and inform maintenance personnel prior to relevant works	
EXTENT:	<10m ² or <10m pipe run	
SAMPLE REF:	SPST EC004659 {GW003843}	
RESULT:	Amosite

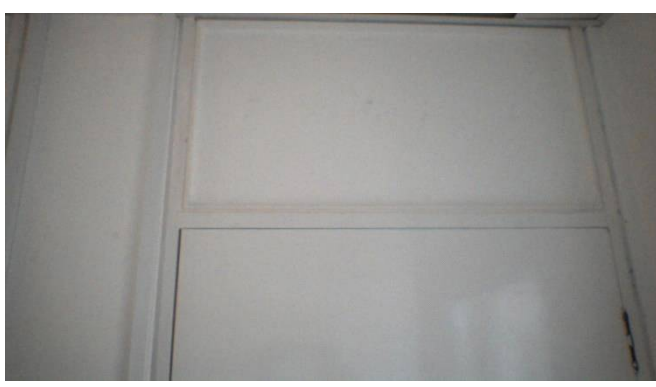
FLOOR/LOCATION:	0016	
DESCRIPTION:	Cement infill panel over door	
RECOMMENDATIONS:	Manage, monitor and inform maintenance personnel prior to relevant works	
EXTENT:	<10m ² or <10m pipe run	
SAMPLE REF:	SPST EC004646 {GW003837}	
RESULT:	Chrysotile

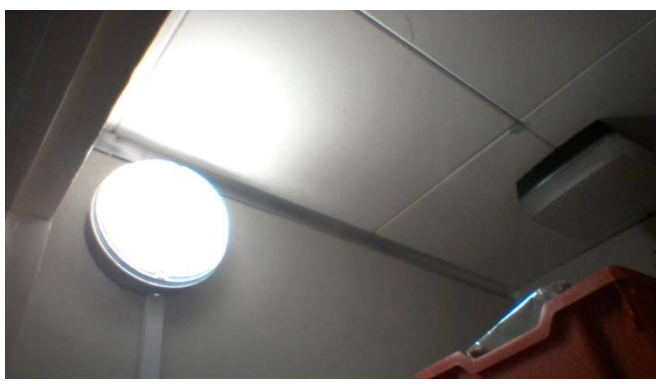
FLOOR/LOCATION:	0016	
DESCRIPTION:	Fixed ceiling tiles	
RECOMMENDATIONS:	Manage, monitor and inform maintenance personnel prior to relevant works	
EXTENT:	<10m ² or <10m pipe run	
SAMPLE REF:	SPST EC004658 {GW003842}	
RESULT:	Amosite

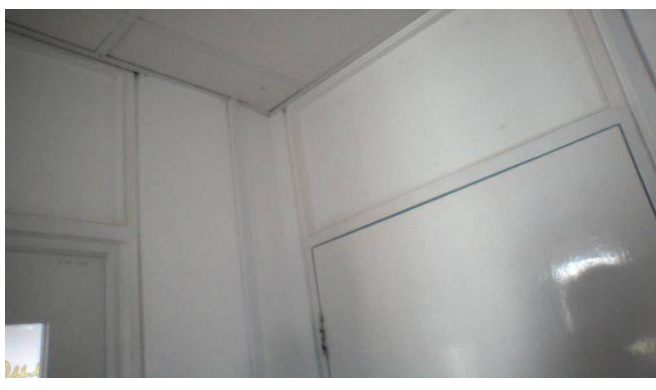
FLOOR/LOCATION:	0017	
DESCRIPTION:	Cement infill panel over door	
RECOMMENDATIONS:	Manage, monitor and inform maintenance personnel prior to relevant works	
EXTENT:	<10m ² or <10m pipe run	
SAMPLE REF:	SPST EC004646 {GW003837}	
RESULT:	Chrysotile

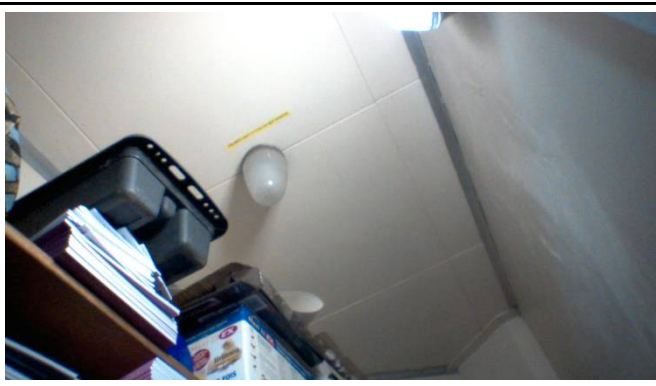
FLOOR/LOCATION:	0017	
DESCRIPTION:	Fixed ceiling tiles	
RECOMMENDATIONS:	Manage, monitor and inform maintenance personnel prior to relevant works	
EXTENT:	<10m ² or <10m pipe run	
SAMPLE REF:	EC004657 {GW003844}	
RESULT:	Amosite

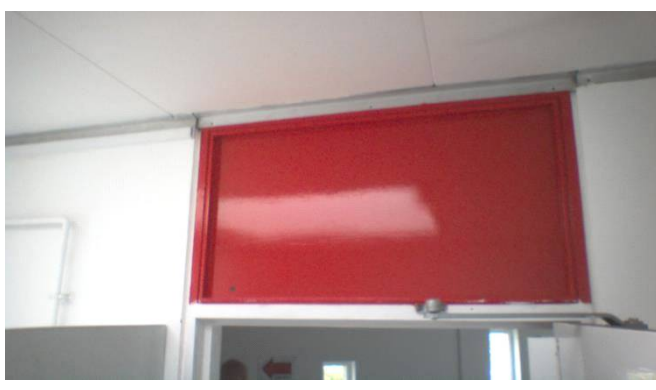
FLOOR/LOCATION:	0018	
DESCRIPTION:	Cement infill panel over door	
RECOMMENDATIONS:	Manage, monitor and inform maintenance personnel prior to relevant works	
EXTENT:	<10m ² or <10m pipe run	
SAMPLE REF:	SPST EC004646 {GW003837}	
RESULT:	Chrysotile

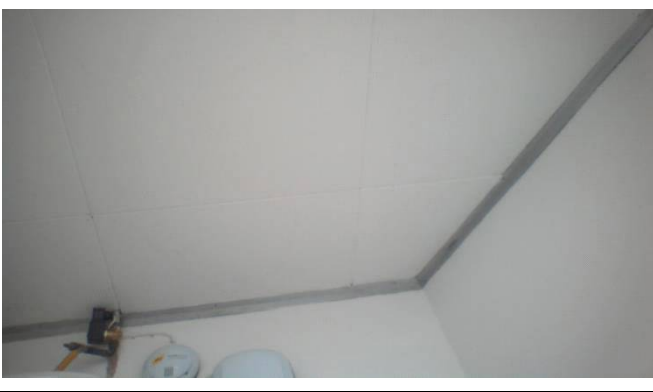
FLOOR/LOCATION:	0018	
DESCRIPTION:	Fixed ceiling tiles	
RECOMMENDATIONS:	Manage, monitor and inform maintenance personnel prior to relevant works	
EXTENT:	<10m ² or <10m pipe run	
SAMPLE REF:	SPST EC004657 {GW003844}	
RESULT:	Amosite

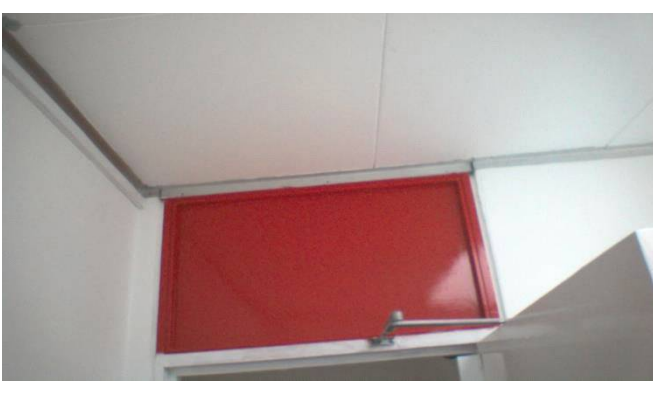
FLOOR/LOCATION:	0019	
DESCRIPTION:	Cement infill panel over door	
RECOMMENDATIONS:	Manage, monitor and inform maintenance personnel prior to relevant works	
EXTENT:	<10m ² or <10m pipe run	
SAMPLE REF:	SPST EC004646 {GW003837}	
RESULT:	Chrysotile

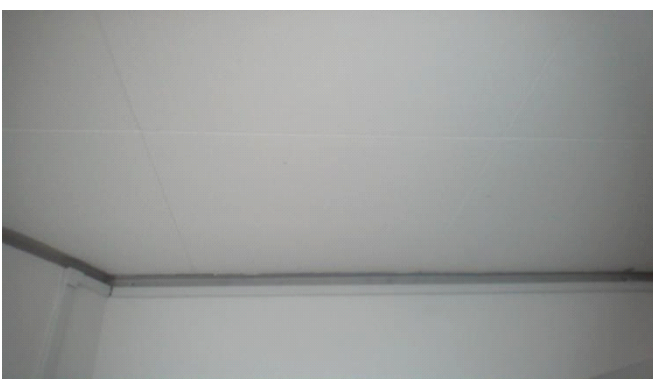
FLOOR/LOCATION:	0019	
DESCRIPTION:	Fixed ceiling tiles	
RECOMMENDATIONS:	Manage, monitor and inform maintenance personnel prior to relevant works	
EXTENT:	<10m ² or <10m pipe run	
SAMPLE REF:	SPST EC004657 {GW003844}	
RESULT:	Amosite

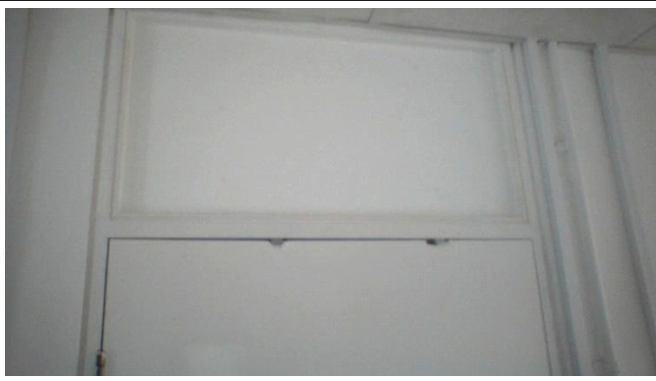
FLOOR/LOCATION:	0020	
DESCRIPTION:	Panel above door	
RECOMMENDATIONS:	Manage, monitor and inform maintenance personnel prior to relevant works	
EXTENT:	<10m ² or <10m pipe run	
SAMPLE REF:	SPST 123 {GW003838}	
RESULT:	Chrysotile

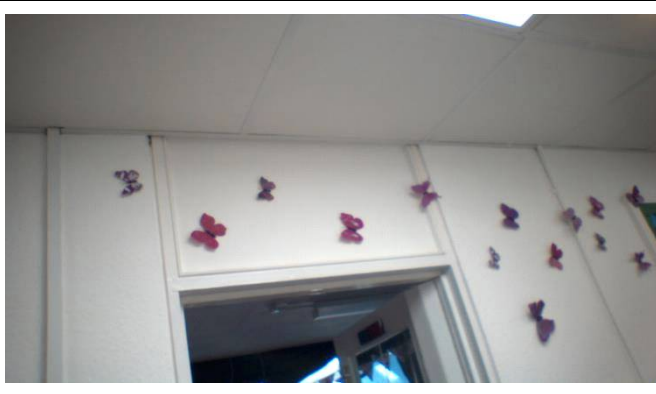
FLOOR/LOCATION:	0022	
DESCRIPTION:	Cement infill panel over door	
RECOMMENDATIONS:	Manage, monitor and inform maintenance personnel prior to relevant works	
EXTENT:	<10m ² or <10m pipe run	
SAMPLE REF:	SPST EC004646 {GW003837}	
RESULT:	Chrysotile

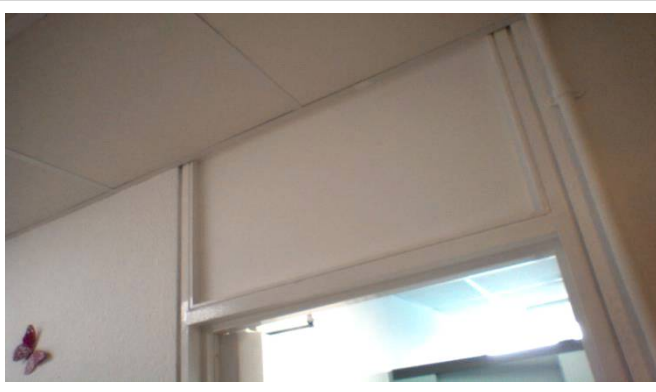
FLOOR/LOCATION:	0024	
DESCRIPTION:	Cement infill panel over door	
RECOMMENDATIONS:	Manage, monitor and inform maintenance personnel prior to relevant works	
EXTENT:	<10m ² or <10m pipe run	
SAMPLE REF:	SPST EC004646 {GW003837}	
RESULT:	Chrysotile

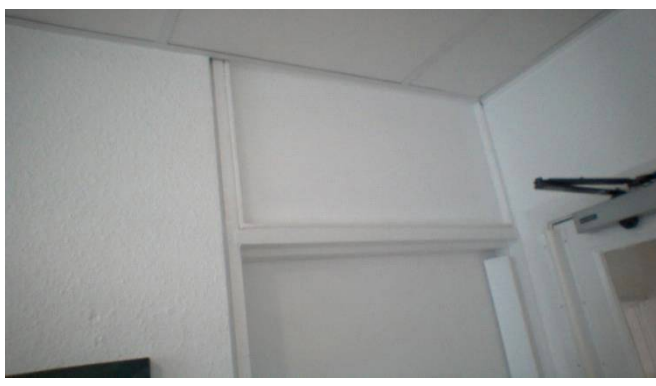
FLOOR/LOCATION:	0026	
DESCRIPTION:	Cement infill panel over door	
RECOMMENDATIONS:	Manage, monitor and inform maintenance personnel prior to relevant works	
EXTENT:	<10m ² or <10m pipe run	
SAMPLE REF:	SPST EC004646 {GW003837}	
RESULT:	Chrysotile

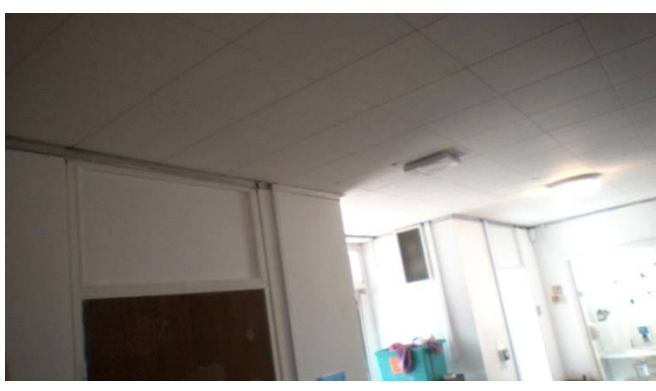
FLOOR/LOCATION:	0027	
DESCRIPTION:	Cement infill panels over doors	
RECOMMENDATIONS:	Manage, monitor and inform maintenance personnel prior to relevant works	
EXTENT:	<10m ² or <10m pipe run	
SAMPLE REF:	SPST EC004646 {GW003837}	
RESULT:	Chrysotile

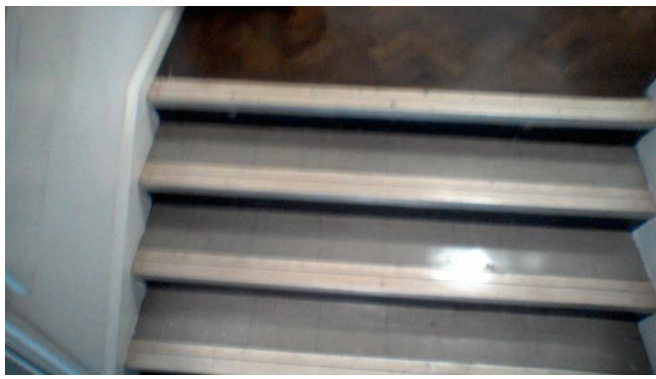
FLOOR/LOCATION:	0027	
DESCRIPTION:	Grey floor tiles	
RECOMMENDATIONS:	Manage, monitor and inform maintenance personnel prior to relevant works	
EXTENT:	<10m ² or <10m pipe run	
SAMPLE REF:	SPST 125 {GW003839}	
RESULT:	Chrysotile

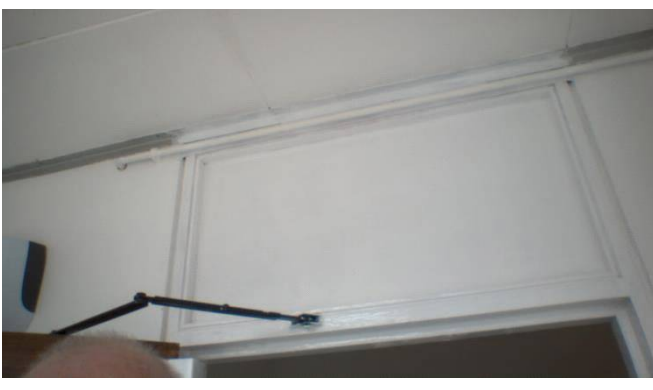
FLOOR/LOCATION:	0030	
DESCRIPTION:	Cement infill panel over door	
RECOMMENDATIONS:	Manage, monitor and inform maintenance personnel prior to relevant works	
EXTENT:	<10m ² or <10m pipe run	
SAMPLE REF:	SPST EC004646 {GW003837}	
RESULT:	Chrysotile

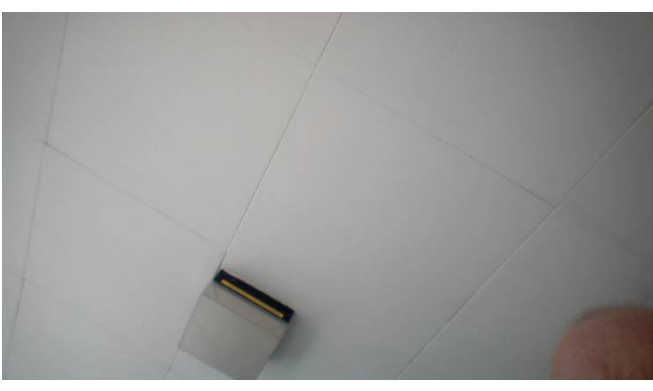
FLOOR/LOCATION:	0030	
DESCRIPTION:	Fixed ceiling tiles	
RECOMMENDATIONS:	Manage, monitor and inform maintenance personnel prior to relevant works	
EXTENT:	<10m ² or <10m pipe run	
SAMPLE REF:	SPST EC004653 {GW003846}	
RESULT:	Amosite

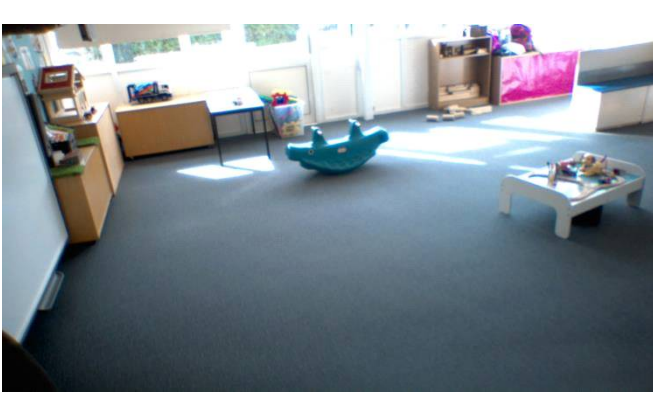
FLOOR/LOCATION:	0032	
DESCRIPTION:	Beige vinyl floor tiles and adhesive below new flooring	
RECOMMENDATIONS:	Manage, monitor and inform maintenance personnel prior to relevant works	
EXTENT:	>50m ² or >50m pipe run	
SAMPLE REF:	SPST ED007249 {GW003845}	
RESULT:	Chrysotile

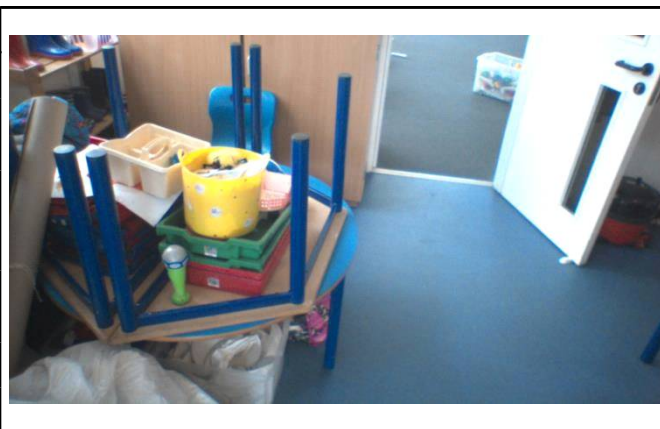
BUILDING NAME:	Redhills School
FLOOR/LOCATION:	0034
DESCRIPTION:	Beige vinyl floor tiles and adhesive below new flooring
RECOMMENDATIONS:	Manage, monitor and inform maintenance personnel prior to relevant works
EXTENT:	>50m ² or >50m pipe run
SAMPLE REF:	SPST ED007248 {GW003848}
RESULT:	Chrysotile

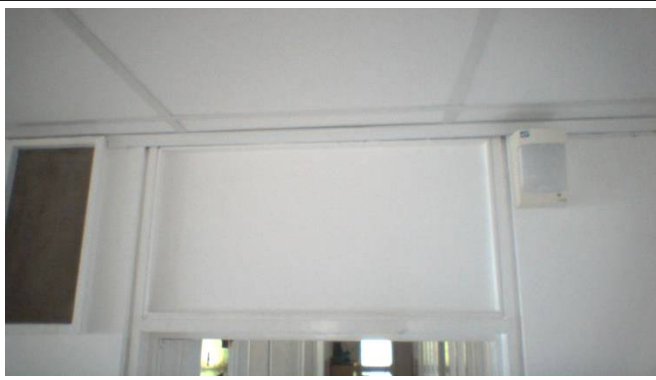
FLOOR/LOCATION:	0038	
DESCRIPTION:	Panel above door	
RECOMMENDATIONS:	Manage, monitor and inform maintenance personnel prior to relevant works	
EXTENT:	<10m² or <10m pipe run	
SAMPLE REF:	SPST 123 {GW003838}	
RESULT:	Chrysotile

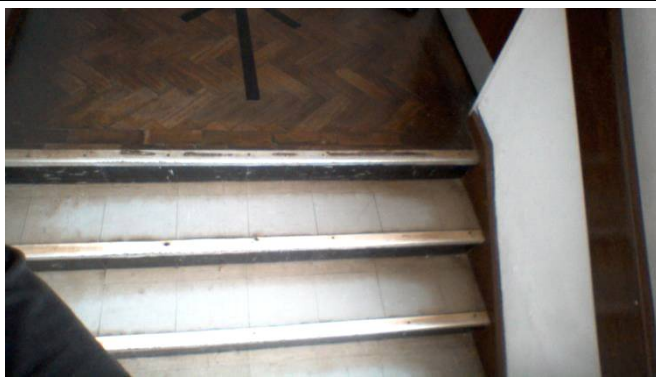
FLOOR/LOCATION:	0038	
DESCRIPTION:	Grey floor tiles	
RECOMMENDATIONS:	Manage, monitor and inform maintenance personnel prior to relevant works	
EXTENT:	<10m² or <10m pipe run	
SAMPLE REF:	SPST 125 {GW003839}	
RESULT:	Chrysotile

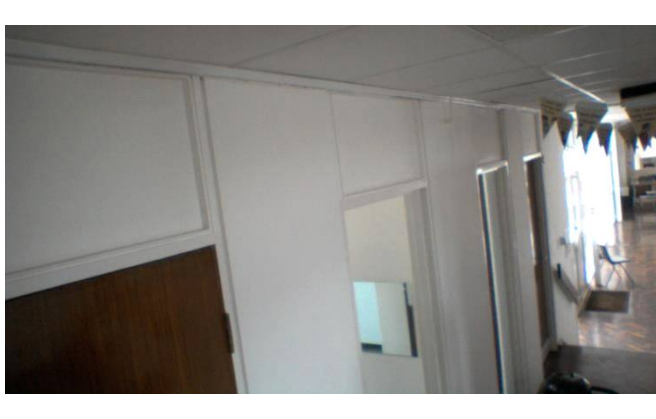
FLOOR/LOCATION:	0039	
DESCRIPTION:	Cement infill panels over doors to 0045, 0046, 0047, 0048	
RECOMMENDATIONS:	Manage, monitor and inform maintenance personnel prior to relevant works	
EXTENT:	<10m² or <10m pipe run	
SAMPLE REF:	SPST EC004646 {GW003837}	
RESULT:	Chrysotile

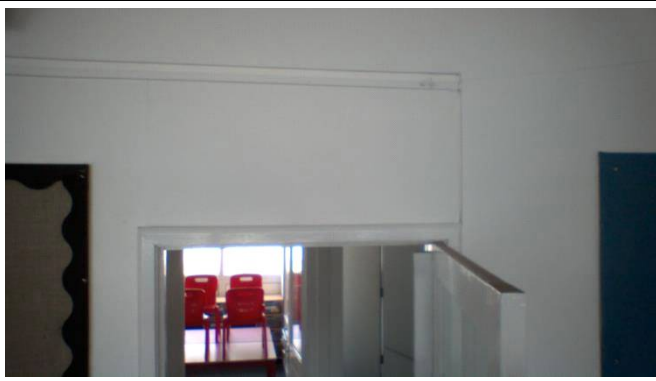
FLOOR/LOCATION:	0042	
DESCRIPTION:	Panel above door	
RECOMMENDATIONS:	Manage, monitor and inform maintenance personnel prior to relevant works	
EXTENT:	<10m ² or <10m pipe run	
SAMPLE REF:	SPST 123 {GW003838}	
RESULT:	Chrysotile

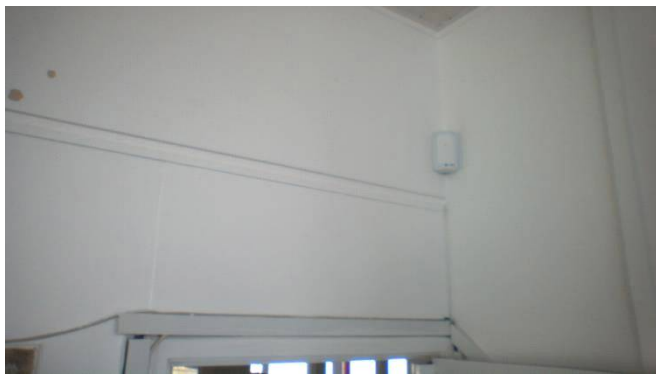
FLOOR/LOCATION:	0044	
DESCRIPTION:	Panel above door	
RECOMMENDATIONS:	Manage, monitor and inform maintenance personnel prior to relevant works	
EXTENT:	<10m ² or <10m pipe run	
SAMPLE REF:	SPST 123 {GW003838}	
RESULT:	Chrysotile

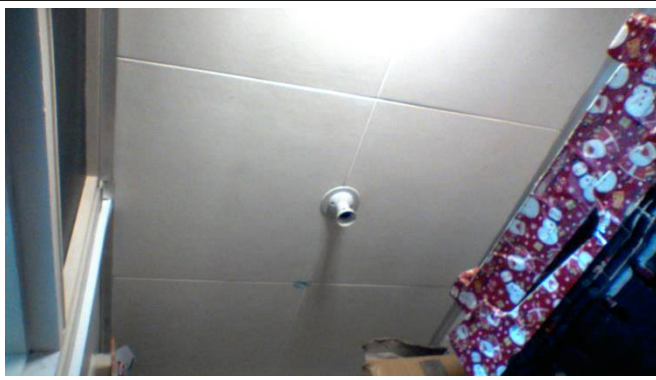
FLOOR/LOCATION:	0045	
DESCRIPTION:	Fixed ceiling tiles	
RECOMMENDATIONS:	Manage, monitor and inform maintenance personnel prior to relevant works	
EXTENT:	<10m ² or <10m pipe run	
SAMPLE REF:	EC004649 {GW003849}	
RESULT:	Amosite

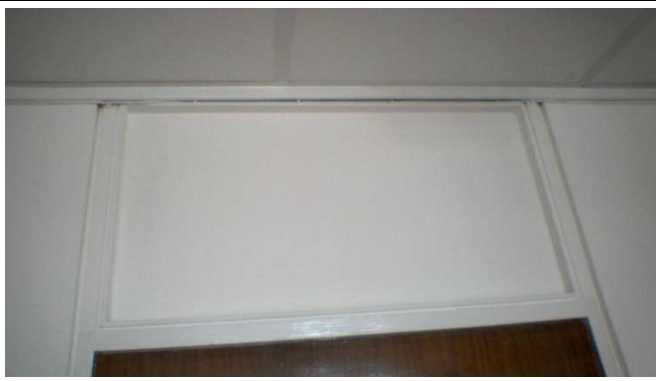
FLOOR/LOCATION:	0045	
DESCRIPTION:	Cement infill panel over door	
RECOMMENDATIONS:	Manage, monitor and inform maintenance personnel prior to relevant works	
EXTENT:	<10m ² or <10m pipe run	
SAMPLE REF:	EC004632 {GW003850}	
RESULT:	Chrysotile

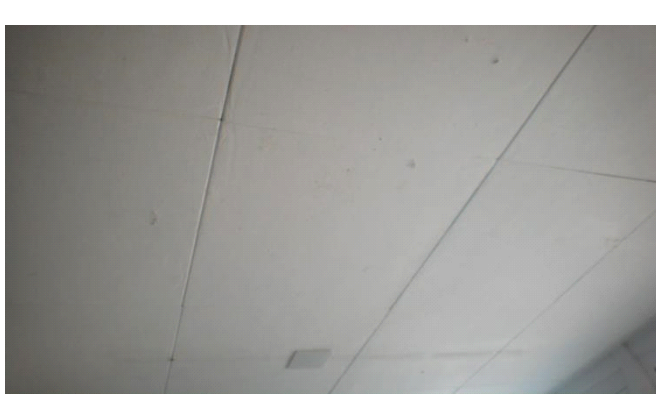
FLOOR/LOCATION:	0046	
DESCRIPTION:	Fixed ceiling tiles	
RECOMMENDATIONS:	Manage, monitor and inform maintenance personnel prior to relevant works	
EXTENT:	10 - 50 m ² or 10 - 50m pipe run	
SAMPLE REF:	SPST EC004649 {GW003849}	
RESULT:	Amosite

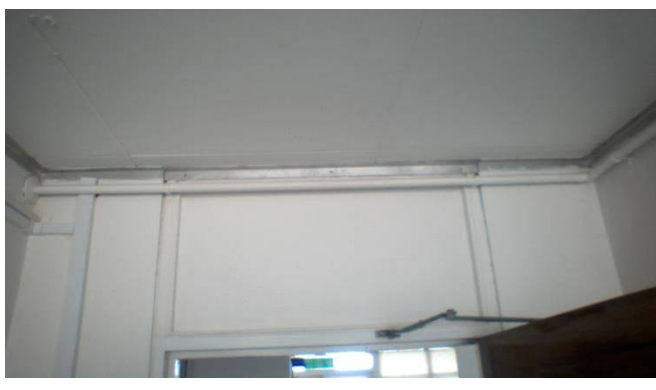
FLOOR/LOCATION:	0046	
DESCRIPTION:	Cement infill panel over door	
RECOMMENDATIONS:	Manage, monitor and inform maintenance personnel prior to relevant works	
EXTENT:	<10m ² or <10m pipe run	
SAMPLE REF:	SPST EC004646 {GW003837}	
RESULT:	Chrysotile

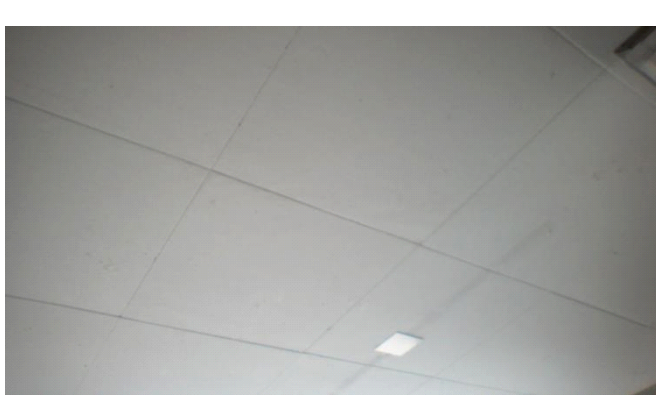
FLOOR/LOCATION:	0047	
DESCRIPTION:	Fixed ceiling tiles	
RECOMMENDATIONS:	Manage, monitor and inform maintenance personnel prior to relevant works	
EXTENT:	10 - 50 m ² or 10 - 50m pipe run	
SAMPLE REF:	SPST EC004649 {GW003849}	
RESULT:	Amosite
