Asbestos Survey Report

Report Reference: J007189

Client	The Redstart Learning Partnership
UPRN	-
Address	Winsham Primary School 10 Church Street Winsham TA20 4HY
Survey Date	11 August 2021
Report Issue Date	23 August 2021
Report Reference	J007189
Survey Type	Management Survey

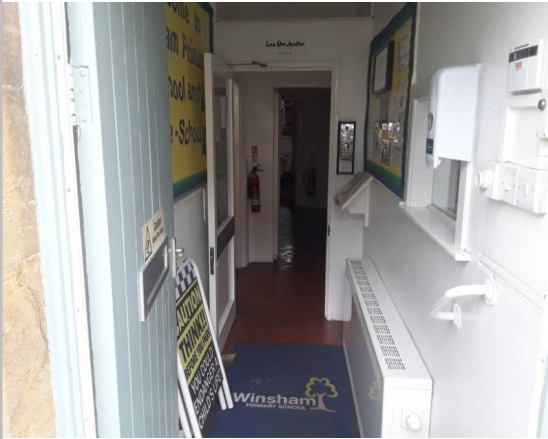
Item	Level	Location / Room Number	Survey Type	Sample Reference	Asbestos Present	Quantity		
1	Ground Floor	Main Bldg - Entrance Lobby	Management	Visual Inspection	NO	-

Material Description		Material Risk			
			No Suspect Asbestos Containing Materials Observed		Product Type	Extent of Damage	Surface Treatment	Asbestos Type
					-	-	-	-
			Additional Information		Score - Material Risk			
			Timber Doors. Timber Architraves. Modern Electrical Installations		-	-		
					Accessibility			
		-						
Recommendations		Action Date						
		-						
Ceilings		Ceiling Soffits	Walls	Flooring	Other			
Lath/Plaster		Timber	Plastered Brick	Concrete/Quarry Tiles	N/A

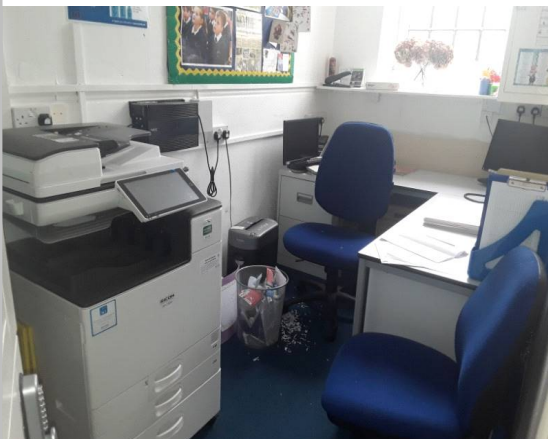
Item	Level	Location / Room Number	Survey Type	Sample Reference	Asbestos Present	Quantity		
2	Ground Floor	Main Bldg - School Office	Management	Visual Inspection	NO	-

Material Description		Material Risk			
			No Suspect Asbestos Containing Materials Observed		Product Type	Extent of Damage	Surface Treatment	Asbestos Type
					-	-	-	-
			Additional Information		Score - Material Risk			
			Timber Doors. Timber Architraves. Modern Electrical Installations		-	-		
					Accessibility			
		-						
Recommendations		Action Date						
		-						
Ceilings		Ceiling Soffits	Walls	Flooring	Other			
Lath/Plaster		Fixed Timber	Plastered Brick	Concrete/Quarry Tiles	N/A

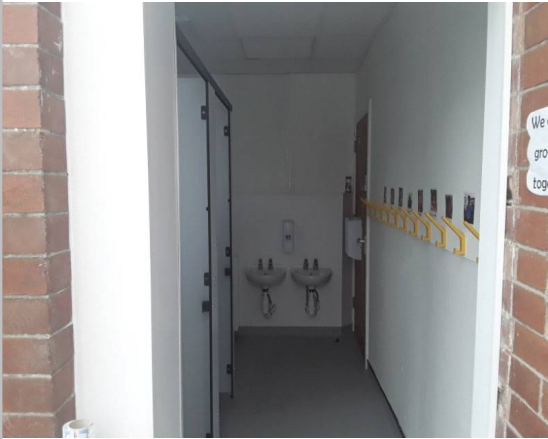
Item	Level	Location / Room Number	Survey Type	Sample Reference	Asbestos Present	Quantity		
3	Ground Floor	Main Bldg - Nursery WCs	Management	Visual Inspection	NO	-

Material Description		Material Risk			
			No Suspect Asbestos Containing Materials Observed		Product Type	Extent of Damage	Surface Treatment	Asbestos Type
					-	-	-	-
			Additional Information		Score - Material Risk			
			Timber Doors. Timber Architraves. Modern Electrical Installations		-	-		
					Accessibility			
					-			
Recommendations		Action Date						
		-						
Ceilings		Ceiling Soffits		Walls		Flooring		Other
Lath/Plaster		Suspended MMMF Tiles		Plastered Brick/Plastic		Concrete/Fixed Vinyl		N/A

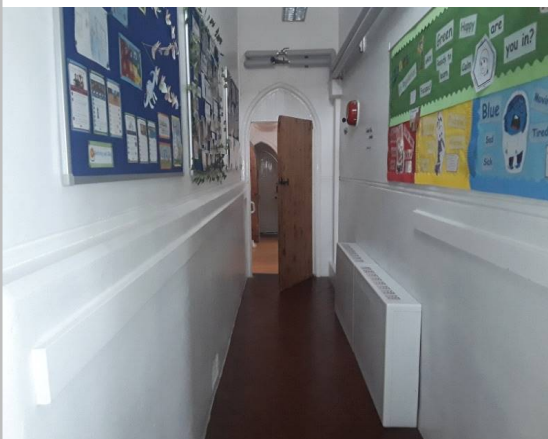
Item	Level	Location / Room Number	Survey Type	Sample Reference	Asbestos Present	Quantity		
4	Ground Floor	Main Bldg - Corridor	Management	Visual Inspection	NO	-

Material Description		Material Risk			
			No Suspect Asbestos Containing Materials Observed		Product Type	Extent of Damage	Surface Treatment	Asbestos Type
					-	-	-	-
			Additional Information		Score - Material Risk			
			Timber Doors. Timber Architraves. Modern Electrical Installations. Fibreglass Insulation To High Level Pipework		-	-		
					Accessibility			
					-			
Recommendations		Action Date						
		-						
Ceilings		Ceiling Soffits		Walls		Flooring		Other
No Access		Fixed Timber		Plastered Brick		Concrete/Quarry Tiles		N/A

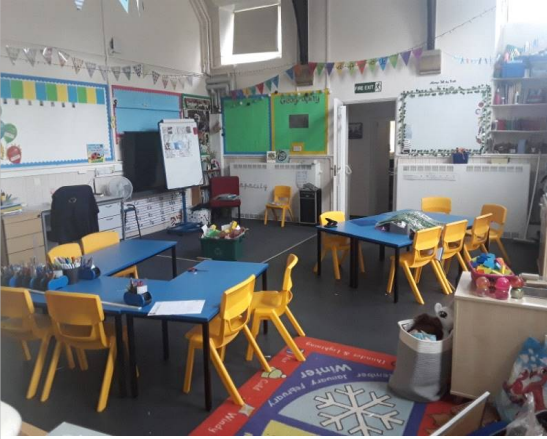
Item	Level	Location / Room Number	Survey Type	Sample Reference	Asbestos Present	Quantity			
5	Ground Floor	Main Bldg - Woodpecker Class	Management	Visual Inspection	NO	-

Material Description		Material Risk				
			No Suspect Asbestos Containing Materials Observed Below Fixed Ceiling Soffit		Product Type	Extent of Damage	Surface Treatment	Asbestos Type	
					-	-	-	-	
			Additional Information		Score - Material Risk				
			Timber Doors. Timber Architraves And Skirting Boards. Modern Electrical Installations. Fibreglass Insulation To High Level Pipework		-	-			
			Recommendations		Action Date				
		-							
Ceilings		Ceiling Soffits		Walls		Flooring		Other	
No Access		No Access		Plastered Brick/Timber		Concrete/Fixed Vinyl		N/A

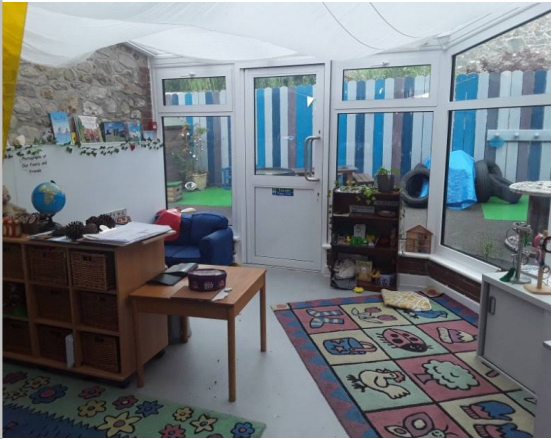
Item	Level	Location / Room Number	Survey Type	Sample Reference	Asbestos Present	Quantity		
7	Ground Floor	Main Bldg - Nursery	Management	Visual Inspection	NO	-

Material Description		Material Risk			
			No Suspect Asbestos Containing Materials Observed		Product Type	Extent of Damage	Surface Treatment	Asbestos Type
					-	-	-	-
			Additional Information		Score - Material Risk			
			N/A		-	-		
					Accessibility			
					-			
Recommendations		Action Date						
		-						
Ceilings		Ceiling Soffits	Walls	Flooring	Other			
Polycarbonate		N/A	Glass	Timber/Fixed Vinyl	N/A

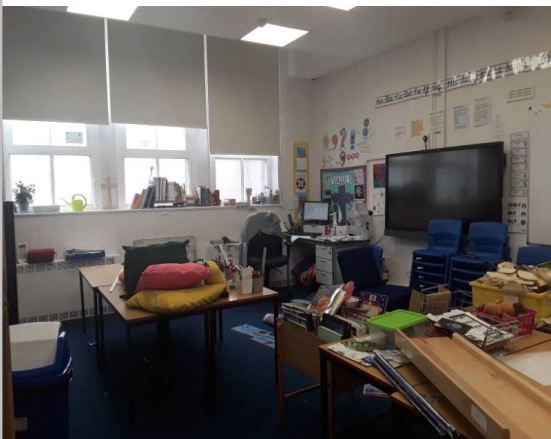
Item	Level	Location / Room Number	Survey Type	Sample Reference	Asbestos Present	Quantity		
8	Ground Floor	Main Bldg - Library	Management	Visual Inspection	NO	-

Material Description		Material Risk			
			No Suspect Asbestos Containing Materials Observed		Product Type	Extent of Damage	Surface Treatment	Asbestos Type
					-	-	-	-
			Additional Information		Score - Material Risk			
			Timber Doors. Timber Architraves And Skirting Boards. Modern Electrical Installations. Modern Step Nosings		-	-		
					Accessibility			
					-			
Recommendations		Action Date						
		-						
Ceilings		Ceiling Soffits	Walls	Flooring	Other			
Lath/Plaster		Suspended MMMF Tiles	Plastered Brick/Timber	Timber/Fixed Carpet	N/A

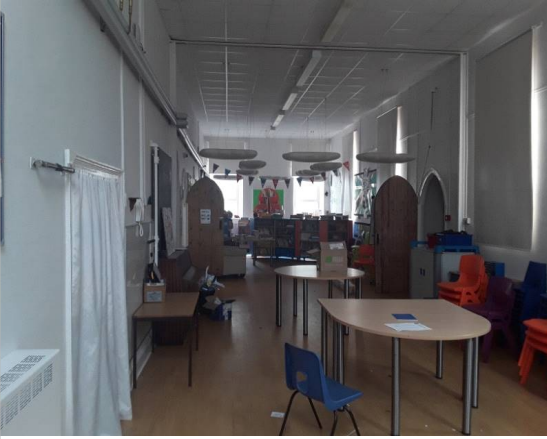
Item	Level	Location / Room Number	Survey Type	Sample Reference	Asbestos Present	Quantity			
9	Ground Floor	Main Bldg - Hall	Management	Visual Inspection	NO	-

Material Description		Material Risk				
			No Suspect Asbestos Containing Materials Observed Below Suspended Ceiling Tiles		Product Type	Extent of Damage	Surface Treatment	Asbestos Type	
					-	-	-	-	
			Additional Information		Score - Material Risk				
			Timber Doors. Timber Architraves And Skirting Boards. Modern Electrical Installations. Fibreglass Insulation To High Level Pipework		-	-			
			Recommendations		Action Date				
		-							
Ceilings		Ceiling Soffits		Walls		Flooring		Other	
No Access		Suspended MMMF Tiles		Plastered Brick/Timber		Timber/Fixed Vinyl		N/A

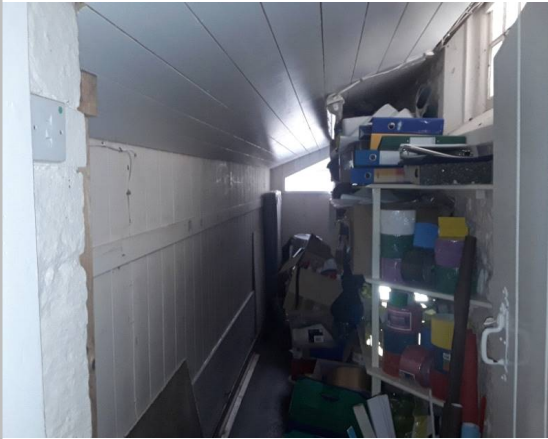
Item	Level	Location / Room Number	Survey Type	Sample Reference	Asbestos Present	Quantity		
11	Ground Floor	Main Bldg - Store Rm	Management	Visual Inspection	NO	-

Material Description		Material Risk			
			No Suspect Asbestos Containing Materials Observed. Inspection Includes Lobby		Product Type	Extent of Damage	Surface Treatment	Asbestos Type
					-	-	-	-
			Additional Information		Score - Material Risk			
			Timber Doors. Timber Architraves		-	-		
					Accessibility			
					-			
Recommendations		Action Date						
		-						
Ceilings		Ceiling Soffits	Walls	Flooring	Other			
No Access		Fixed Timber	Stone/Timber	Concrete	N/A

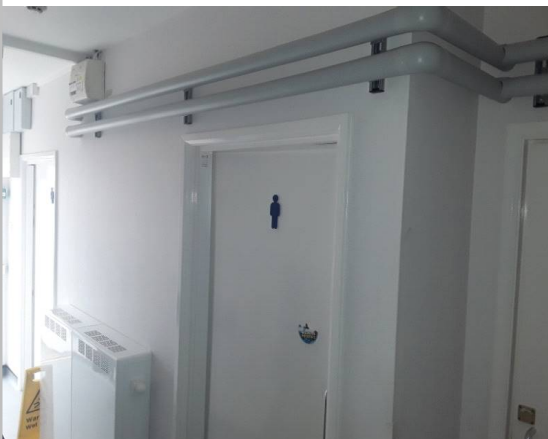
Item	Level	Location / Room Number	Survey Type	Sample Reference	Asbestos Present	Quantity		
12	Ground Floor	Main Bldg - WCs/Lobby	Management	Visual Inspection	NO	-

Material Description		Material Risk			
			No Suspect Asbestos Containing Materials Observed. Inspection Includes Accessible, Female, Male WCs & The Adjacent Corridor		Product Type	Extent of Damage	Surface Treatment	Asbestos Type
					-	-	-	-
			Additional Information		Score - Material Risk			
			Timber Doors. Timber Architraves. Modern Electrical Installations. Fibreglass Insulation To High Level Pipework. Modern Sanitary Ware		-	-		
					Accessibility			
					-			
Recommendations		Action Date						
		-						
Ceilings		Ceiling Soffits	Walls	Flooring	Other			
No Access		Fixed Plasterboard	Plastered Brick	Concrete/Vinyl	N/A

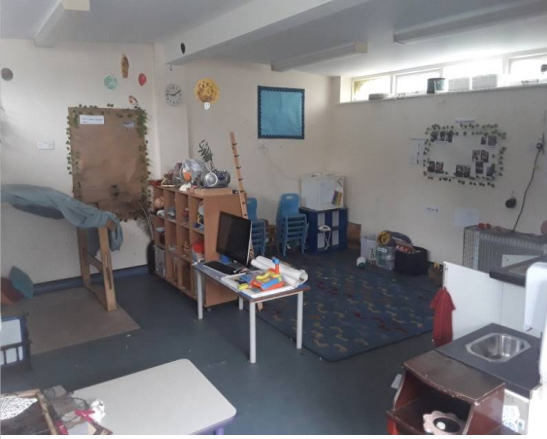
Item	Level	Location / Room Number	Survey Type	Sample Reference	Asbestos Present	Quantity		
20	Ground Floor	Pre - School Building	Management	Visual Inspection	NO	-

Material Description		Material Risk			
			No Suspect Asbestos Containing Materials Observed Throughout. Inspection Includes The WC		Product Type	Extent of Damage	Surface Treatment	Asbestos Type
					-	-	-	-
			Additional Information		Score - Material Risk			
			-		-	-		
					Accessibility			
					-			
Recommendations			Action Date					
-			-					
Ceilings		Ceiling Soffits	Walls	Flooring	Other			
No Access		Fixed Plasterboard	Plastered Block	Concrete/Carpet/Vinyl	N/A

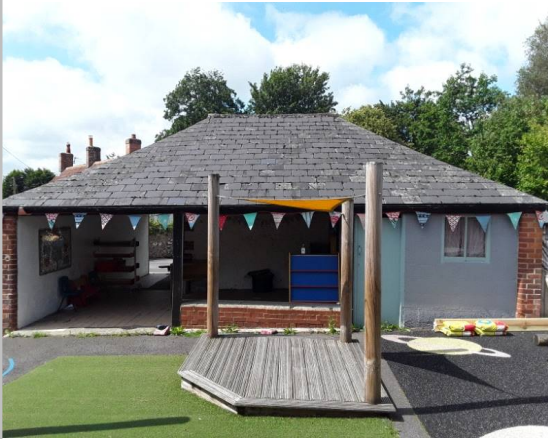
Item	Level	Location / Room Number	Survey Type	Sample Reference	Asbestos Present	Quantity			
21	Ground Floor	Open Play Structure	Management	Visual Inspection	NO	-

Material Description		Material Risk				
			No Suspect Asbestos Containing Materials Observed To All Internal Areas Of Structure		Product Type	Extent of Damage	Surface Treatment	Asbestos Type	
					-	-	-	-	
			Additional Information		Score - Material Risk				
			N/A		-	-			
					Accessibility				
					-				
Recommendations		Action Date							
		-							
Ceilings		Ceiling Soffits		Walls		Flooring		Other	
Fixed Timber		N/A		Stone/Block		Concrete		N/A

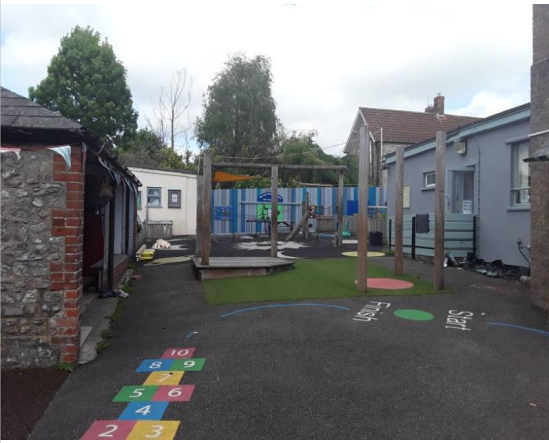
Item	Level	Location / Room Number	Survey Type	Sample Reference	Asbestos Present	Quantity		
25	External	All Elevations	Management	Visual Inspection	NO	-

Material Description		Material Risk			
			No Suspect Asbestos Containing Materials Observed To All Remaining External Elevations Of Buildings & Outbuildings Located Within The School Grounds		Product Type	Extent of Damage	Surface Treatment	Asbestos Type
					-	-	-	-
			Additional Information		Score - Material Risk			
			N/A		-	-		
					Accessibility			
					-			
Recommendations			Action Date					
			-					
Ceilings	Ceiling Soffits	Walls	Flooring	Other				
N/A	N/A	N/A	N/A	N/A
