ASBESTOS RE-INSPECTION SURVEY REPORT

Site Name and Address	Stoberry Park Primary School, North Road, Wells, BA5 2TJ	
Client Name and Address	Somerset Council, Strategic Asset Management, County Hall, Taunton, Somerset, TA1 4DY	
Client Contact & Phone No.	Oliver Woodhams 07977400667	
Job No.	J006176	
Date of Re-inspection	9th January 2025 to 10th January 2025	
Next Inspection due	09/01/2026	
Report Date	27 Feb 2025	
Report Revision No.	1	
Inspector/Surveyor	Name: Tracy Chulk	Signature:

Report Issue Date	27 Feb 2025

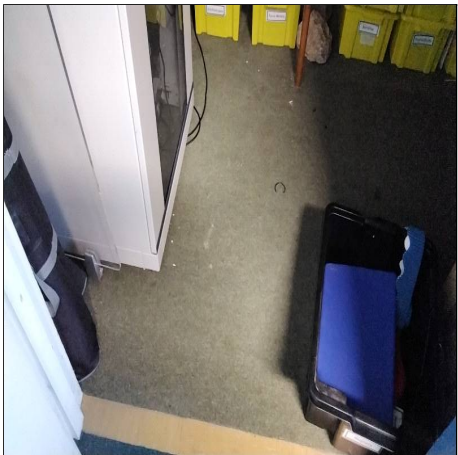
Re-inspection Date:	Lead Surveyor	Survey Type	Floor	Analysis
	9 Jan 2025 to 10 Jan 2025	Tracy Chulk	Reinspection Survey	Ground	Chrysotile (1)
	Building	Room	Item	Quantity	
	Block A	Store A002B	Floor tile adhesive beneath carpet	8m ²	
	Sample No (S,SP,P,As)	Product Type	Surface Treatment	Condition	Accessibility
	As 20761321 {AB000275}* (SP)	Well Bound Material (1)	Completely Sealed (0)	Good Condition (0)	Usually inaccessible or unlikely to be disturbed (0)

Normal Occupancy	Score	Likelihood of disturbance	Score	Exposure Potential	Score	Maintenance Activity	Score
Main type of activity	0	Location	2	Number of occupants	1	Type of Maintenance	0
		Accessibility	0	Frequency of use	0	Frequency of maintenance	0
		Amount	2	Average Time	0		
Average Score	0	Average Score	2	Average Score	1	Average Score	0
Recommendation	D - No Attention Required, inspect at intervals						
Comments	Carpet glued in place, presumed to remain in situ

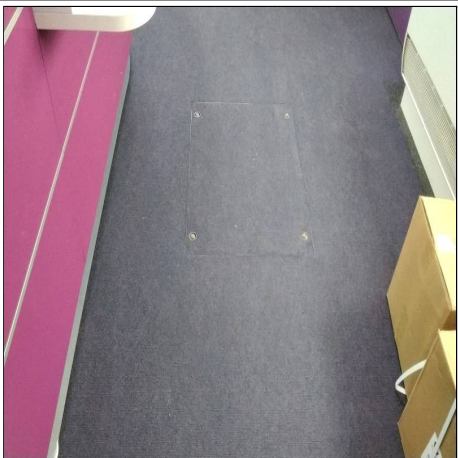
Re-inspection Date:	Lead Surveyor	Survey Type	Floor	Analysis
	9 Jan 2025 to 10 Jan 2025	Tracy Chulk	Reinspection Survey	Ground	N/A
	Building	Room	Item	Quantity	
	Block A	Circulation A004	Floor void	N/A	
	Sample No (S,SP,P,As)	Product Type	Surface Treatment	Condition	Accessibility
	Visual (P)	N/A	N/A	N/A	N/A

Normal Occupancy	Score	Likelihood of disturbance	Score	Exposure Potential	Score	Maintenance Activity	Score
Main type of activity	N/A	Location	N/A	Number of occupants	N/A	Type of Maintenance	N/A
		Accessibility	N/A	Frequency of use	N/A	Frequency of maintenance	N/A
		Amount	N/A	Average Time	N/A		
Average Score	N/A	Average Score	N/A	Average Score	N/A	Average Score	N/A
Recommendation	Inspection Required						
Comments	Unable to access without specific access keys

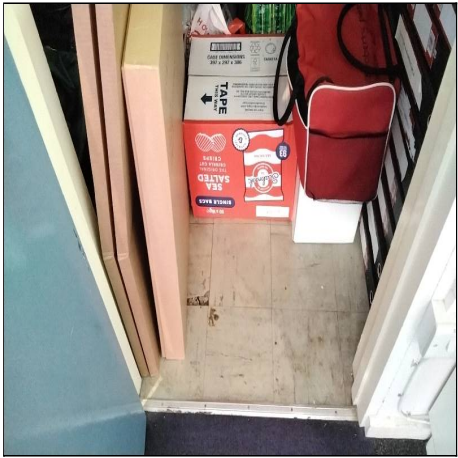
Re-inspection Date:	Lead Surveyor	Survey Type	Floor	Analysis
	9 Jan 2025 to 10 Jan 2025	Tracy Chulk	Reinspection Survey	Ground	Chrysotile (1)
	Building	Room	Item	Quantity	
	Block A	Store A005	Vinyl floor tiles	2m ²	
	Sample No (S,SP,P,As)	Product Type	Surface Treatment	Condition	Accessibility
	21360079 {AB000286}* (S)	Well Bound Material (1)	Completely Sealed (0)	Low Damage (1)	Easily disturbed (2)

Normal Occupancy	Score	Likelihood of disturbance	Score	Exposure Potential	Score	Maintenance Activity	Score
Main type of activity	0	Location	2	Number of occupants	1	Type of Maintenance	0
		Accessibility	2	Frequency of use	0	Frequency of maintenance	0
		Amount	1	Average Time	0		
Average Score	0	Average Score	2	Average Score	1	Average Score	0
Recommendation	D - No Attention Required, inspect at intervals						
Comments	Single tile damaged, but remaining section not lifting

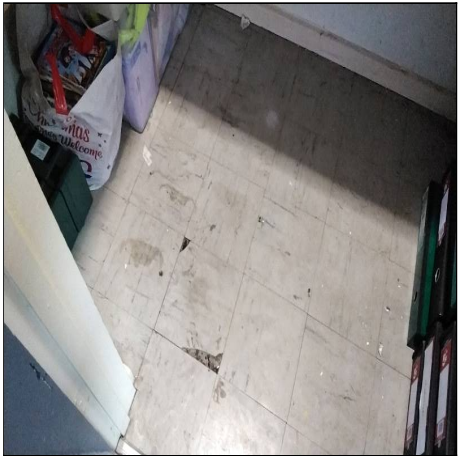
Re-inspection Date:	Lead Surveyor	Survey Type	Floor	Analysis
	9 Jan 2025 to 10 Jan 2025	Tracy Chulk	Reinspection Survey	Ground	Chrysotile (1)
	Building	Room	Item	Quantity	
	Block A	Store A005	Floor tile adhesive	2m ²	
	Sample No (S,SP,P,As)	Product Type	Surface Treatment	Condition	Accessibility
	21360079 {AB000287}* (S)	Well Bound Material (1)	Completely Sealed (0)	Good Condition (0)	Usually inaccessible or unlikely to be disturbed (0)

Normal Occupancy	Score	Likelihood of disturbance	Score	Exposure Potential	Score	Maintenance Activity	Score
Main type of activity	0	Location	2	Number of occupants	1	Type of Maintenance	0
		Accessibility	0	Frequency of use	0	Frequency of maintenance	0
		Amount	1	Average Time	0		
Average Score	0	Average Score	1	Average Score	1	Average Score	0
Recommendation	D - No Attention Required, inspect at intervals						
Comments	N/A

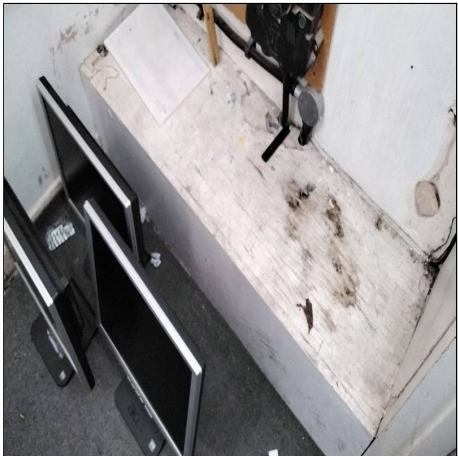
Re-inspection Date:	Lead Surveyor	Survey Type	Floor	Analysis
	9 Jan 2025 to 10 Jan 2025	Tracy Chulk	Reinspection Survey	Ground	N/A
	Building	Room	Item	Quantity	
	Block A	Cleaner A006	Low level horizontal wooden boxing to North wall	N/A	
	Sample No (S,SP,P,As)	Product Type	Surface Treatment	Condition	Accessibility
	Visual (P)	N/A	N/A	N/A	N/A

Normal Occupancy	Score	Likelihood of disturbance	Score	Exposure Potential	Score	Maintenance Activity	Score
Main type of activity	N/A	Location	N/A	Number of occupants	N/A	Type of Maintenance	N/A
		Accessibility	N/A	Frequency of use	N/A	Frequency of maintenance	N/A
		Amount	N/A	Average Time	N/A		
Average Score	N/A	Average Score	N/A	Average Score	N/A	Average Score	N/A
Recommendation	Inspection Required						
Comments	N/A

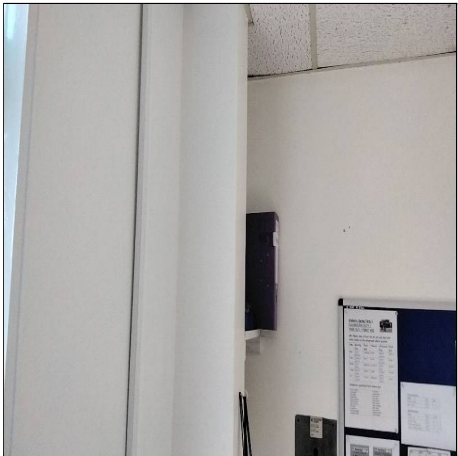
Re-inspection Date:	Lead Surveyor	Survey Type	Floor	Analysis
	9 Jan 2025 to 10 Jan 2025	Tracy Chulk	Reinspection Survey	Ground	N/A
	Building	Room	Item	Quantity	
	Block A	Office A008	Vertical wooden boxing to North West corner	N/A	
	Sample No (S,SP,P,As)	Product Type	Surface Treatment	Condition	Accessibility
	Visual (P)	N/A	N/A	N/A	N/A

Normal Occupancy	Score	Likelihood of disturbance	Score	Exposure Potential	Score	Maintenance Activity	Score
Main type of activity	N/A	Location	N/A	Number of occupants	N/A	Type of Maintenance	N/A
		Accessibility	N/A	Frequency of use	N/A	Frequency of maintenance	N/A
		Amount	N/A	Average Time	N/A		
Average Score	N/A	Average Score	N/A	Average Score	N/A	Average Score	N/A
Recommendation	Inspection Required						
Comments	Unable to access without causing excessive damage

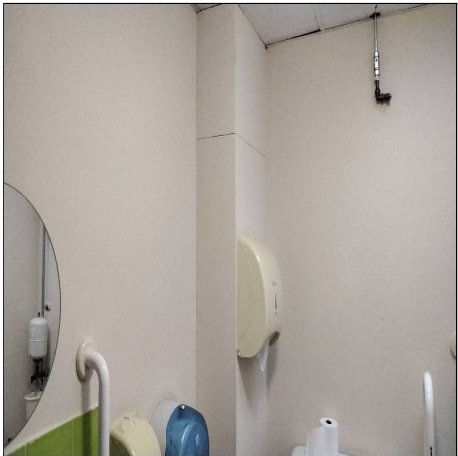
Re-inspection Date:	Lead Surveyor	Survey Type	Floor	Analysis
	9 Jan 2025 to 10 Jan 2025	Tracy Chulk	Reinspection Survey	Ground	N/A
	Building	Room	Item	Quantity	
	Block A	Staff WC A012	Vertical wooden boxing to South and West walls	N/A	
	Sample No (S,SP,P,As)	Product Type	Surface Treatment	Condition	Accessibility
	Visual (P)	N/A	N/A	N/A	N/A

Normal Occupancy	Score	Likelihood of disturbance	Score	Exposure Potential	Score	Maintenance Activity	Score
Main type of activity	N/A	Location	N/A	Number of occupants	N/A	Type of Maintenance	N/A
		Accessibility	N/A	Frequency of use	N/A	Frequency of maintenance	N/A
		Amount	N/A	Average Time	N/A		
Average Score	N/A	Average Score	N/A	Average Score	N/A	Average Score	N/A
Recommendation	Inspection Required						
Comments	Unable to access without causing excessive damage

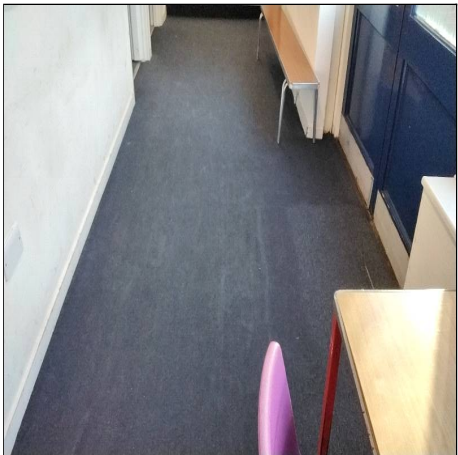
Re-inspection Date:	Lead Surveyor	Survey Type	Floor	Analysis
	9 Jan 2025 to 10 Jan 2025	Tracy Chulk	Reinspection Survey	Ground	Chrysotile (1)
	Building	Room	Item	Quantity	
	Block A	Circulation A014	Black mastic beneath carpet	30m ²	
	Sample No (S,SP,P,As)	Product Type	Surface Treatment	Condition	Accessibility
	Visual (P)	Well-bound Material (1)	Completely Sealed (0)	Good Condition (0)	Usually inaccessible or unlikely to be disturbed (0)

Normal Occupancy	Score	Likelihood of disturbance	Score	Exposure Potential	Score	Maintenance Activity	Score
Main type of activity	1	Location	2	Number of occupants	3	Type of Maintenance	0
		Accessibility	0	Frequency of use	3	Frequency of maintenance	0
		Amount	2	Average Time	1		
Average Score	1	Average Score	2	Average Score	3	Average Score	0
Recommendation	D - No Attention Required, inspect at intervals						
Comments	Carpet glued in place, presumed to remain in situ

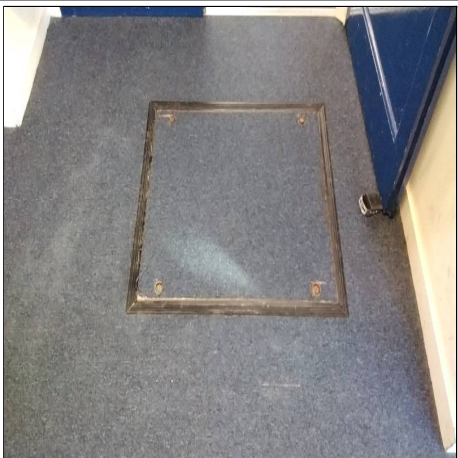
Re-inspection Date:	Lead Surveyor	Survey Type	Floor	Analysis
	9 Jan 2025 to 10 Jan 2025	Tracy Chulk	Reinspection Survey	Ground	N/A
	Building	Room	Item	Quantity	
	Block A	Circulation A014	Floor void	N/A	
	Sample No (S,SP,P,As)	Product Type	Surface Treatment	Condition	Accessibility
	Visual (P)	N/A	N/A	N/A	N/A

Normal Occupancy	Score	Likelihood of disturbance	Score	Exposure Potential	Score	Maintenance Activity	Score
Main type of activity	N/A	Location	N/A	Number of occupants	N/A	Type of Maintenance	N/A
		Accessibility	N/A	Frequency of use	N/A	Frequency of maintenance	N/A
		Amount	N/A	Average Time	N/A		
Average Score	N/A	Average Score	N/A	Average Score	N/A	Average Score	N/A
Recommendation	Inspection Required						
Comments	Unable to access without specific lifting keys

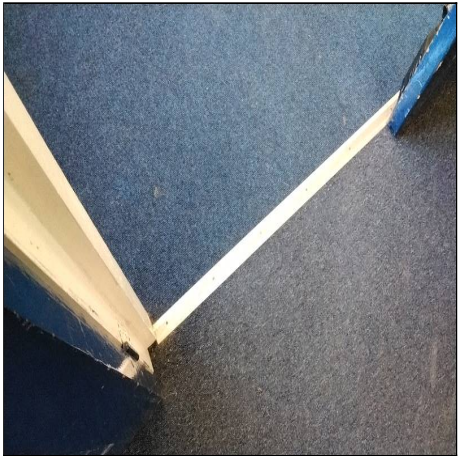
Re-inspection Date:	Lead Surveyor	Survey Type	Floor	Analysis
	9 Jan 2025 to 10 Jan 2025	Tracy Chulk	Reinspection Survey	Ground	Chrysotile (1)
	Building	Room	Item	Quantity	
	Block A	Circulation A014A	Floor tile adhesive	5m ²	
	Sample No (S,SP,P,As)	Product Type	Surface Treatment	Condition	Accessibility
	Visual (P)	Well-bound Material (1)	Completely Sealed (0)	Good Condition (0)	Usually inaccessible or unlikely to be disturbed (0)

Normal Occupancy	Score	Likelihood of disturbance	Score	Exposure Potential	Score	Maintenance Activity	Score
Main type of activity	1	Location	2	Number of occupants	3	Type of Maintenance	0
		Accessibility	0	Frequency of use	3	Frequency of maintenance	0
		Amount	1	Average Time	2		
Average Score	1	Average Score	1	Average Score	3	Average Score	0
Recommendation	D - No Attention Required, inspect at intervals						
Comments	Carpet glued in place, presumed to remain in situ

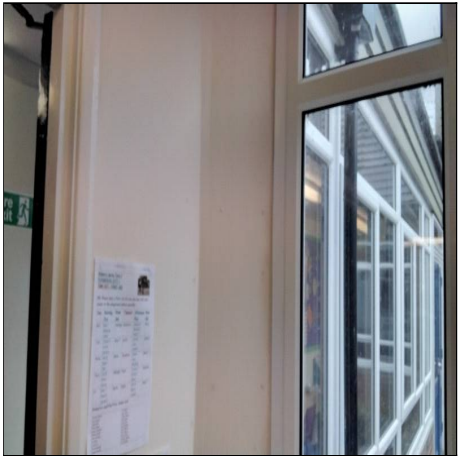
Re-inspection Date:	Lead Surveyor	Survey Type	Floor	Analysis
	9 Jan 2025 to 10 Jan 2025	Tracy Chulk	Reinspection Survey	Ground	N/A
	Building	Room	Item	Quantity	
	Block A	Circulation A014B	Vertical wooden boxing to corner adjacent A014	N/A	
	Sample No (S,SP,P,As)	Product Type	Surface Treatment	Condition	Accessibility
	Visual (P)	N/A	N/A	N/A	N/A

Normal Occupancy	Score	Likelihood of disturbance	Score	Exposure Potential	Score	Maintenance Activity	Score
Main type of activity	N/A	Location	N/A	Number of occupants	N/A	Type of Maintenance	N/A
		Accessibility	N/A	Frequency of use	N/A	Frequency of maintenance	N/A
		Amount	N/A	Average Time	N/A		
Average Score	N/A	Average Score	N/A	Average Score	N/A	Average Score	N/A
Recommendation	Inspection Required						
Comments	Unable to access without causing excessive damage

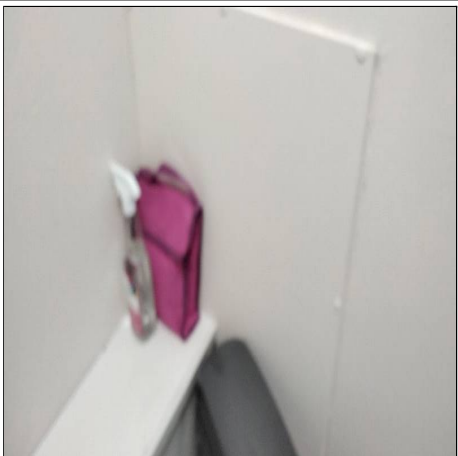
Re-inspection Date:	Lead Surveyor	Survey Type	Floor	Analysis
	9 Jan 2025 to 10 Jan 2025	Tracy Chulk	Reinspection Survey	Ground	N/A
	Building	Room	Item	Quantity	
	Block A	Staff WC A017	Wall void East wall	N/A	
	Sample No (S,SP,P,As)	Product Type	Surface Treatment	Condition	Accessibility
	Visual (P)	N/A	N/A	N/A	N/A

Normal Occupancy	Score	Likelihood of disturbance	Score	Exposure Potential	Score	Maintenance Activity	Score
Main type of activity	N/A	Location	N/A	Number of occupants	N/A	Type of Maintenance	N/A
		Accessibility	N/A	Frequency of use	N/A	Frequency of maintenance	N/A
		Amount	N/A	Average Time	N/A		
Average Score	N/A	Average Score	N/A	Average Score	N/A	Average Score	N/A
Recommendation	Inspection Required						
Comments	Unable to access without causing excessive damage

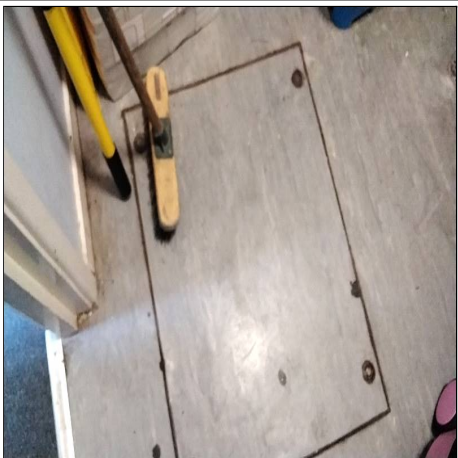
Re-inspection Date:	Lead Surveyor	Survey Type	Floor	Analysis
	9 Jan 2025 to 10 Jan 2025	Tracy Chulk	Reinspection Survey	Ground	N/A
	Building	Room	Item	Quantity	
	Block A	Cleaner A018A	Floor void	N/A	
	Sample No (S,SP,P,As)	Product Type	Surface Treatment	Condition	Accessibility
	Visual (P)	N/A	N/A	N/A	N/A

Normal Occupancy	Score	Likelihood of disturbance	Score	Exposure Potential	Score	Maintenance Activity	Score
Main type of activity	N/A	Location	N/A	Number of occupants	N/A	Type of Maintenance	N/A
		Accessibility	N/A	Frequency of use	N/A	Frequency of maintenance	N/A
		Amount	N/A	Average Time	N/A		
Average Score	N/A	Average Score	N/A	Average Score	N/A	Average Score	N/A
Recommendation	Inspection Required						
Comments	Unable to access without specific lifting keys

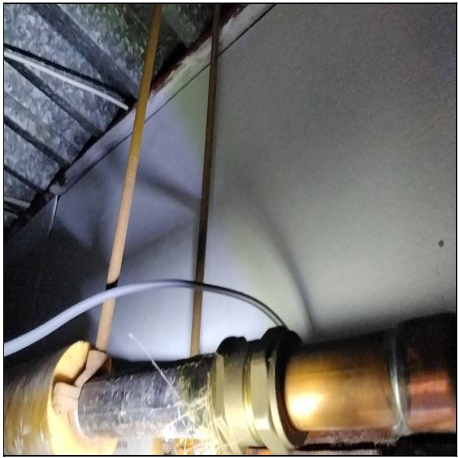
Re-inspection Date:	Lead Surveyor	Survey Type	Floor	Analysis
	9 Jan 2025 to 10 Jan 2025	Tracy Chulk	Reinspection Survey	Ground	Chrysotile + Amosite (2)
	Building	Room	Item	Quantity	
	Block A	Classroom A019	Firebreak above wall to A022, A023 and A019A	5m	
	Sample No (S,SP,P,As)	Product Type	Surface Treatment	Condition	Accessibility
	As DD000842 (SP)	Asbestos Insulating Board (2)	Surface Sealed (1)	Good Condition (0)	Usually inaccessible or unlikely to be disturbed (0)

Normal Occupancy	Score	Likelihood of disturbance	Score	Exposure Potential	Score	Maintenance Activity	Score
Main type of activity	1	Location	2	Number of occupants	3	Type of Maintenance	0
		Accessibility	0	Frequency of use	3	Frequency of maintenance	0
		Amount	1	Average Time	3		
Average Score	1	Average Score	1	Average Score	3	Average Score	0
Recommendation	D - No Attention Required, inspect at intervals						
Comments	N/A

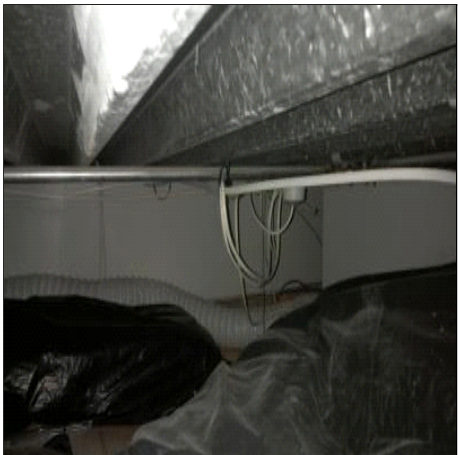
Re-inspection Date:	Lead Surveyor	Survey Type	Floor	Analysis
	9 Jan 2025 to 10 Jan 2025	Tracy Chulk	Reinspection Survey	Ground	Crocidolite (or unknown) (3)
	Building	Room	Item	Quantity	
	Block A	Girls WC A023	Firebreak in ceiling void above wall to A019	2m	
	Sample No (S,SP,P,As)	Product Type	Surface Treatment	Condition	Accessibility
	Visual (P)	Asbestos Insulating Board (2)	Surface Sealed (1)	Good Condition (0)	Usually inaccessible or unlikely to be disturbed (0)

Normal Occupancy	Score	Likelihood of disturbance	Score	Exposure Potential	Score	Maintenance Activity	Score
Main type of activity	0	Location	2	Number of occupants	3	Type of Maintenance	0
		Accessibility	0	Frequency of use	3	Frequency of maintenance	0
		Amount	1	Average Time	0		
Average Score	0	Average Score	1	Average Score	2	Average Score	0
Recommendation	D - No Attention Required, inspect at intervals						
Comments	Unable to access at time of survey, ceiling tiles unliftable without causing damage

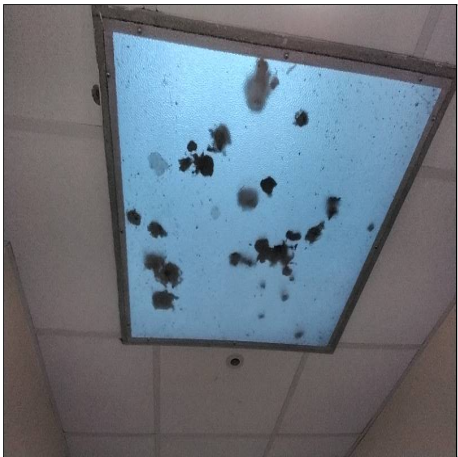
Re-inspection Date:	Lead Surveyor	Survey Type	Floor	Analysis
	9 Jan 2025 to 10 Jan 2025	Tracy Chulk	Reinspection Survey	Ground	Crocidolite (or unknown) (3)
	Building	Room	Item	Quantity	
	Block A	Boys WC A024	Skylight cheeks (sealed both sides)	2m ²	
	Sample No (S,SP,P,As)	Product Type	Surface Treatment	Condition	Accessibility
	Visual (P)	Asbestos Insulating Board (2)	Surface Sealed (1)	Good Condition (0)	Usually inaccessible or unlikely to be disturbed (0)

Normal Occupancy	Score	Likelihood of disturbance	Score	Exposure Potential	Score	Maintenance Activity	Score
Main type of activity	0	Location	2	Number of occupants	3	Type of Maintenance	0
		Accessibility	0	Frequency of use	3	Frequency of maintenance	0
		Amount	1	Average Time	0		
Average Score	0	Average Score	1	Average Score	2	Average Score	0
Recommendation	D - No Attention Required, inspect at intervals						
Comments	Enclosed with polycarbonate panel beneath

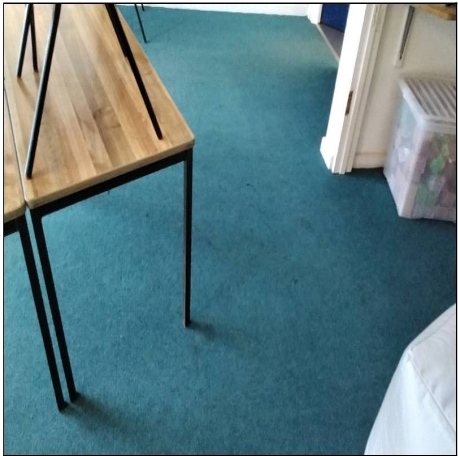
Re-inspection Date:	Lead Surveyor	Survey Type	Floor	Analysis
	9 Jan 2025 to 10 Jan 2025	Tracy Chulk	Reinspection Survey	Ground	Chrysotile (1)
	Building	Room	Item	Quantity	
	Block A	Group room A025	Floor tile adhesive beneath carpet and screed	20m ²	
	Sample No (S,SP,P,As)	Product Type	Surface Treatment	Condition	Accessibility
	Visual (P)	Well-bound Material (1)	Completely Sealed (0)	Good Condition (0)	Usually inaccessible or unlikely to be disturbed (0)

Normal Occupancy	Score	Likelihood of disturbance	Score	Exposure Potential	Score	Maintenance Activity	Score
Main type of activity	1	Location	2	Number of occupants	3	Type of Maintenance	0
		Accessibility	0	Frequency of use	3	Frequency of maintenance	0
		Amount	2	Average Time	2		
Average Score	1	Average Score	2	Average Score	3	Average Score	0
Recommendation	D - No Attention Required, inspect at intervals						
Comments	Carpet glued in place, presumed to remain in situ

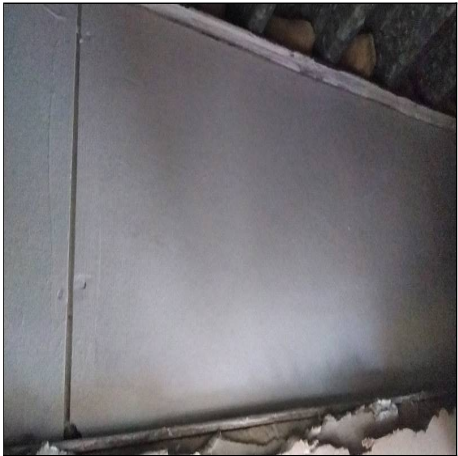
Re-inspection Date:	Lead Surveyor	Survey Type	Floor	Analysis
	9 Jan 2025 to 10 Jan 2025	Tracy Chulk	Reinspection Survey	Ground	Amosite (2)
	Building	Room	Item	Quantity	
	Block A	Group room A025	Firebreak above wall to A029 South East corner	5m	
	Sample No (S,SP,P,As)	Product Type	Surface Treatment	Condition	Accessibility
	DD000841 (S)	Asbestos Insulating Board (2)	Surface Sealed (1)	Good Condition (0)	Usually inaccessible or unlikely to be disturbed (0)

Normal Occupancy	Score	Likelihood of disturbance	Score	Exposure Potential	Score	Maintenance Activity	Score
Main type of activity	1	Location	2	Number of occupants	3	Type of Maintenance	0
		Accessibility	0	Frequency of use	3	Frequency of maintenance	0
		Amount	1	Average Time	2		
Average Score	1	Average Score	1	Average Score	3	Average Score	0
Recommendation	D - No Attention Required, inspect at intervals						
Comments	N/A

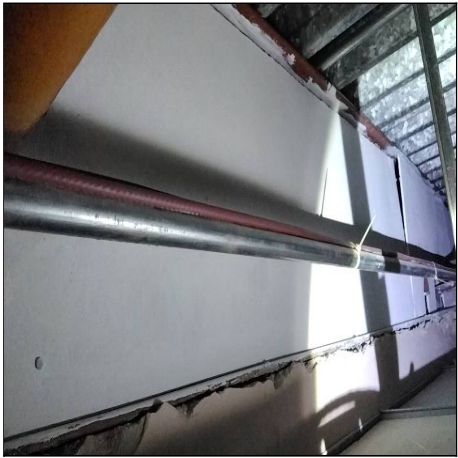
Re-inspection Date:	Lead Surveyor	Survey Type	Floor	Analysis
	9 Jan 2025 to 10 Jan 2025	Tracy Chulk	Reinspection Survey	Ground	Amosite (2)
	Building	Room	Item	Quantity	
	Block A	Group room A025	Firebreak above doors to A027 and adjoining wall to A029	3-4m ²	
	Sample No (S,SP,P,As)	Product Type	Surface Treatment	Condition	Accessibility
	As DD000841 (SP)	Asbestos Insulating Board (2)	Surface Sealed (1)	Good Condition (0)	Usually inaccessible or unlikely to be disturbed (0)

Normal Occupancy	Score	Likelihood of disturbance	Score	Exposure Potential	Score	Maintenance Activity	Score
Main type of activity	1	Location	2	Number of occupants	3	Type of Maintenance	0
		Accessibility	0	Frequency of use	3	Frequency of maintenance	0
		Amount	1	Average Time	2		
Average Score	1	Average Score	1	Average Score	3	Average Score	0
Recommendation	D - No Attention Required, inspect at intervals						
Comments	N/A

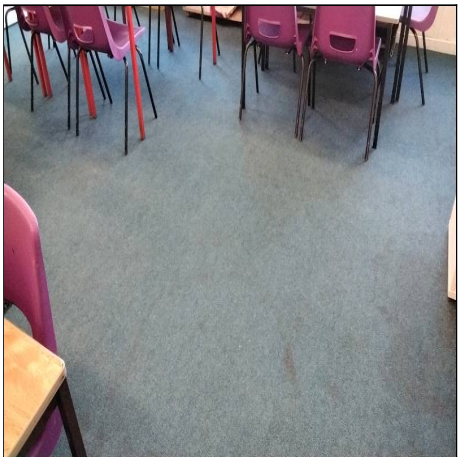
Re-inspection Date:	Lead Surveyor	Survey Type	Floor	Analysis
	9 Jan 2025 to 10 Jan 2025	Tracy Chulk	Reinspection Survey	Ground	Chrysotile (1)
	Building	Room	Item	Quantity	
	Block A	Store A027	Floor tile adhesive beneath carpet and screed (presumed to remain)	1m ²	
	Sample No (S,SP,P,As)	Product Type	Surface Treatment	Condition	Accessibility
	Visual (P)	Well-bound Material (1)	Completely Sealed (0)	Good Condition (0)	Usually inaccessible or unlikely to be disturbed (0)

Normal Occupancy	Score	Likelihood of disturbance	Score	Exposure Potential	Score	Maintenance Activity	Score
Main type of activity	0	Location	2	Number of occupants	3	Type of Maintenance	0
		Accessibility	0	Frequency of use	3	Frequency of maintenance	0
		Amount	2	Average Time	2		
Average Score	0	Average Score	2	Average Score	3	Average Score	0
Recommendation	D - No Attention Required, inspect at intervals						
Comments	Carpet glued in place, presumed to remain in situ

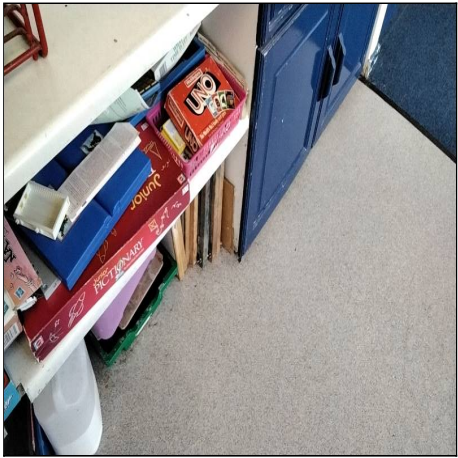
Re-inspection Date:	Lead Surveyor	Survey Type	Floor	Analysis
	9 Jan 2025 to 10 Jan 2025	Tracy Chulk	Reinspection Survey	Ground	Chrysotile (1)
	Building	Room	Item	Quantity	
	Block A	Practical A028	Floor tile adhesive beneath modern vinyl sheet	3m ²	
	Sample No (S,SP,P,As)	Product Type	Surface Treatment	Condition	Accessibility
	Visual (P)	Well-bound Material (1)	Completely Sealed (0)	Good Condition (0)	Usually inaccessible or unlikely to be disturbed (0)

Normal Occupancy	Score	Likelihood of disturbance	Score	Exposure Potential	Score	Maintenance Activity	Score
Main type of activity	1	Location	2	Number of occupants	2	Type of Maintenance	0
		Accessibility	0	Frequency of use	3	Frequency of maintenance	0
		Amount	1	Average Time	1		
Average Score	1	Average Score	1	Average Score	2	Average Score	0
Recommendation	D - No Attention Required, inspect at intervals						
Comments	new vinyl sheet glued in place, presumed to remain in situ

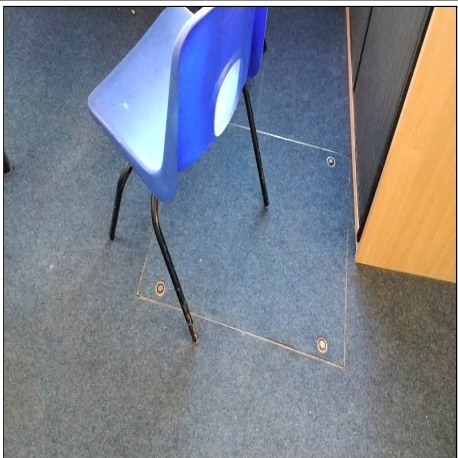
Re-inspection Date:	Lead Surveyor	Survey Type	Floor	Analysis
	9 Jan 2025 to 10 Jan 2025	Tracy Chulk	Reinspection Survey	Ground	N/A
	Building	Room	Item	Quantity	N/A
	Block A	Practical A028B	Floor void	N/A	
	Sample No (S,SP,P,As)	Product Type	Surface Treatment	Condition	Accessibility
	Visual (P)	N/A	N/A	N/A	N/A

Normal Occupancy	Score	Likelihood of disturbance	Score	Exposure Potential	Score	Maintenance Activity	Score
Main type of activity	N/A	Location	N/A	Number of occupants	N/A	Type of Maintenance	N/A
		Accessibility	N/A	Frequency of use	N/A	Frequency of maintenance	N/A
		Amount	N/A	Average Time	N/A		
Average Score	N/A	Average Score	N/A	Average Score	N/A	Average Score	N/A
Recommendation	Inspection Required						
Comments	Unable to access without specific lifting keys

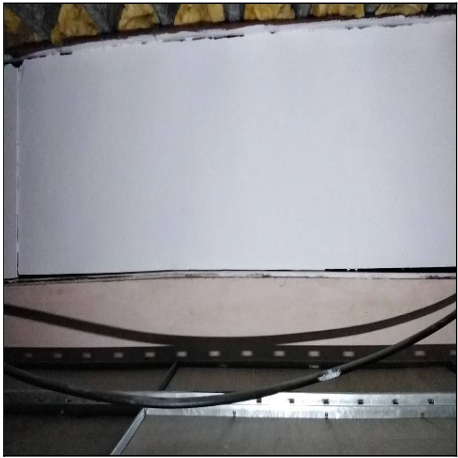
Re-inspection Date:	Lead Surveyor	Survey Type	Floor	Analysis
	9 Jan 2025 to 10 Jan 2025	Tracy Chulk	Reinspection Survey	Ground	Crocidolite (or unknown) (3)
	Building	Room	Item	Quantity	
	Block A	Classroom A029	Firebreak above wall to A025 (adjoining A027)	3m ²	
	Sample No (S,SP,P,As)	Product Type	Surface Treatment	Condition	Accessibility
	Visual (P)	Asbestos Insulating Board (2)	Surface Sealed (1)	Good Condition (0)	Usually inaccessible or unlikely to be disturbed (0)

Normal Occupancy	Score	Likelihood of disturbance	Score	Exposure Potential	Score	Maintenance Activity	Score
Main type of activity	1	Location	2	Number of occupants	3	Type of Maintenance	0
		Accessibility	0	Frequency of use	3	Frequency of maintenance	0
		Amount	1	Average Time	3		
Average Score	1	Average Score	1	Average Score	3	Average Score	0
Recommendation	D - No Attention Required, inspect at intervals						
Comments	N/A

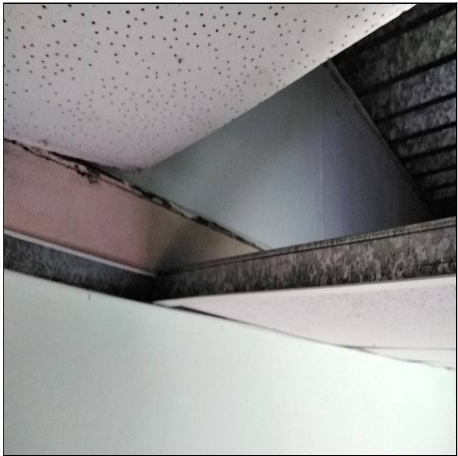
Re-inspection Date:	Lead Surveyor	Survey Type	Floor	Analysis
	9 Jan 2025 to 10 Jan 2025	Tracy Chulk	Reinspection Survey	Ground	Crocidolite (or unknown) (3)
	Building	Room	Item	Quantity	
	Block A	Classroom A029	Firebreak above wall to A025 South West corner	4m	
	Sample No (S,SP,P,As)	Product Type	Surface Treatment	Condition	Accessibility
	Visual (P)	Asbestos Insulating Board (2)	Surface Sealed (1)	Good Condition (0)	Usually inaccessible or unlikely to be disturbed (0)

Normal Occupancy	Score	Likelihood of disturbance	Score	Exposure Potential	Score	Maintenance Activity	Score
Main type of activity	1	Location	2	Number of occupants	3	Type of Maintenance	0
		Accessibility	0	Frequency of use	3	Frequency of maintenance	0
		Amount	1	Average Time	3		
Average Score	1	Average Score	1	Average Score	3	Average Score	0
Recommendation	D - No Attention Required, inspect at intervals						
Comments	N/A

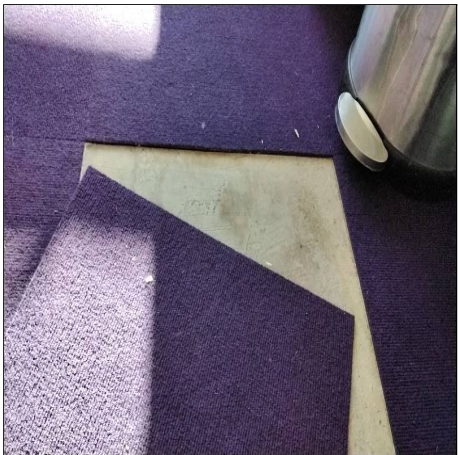
Re-inspection Date:	Lead Surveyor	Survey Type	Floor	Analysis
	9 Jan 2025 to 10 Jan 2025	Tracy Chulk	Reinspection Survey	Ground	Chrysotile (1)
	Building	Room	Item	Quantity	
	Block A	Classroom A029	Vinyl floor tiles beneath carpet and screed	15m ²	
	Sample No (S,SP,P,As)	Product Type	Surface Treatment	Condition	Accessibility
	Visual (P)	Well-bound Material (1)	Completely Sealed (0)	Good Condition (0)	Usually inaccessible or unlikely to be disturbed (0)

Normal Occupancy	Score	Likelihood of disturbance	Score	Exposure Potential	Score	Maintenance Activity	Score
Main type of activity	1	Location	2	Number of occupants	3	Type of Maintenance	0
		Accessibility	0	Frequency of use	3	Frequency of maintenance	0
		Amount	2	Average Time	3		
Average Score	1	Average Score	2	Average Score	3	Average Score	0
Recommendation	D - No Attention Required, inspect at intervals						
Comments	Unable to access, presumed to remain in situ

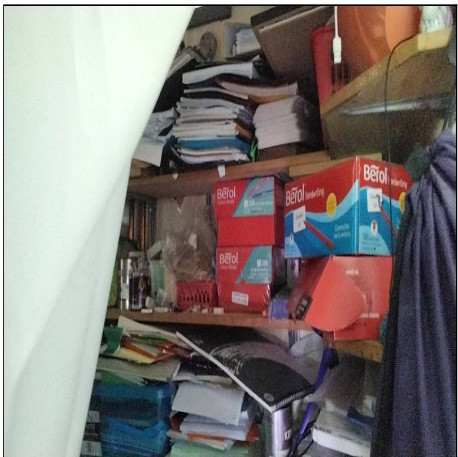
9 Jan 2025 to 10 Jan 2025	Tracy Chulk	Reinspection Survey	Ground	Crocidolite (or unknown) (3)
	Building	Room	Item	Quantity	
	Block A	Store A031	Firebreak above wall to A014A (can be seen from adjacent room)	1m ²	
	Sample No (S,SP,P,As)	Product Type	Surface Treatment	Condition	Accessibility
	Visual (P)	Asbestos Insulating Board (2)	Surface Sealed (1)	Good Condition (0)	Usually inaccessible or unlikely to be disturbed (0)

Normal Occupancy	Score	Likelihood of disturbance	Score	Exposure Potential	Score	Maintenance Activity	Score
Main type of activity	0	Location	2	Number of occupants	1	Type of Maintenance	0
		Accessibility	0	Frequency of use	0	Frequency of maintenance	1
		Amount	1	Average Time	0		
Average Score	0	Average Score	1	Average Score	1	Average Score	1
Recommendation	D - No Attention Required, inspect at intervals						
Comments	Unable to access due to stored items in cupboard

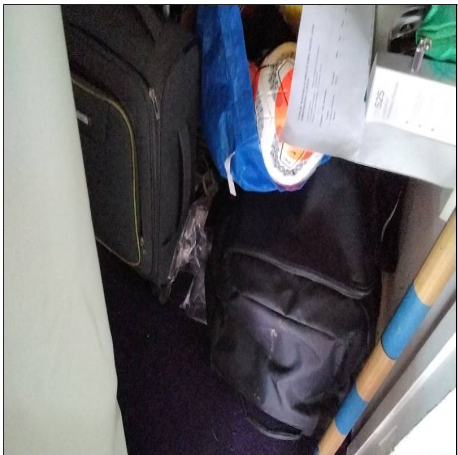
Re-inspection Date:	Lead Surveyor	Survey Type	Floor	Analysis
	9 Jan 2025 to 10 Jan 2025	Tracy Chulk	Reinspection Survey	Ground	Chrysotile (1)
	Building	Room	Item	Quantity	
	Block A	Store A031	Vinyl floor tiles beneath carpet and screed	1m ²	
	Sample No (S,SP,P,As)	Product Type	Surface Treatment	Condition	Accessibility
	Visual (P)	Well-bound Material (1)	Completely Sealed (0)	Good Condition (0)	Usually inaccessible or unlikely to be disturbed (0)

Normal Occupancy	Score	Likelihood of disturbance	Score	Exposure Potential	Score	Maintenance Activity	Score
Main type of activity	0	Location	2	Number of occupants	0	Type of Maintenance	0
		Accessibility	0	Frequency of use	0	Frequency of maintenance	0
		Amount	2	Average Time	0		
Average Score	0	Average Score	2	Average Score	0	Average Score	0
Recommendation	D - No Attention Required, inspect at intervals						
Comments	Unable to access, presumed to remain in situ

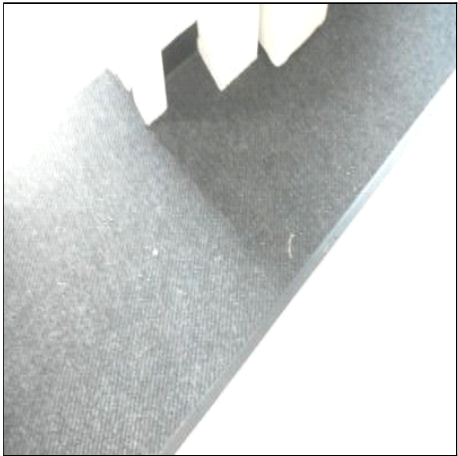
Re-inspection Date:	Lead Surveyor	Survey Type	Floor	Analysis
	9 Jan 2025 to 10 Jan 2025	Tracy Chulk	Reinspection Survey	Ground	No Asbestos Detected (0)
	Building	Room	Item	Quantity	
	Block A	Circulation A032	Vinyl floor tiles	5m ²	
	Sample No (S,SP,P,As)	Product Type	Surface Treatment	Condition	Accessibility
	20761323 {AB000273}* (S)	Not applicable (No asbestos detected) (0)	Completely Sealed (0)	Good Condition (0)	Usually inaccessible or unlikely to be disturbed (0)

Normal Occupancy	Score	Likelihood of disturbance	Score	Exposure Potential	Score	Maintenance Activity	Score
Main type of activity	N/A	Location	N/A	Number of occupants	N/A	Type of Maintenance	N/A
		Accessibility	N/A	Frequency of use	N/A	Frequency of maintenance	N/A
		Amount	N/A	Average Time	N/A		
Average Score	N/A	Average Score	N/A	Average Score	N/A	Average Score	N/A
Recommendation	No further action required						
Comments	N/A

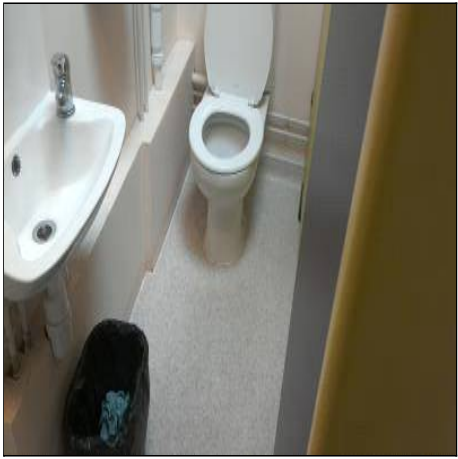
Re-inspection Date:	Lead Surveyor	Survey Type	Floor	Analysis
	9 Jan 2025 to 10 Jan 2025	Tracy Chulk	Reinspection Survey	Ground	N/A
	Building	Room	Item	Quantity	
	Block A	Girls WC A033	Void where pipe enters floor construction	N/A	
	Sample No (S,SP,P,As)	Product Type	Surface Treatment	Condition	Accessibility
	Visual (P)	N/A	N/A	N/A	N/A

Normal Occupancy	Score	Likelihood of disturbance	Score	Exposure Potential	Score	Maintenance Activity	Score
Main type of activity	N/A	Location	N/A	Number of occupants	N/A	Type of Maintenance	N/A
		Accessibility	N/A	Frequency of use	N/A	Frequency of maintenance	N/A
		Amount	N/A	Average Time	N/A		
Average Score	N/A	Average Score	N/A	Average Score	N/A	Average Score	N/A
Recommendation	Inspection Required						
Comments	N/A

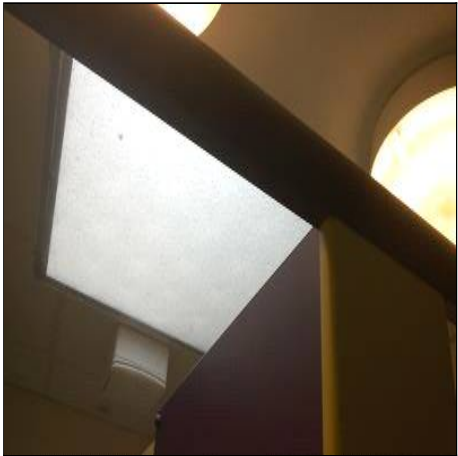
Re-inspection Date:	Lead Surveyor	Survey Type	Floor	Analysis
	9 Jan 2025 to 10 Jan 2025	Tracy Chulk	Reinspection Survey	Ground	Chrysotile (1)
	Building	Room	Item	Quantity	
	Block A	Girls WC A033	Skylight cheeks	2m ²	
	Sample No (S,SP,P,As)	Product Type	Surface Treatment	Condition	Accessibility
	Visual (P)	Asbestos Insulating Board (2)	Surface Sealed (1)	Good Condition (0)	Usually inaccessible or unlikely to be disturbed (0)

Normal Occupancy	Score	Likelihood of disturbance	Score	Exposure Potential	Score	Maintenance Activity	Score
Main type of activity	0	Location	2	Number of occupants	3	Type of Maintenance	0
		Accessibility	0	Frequency of use	0	Frequency of maintenance	0
		Amount	1	Average Time	0		
Average Score	0	Average Score	1	Average Score	1	Average Score	0
Recommendation	D - No Attention Required, inspect at intervals						
Comments	N/A

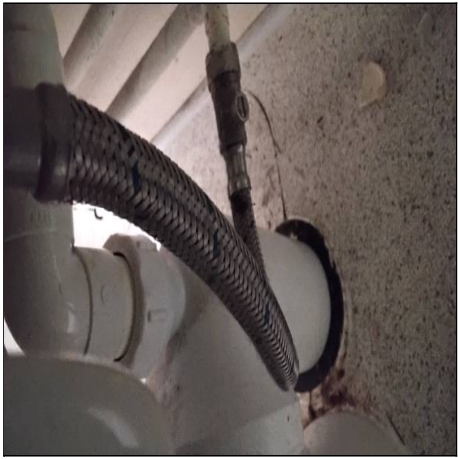
Re-inspection Date:	Lead Surveyor	Survey Type	Floor	Analysis
	9 Jan 2025 to 10 Jan 2025	Tracy Chulk	Reinspection Survey	Ground	N/A
	Building	Room	Item	Quantity	
	Block A	Boys WC A034	Void Where pipe enters floor construction	N/A	
	Sample No (S,SP,P,As)	Product Type	Surface Treatment	Condition	Accessibility
	Visual (P)	N/A	N/A	N/A	N/A

Normal Occupancy	Score	Likelihood of disturbance	Score	Exposure Potential	Score	Maintenance Activity	Score
Main type of activity	N/A	Location	N/A	Number of occupants	N/A	Type of Maintenance	N/A
		Accessibility	N/A	Frequency of use	N/A	Frequency of maintenance	N/A
		Amount	N/A	Average Time	N/A		
Average Score	N/A	Average Score	N/A	Average Score	N/A	Average Score	N/A
Recommendation	Inspection Required						
Comments	Unable to access without causing excessive damage

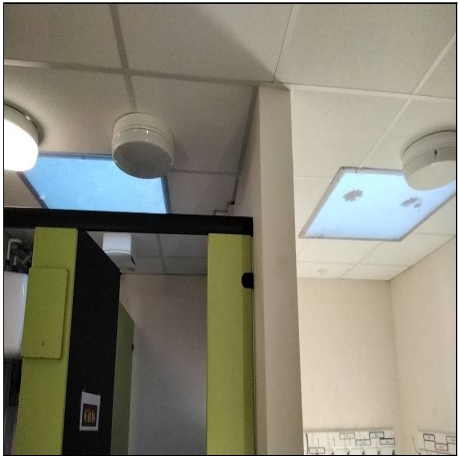
Re-inspection Date:	Lead Surveyor	Survey Type	Floor	Analysis
	9 Jan 2025 to 10 Jan 2025	Tracy Chulk	Reinspection Survey	Ground	Chrysotile + Amosite (2)
	Building	Room	Item	Quantity	
	Block A	Boys WC A034	Skylight cheeks	2m ²	
	Sample No (S,SP,P,As)	Product Type	Surface Treatment	Condition	Accessibility
	20761324 {AB000272}* (S)	Asbestos Insulating Board (2)	Surface Sealed (1)	Good Condition (0)	Usually inaccessible or unlikely to be disturbed (0)

Normal Occupancy	Score	Likelihood of disturbance	Score	Exposure Potential	Score	Maintenance Activity	Score
Main type of activity	0	Location	2	Number of occupants	3	Type of Maintenance	0
		Accessibility	0	Frequency of use	3	Frequency of maintenance	0
		Amount	1	Average Time	0		
Average Score	0	Average Score	1	Average Score	2	Average Score	0
Recommendation	D - No Attention Required, inspect at intervals						
Comments	Enclosed by polycarbonate panels - unable to see rear in ceiling void due to weight of insulation above the ceiling

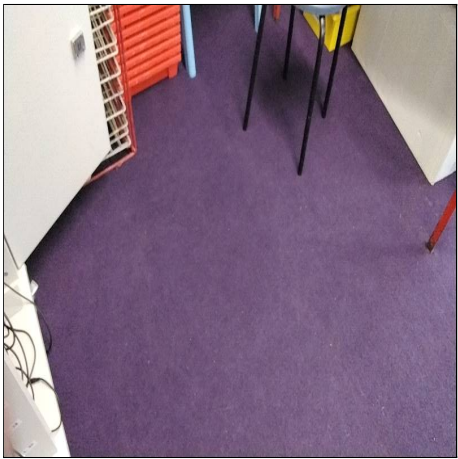
Re-inspection Date:	Lead Surveyor	Survey Type	Floor	Analysis
	9 Jan 2025 to 10 Jan 2025	Tracy Chulk	Reinspection Survey	Ground	Chrysotile (1)
	Building	Room	Item	Quantity	
	Block A	Classroom A035	Vinyl floor tiles beneath carpet East end only (presumed to remain)	6m ²	
	Sample No (S,SP,P,As)	Product Type	Surface Treatment	Condition	Accessibility
	Visual (P)	Well-bound Material (1)	Completely Sealed (0)	Good Condition (0)	Usually inaccessible or unlikely to be disturbed (0)

Normal Occupancy	Score	Likelihood of disturbance	Score	Exposure Potential	Score	Maintenance Activity	Score
Main type of activity	1	Location	2	Number of occupants	3	Type of Maintenance	0
		Accessibility	0	Frequency of use	3	Frequency of maintenance	0
		Amount	1	Average Time	3		
Average Score	1	Average Score	1	Average Score	3	Average Score	0
Recommendation	D - No Attention Required, inspect at intervals						
Comments	Carpet tiles glued in place, presumed to remain in situ

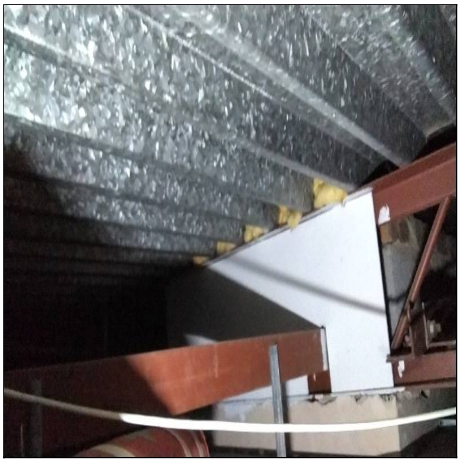
Re-inspection Date:	Lead Surveyor	Survey Type	Floor	Analysis
	9 Jan 2025 to 10 Jan 2025	Tracy Chulk	Reinspection Survey	Ground	Chrysotile + Amosite (2)
	Building	Room	Item	Quantity	
	Block A	Classroom A035	Firebreak in ceiling void above wall adj. A037	2m	
	Sample No (S,SP,P,As)	Product Type	Surface Treatment	Condition	Accessibility
	As DD000842 (SP)	Asbestos Insulating Board (2)	Surface Sealed (1)	Good Condition (0)	Usually inaccessible or unlikely to be disturbed (0)

Normal Occupancy	Score	Likelihood of disturbance	Score	Exposure Potential	Score	Maintenance Activity	Score
Main type of activity	1	Location	2	Number of occupants	3	Type of Maintenance	0
		Accessibility	0	Frequency of use	3	Frequency of maintenance	0
		Amount	1	Average Time	3		
Average Score	1	Average Score	1	Average Score	3	Average Score	0
Recommendation	D - No Attention Required, inspect at intervals						
Comments	N/A

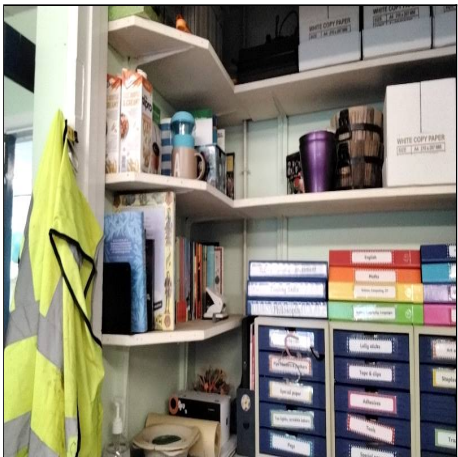
Re-inspection Date:	Lead Surveyor	Survey Type	Floor	Analysis
	9 Jan 2025 to 10 Jan 2025	Tracy Chulk	Reinspection Survey	Ground	Crocidolite (or unknown) (3)
	Building	Room	Item	Quantity	
	Block A	Store A037	Firebreak in ceiling void above wall adj. A035 and A014A (seen the other side)	1m ²	
	Sample No (S,SP,P,As)	Product Type	Surface Treatment	Condition	Accessibility
	Visual (P)	Asbestos Insulating Board (2)	Surface Sealed (1)	Good Condition (0)	Usually inaccessible or unlikely to be disturbed (0)

Normal Occupancy	Score	Likelihood of disturbance	Score	Exposure Potential	Score	Maintenance Activity	Score
Main type of activity	0	Location	2	Number of occupants	1	Type of Maintenance	0
		Accessibility	0	Frequency of use	0	Frequency of maintenance	0
		Amount	1	Average Time	0		
Average Score	0	Average Score	1	Average Score	1	Average Score	0
Recommendation	D - No Attention Required, inspect at intervals						
Comments	No access due to stored items in the cupboard at high level

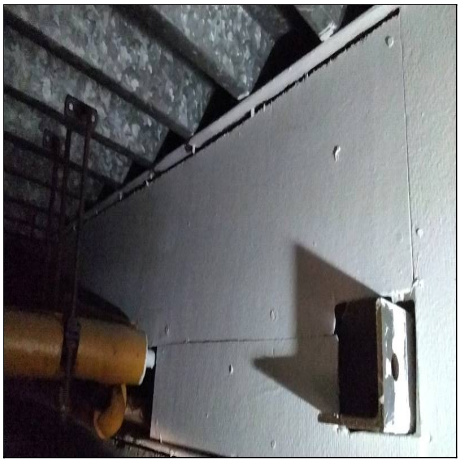
Re-inspection Date:	Lead Surveyor	Survey Type	Floor	Analysis
	9 Jan 2025 to 10 Jan 2025	Tracy Chulk	Reinspection Survey	Ground	Crocidolite (or unknown) (3)
	Building	Room	Item	Quantity	
	Block A	Classroom A038	Firebreak in ceiling void above wall adj. A041	4m	
	Sample No (S,SP,P,As)	Product Type	Surface Treatment	Condition	Accessibility
	Visual (P)	Asbestos Insulating Board (2)	Surface Sealed (1)	Good Condition (0)	Usually inaccessible or unlikely to be disturbed (0)

Normal Occupancy	Score	Likelihood of disturbance	Score	Exposure Potential	Score	Maintenance Activity	Score
Main type of activity	1	Location	2	Number of occupants	3	Type of Maintenance	0
		Accessibility	0	Frequency of use	3	Frequency of maintenance	1
		Amount	1	Average Time	3		
Average Score	1	Average Score	1	Average Score	3	Average Score	1
Recommendation	D - No Attention Required, inspect at intervals						
Comments	N/A

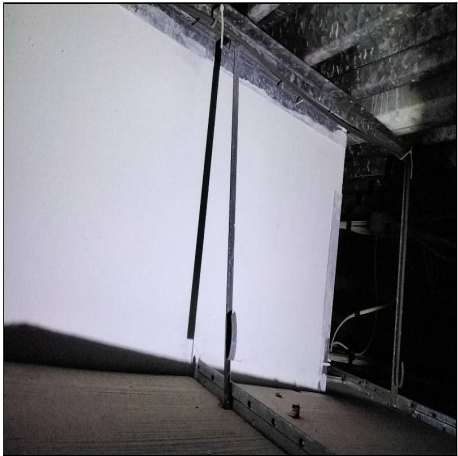
Re-inspection Date:	Lead Surveyor	Survey Type	Floor	Analysis
	9 Jan 2025 to 10 Jan 2025	Tracy Chulk	Reinspection Survey	Ground	Amosite (2)
	Building	Room	Item	Quantity	
	Block A	Classroom A038	Skylight cheeks (sealed both sides)	2m ²	
	Sample No (S,SP,P,As)	Product Type	Surface Treatment	Condition	Accessibility
	As 20761322 {AB000271}* (SP)	Asbestos Insulating Board (2)	Surface Sealed (1)	Good Condition (0)	Occasionally likely to be disturbed (1)

Normal Occupancy	Score	Likelihood of disturbance	Score	Exposure Potential	Score	Maintenance Activity	Score
Main type of activity	1	Location	2	Number of occupants	3	Type of Maintenance	0
		Accessibility	1	Frequency of use	3	Frequency of maintenance	0
		Amount	1	Average Time	3		
Average Score	1	Average Score	2	Average Score	3	Average Score	0
Recommendation	D - No Attention Required, inspect at intervals						
Comments	Enclosed by polycarbonate panel beneath

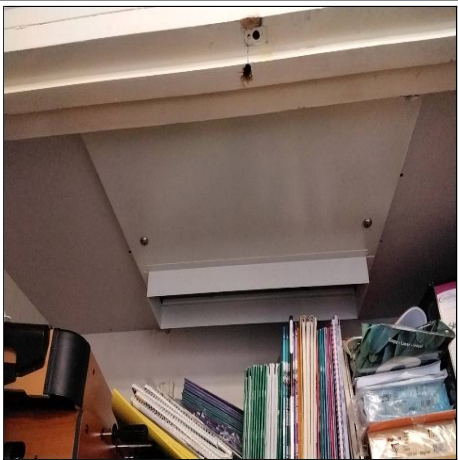
Re-inspection Date:	Lead Surveyor	Survey Type	Floor	Analysis
	9 Jan 2025 to 10 Jan 2025	Tracy Chulk	Reinspection Survey	Ground	N/A
	Building	Room	Item	Quantity	
	Block A	Store A040	Ceiling void	N/A	
	Sample No (S,SP,P,As)	Product Type	Surface Treatment	Condition	Accessibility
	Visual (P)	N/A	N/A	N/A	N/A

Normal Occupancy	Score	Likelihood of disturbance	Score	Exposure Potential	Score	Maintenance Activity	Score
Main type of activity	N/A	Location	N/A	Number of occupants	N/A	Type of Maintenance	N/A
		Accessibility	N/A	Frequency of use	N/A	Frequency of maintenance	N/A
		Amount	N/A	Average Time	N/A		
Average Score	N/A	Average Score	N/A	Average Score	N/A	Average Score	N/A
Recommendation	Inspection Required						
Comments	Unable to access without causing excessive damage

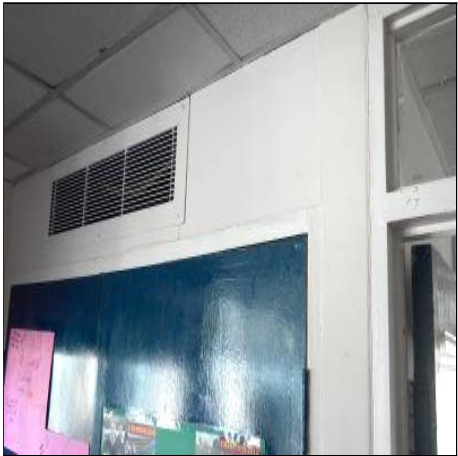
Re-inspection Date:	Lead Surveyor	Survey Type	Floor	Analysis
	9 Jan 2025 to 10 Jan 2025	Tracy Chulk	Reinspection Survey	Ground	No Asbestos Detected (0)
	Building	Room	Item	Quantity	
	Block A	Store A040	Panel above doors	2m ²	
	Sample No (S,SP,P,As)	Product Type	Surface Treatment	Condition	Accessibility
	21261379 {AB000278}* (S)	Not applicable (No asbestos detected) (0)	Completely Sealed (0)	Good Condition (0)	Usually inaccessible or unlikely to be disturbed (0)

Normal Occupancy	Score	Likelihood of disturbance	Score	Exposure Potential	Score	Maintenance Activity	Score
Main type of activity	N/A	Location	N/A	Number of occupants	N/A	Type of Maintenance	N/A
		Accessibility	N/A	Frequency of use	N/A	Frequency of maintenance	N/A
		Amount	N/A	Average Time	N/A		
Average Score	N/A	Average Score	N/A	Average Score	N/A	Average Score	N/A
Recommendation	Inspection Required						
Comments	N/A

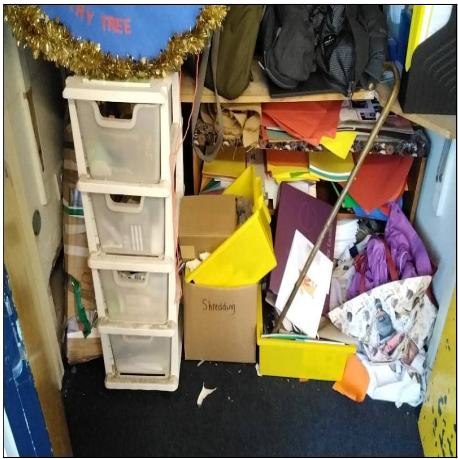
Re-inspection Date:	Lead Surveyor	Survey Type	Floor	Analysis
	9 Jan 2025 to 10 Jan 2025	Tracy Chulk	Reinspection Survey	Ground	Chrysotile (1)
	Building	Room	Item	Quantity	
	Block A	Store A040	Vinyl floor tiles beneath carpet and screed (presumed to remain)	2m ²	
	Sample No (S,SP,P,As)	Product Type	Surface Treatment	Condition	Accessibility
	AB000277* (S)	Well Bound Material (1)	Completely Sealed (0)	Good Condition (0)	Usually inaccessible or unlikely to be disturbed (0)

Normal Occupancy	Score	Likelihood of disturbance	Score	Exposure Potential	Score	Maintenance Activity	Score
Main type of activity	0	Location	2	Number of occupants	1	Type of Maintenance	0
		Accessibility	0	Frequency of use	0	Frequency of maintenance	0
		Amount	1	Average Time	0		
Average Score	0	Average Score	1	Average Score	1	Average Score	0
Recommendation	Inspection Required						
Comments	Unable to access, due to stored items

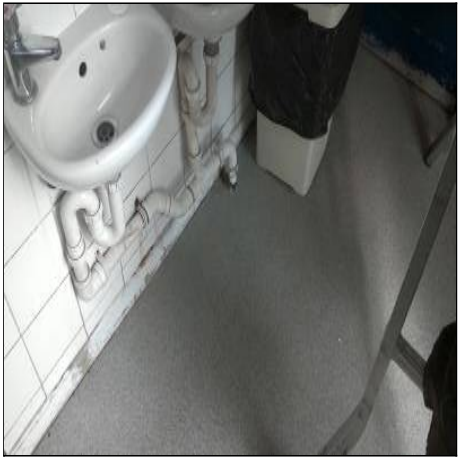
Re-inspection Date:	Lead Surveyor	Survey Type	Floor	Analysis
	9 Jan 2025 to 10 Jan 2025	Tracy Chulk	Reinspection Survey	Ground	N/A
	Building	Room	Item	Quantity	
	Block A	Pupils WC A041	Void where pipe enters floor construction	N/A	
	Sample No (S,SP,P,As)	Product Type	Surface Treatment	Condition	Accessibility
	Visual (P)	N/A	N/A	N/A	N/A

Normal Occupancy	Score	Likelihood of disturbance	Score	Exposure Potential	Score	Maintenance Activity	Score
Main type of activity	N/A	Location	N/A	Number of occupants	N/A	Type of Maintenance	N/A
		Accessibility	N/A	Frequency of use	N/A	Frequency of maintenance	N/A
		Amount	N/A	Average Time	N/A		
Average Score	N/A	Average Score	N/A	Average Score	N/A	Average Score	N/A
Recommendation	Inspection Required						
Comments	Unable to access without causing excessive damage

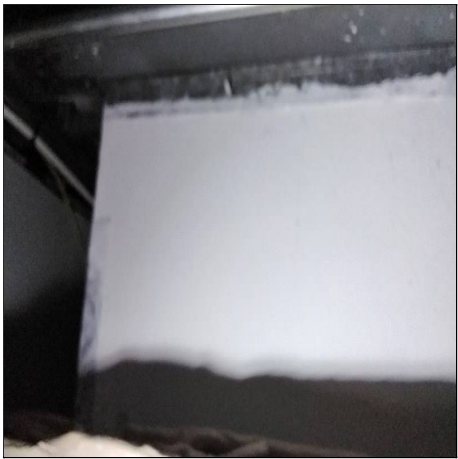
Re-inspection Date:	Lead Surveyor	Survey Type	Floor	Analysis
	9 Jan 2025 to 10 Jan 2025	Tracy Chulk	Reinspection Survey	Ground	Amosite (2)
	Building	Room	Item	Quantity	
	Block A	Pupils WC A041	Skylight cheeks (sealed both sides)	2m ²	
	Sample No (S,SP,P,As)	Product Type	Surface Treatment	Condition	Accessibility
	As 20761322 {AB000271}* (SP)	Asbestos Insulating Board (2)	Surface Sealed (1)	Good Condition (0)	Usually inaccessible or unlikely to be disturbed (0)

Normal Occupancy	Score	Likelihood of disturbance	Score	Exposure Potential	Score	Maintenance Activity	Score
Main type of activity	0	Location	2	Number of occupants	2	Type of Maintenance	0
		Accessibility	0	Frequency of use	3	Frequency of maintenance	0
		Amount	1	Average Time	0		
Average Score	0	Average Score	1	Average Score	2	Average Score	0
Recommendation	D - No Attention Required, inspect at intervals						
Comments	Enclosed with polycarbonate panels beneath

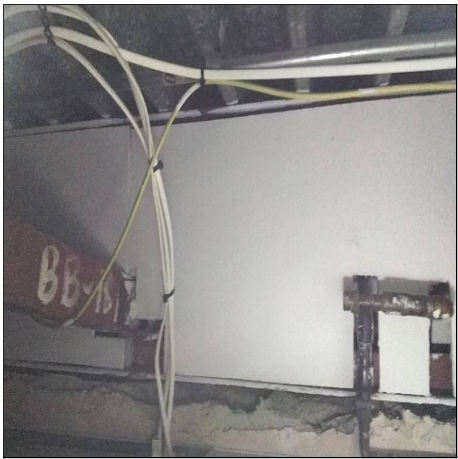
Re-inspection Date:	Lead Surveyor	Survey Type	Floor	Analysis
	9 Jan 2025 to 10 Jan 2025	Tracy Chulk	Reinspection Survey	Ground	Amosite (2)
	Building	Room	Item	Quantity	
	Block A	Pupils WC A041	Firebreak in ceiling void above wall adj. A038	3m	
	Sample No (S,SP,P,As)	Product Type	Surface Treatment	Condition	Accessibility
	As DD000841 (SP)	Asbestos Insulating Board (2)	Surface Sealed (1)	Good Condition (0)	Usually inaccessible or unlikely to be disturbed (0)

Normal Occupancy	Score	Likelihood of disturbance	Score	Exposure Potential	Score	Maintenance Activity	Score
Main type of activity	0	Location	2	Number of occupants	1	Type of Maintenance	0
		Accessibility	0	Frequency of use	3	Frequency of maintenance	1
		Amount	1	Average Time	0		
Average Score	0	Average Score	1	Average Score	2	Average Score	1
Recommendation	D - No Attention Required, inspect at intervals						
Comments	N/A

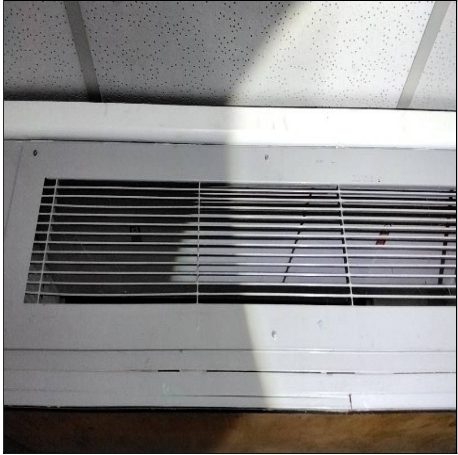
Re-inspection Date:	Lead Surveyor	Survey Type	Floor	Analysis
	9 Jan 2025 to 10 Jan 2025	Tracy Chulk	Reinspection Survey	Ground	Chrysotile + Amosite (2)
	Building	Room	Item	Quantity	
	Block A	Practical A042	Lining panels to wooden ducting adjacent heater in A050 (lining may exist within the rest of the ducting throughout the school)	<2m ²	
	Sample No (S,SP,P,As)	Product Type	Surface Treatment	Condition	Accessibility
	AO001112* (S)	Asbestos Insulating Board (2)	Surface Sealed (1)	Good Condition (0)	Usually inaccessible or unlikely to be disturbed (0)

Normal Occupancy	Score	Likelihood of disturbance	Score	Exposure Potential	Score	Maintenance Activity	Score
Main type of activity	1	Location	2	Number of occupants	2	Type of Maintenance	0
		Accessibility	0	Frequency of use	3	Frequency of maintenance	0
		Amount	1	Average Time	1		
Average Score	1	Average Score	1	Average Score	2	Average Score	0
Recommendation	D - No Attention Required, inspect at intervals						
Comments	N/A

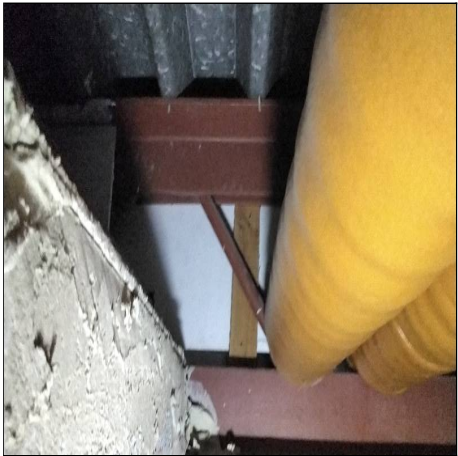
Re-inspection Date:	Lead Surveyor	Survey Type	Floor	Analysis
	9 Jan 2025 to 10 Jan 2025	Tracy Chulk	Reinspection Survey	Ground	Chrysotile + Amosite (2)
	Building	Room	Item	Quantity	
	Block A	Store A044	Rear of firebreak above wall to classroom A045	2lm	
	Sample No (S,SP,P,As)	Product Type	Surface Treatment	Condition	Accessibility
	As 20761319 {AB000280}* (SP)	Asbestos Insulating Board (2)	Surface Sealed (1)	Low Damage (1)	Usually inaccessible or unlikely to be disturbed (0)

Normal Occupancy	Score	Likelihood of disturbance	Score	Exposure Potential	Score	Maintenance Activity	Score
Main type of activity	0	Location	2	Number of occupants	1	Type of Maintenance	0
		Accessibility	0	Frequency of use	0	Frequency of maintenance	0
		Amount	1	Average Time	0		
Average Score	0	Average Score	1	Average Score	1	Average Score	0
Recommendation	Inspection Required						
Comments	N/A

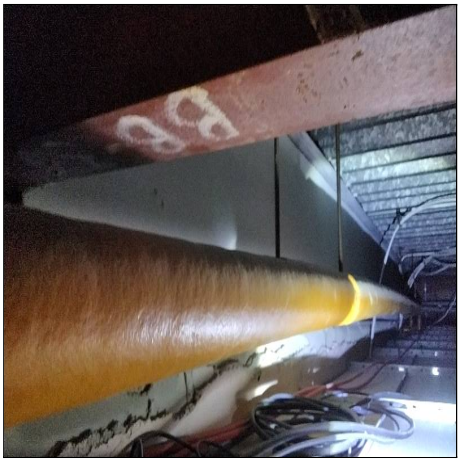
Re-inspection Date:	Lead Surveyor	Survey Type	Floor	Analysis
	9 Jan 2025 to 10 Jan 2025	Tracy Chulk	Reinspection Survey	Ground	Crocidolite (or unknown) (3)
	Building	Room	Item	Quantity	
	Block A	Classroom A045	Firebreak in ceiling void above wall adj. A044, A046 and A048	3m	
	Sample No (S,SP,P,As)	Product Type	Surface Treatment	Condition	Accessibility
	Visual (P)	Asbestos Insulating Board (2)	Surface Sealed (1)	Good Condition (0)	Usually inaccessible or unlikely to be disturbed (0)

Normal Occupancy	Score	Likelihood of disturbance	Score	Exposure Potential	Score	Maintenance Activity	Score
Main type of activity	0	Location	2	Number of occupants	3	Type of Maintenance	0
		Accessibility	0	Frequency of use	3	Frequency of maintenance	0
		Amount	1	Average Time	3		
Average Score	0	Average Score	1	Average Score	3	Average Score	0
Recommendation	D - No Attention Required, inspect at intervals						
Comments	N/A

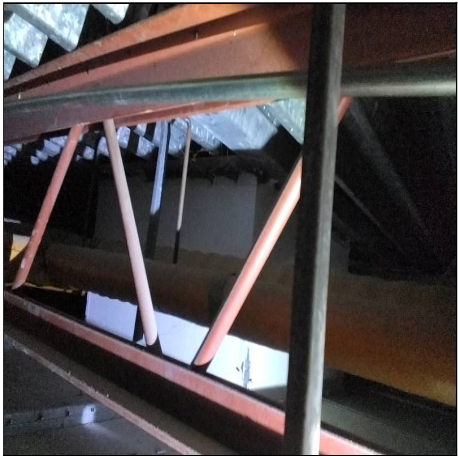
Re-inspection Date:	Lead Surveyor	Survey Type	Floor	Analysis
	9 Jan 2025 to 10 Jan 2025	Tracy Chulk	Reinspection Survey	Ground	Amosite (2)
	Building	Room	Item	Quantity	
	Block A	Classroom A045	Skylight cheeks	2m ²	
	Sample No (S,SP,P,As)	Product Type	Surface Treatment	Condition	Accessibility
	As 20761322 {AB000271}* (SP)	Asbestos Insulating Board (2)	Surface Sealed (1)	Good Condition (0)	Usually inaccessible or unlikely to be disturbed (0)

Normal Occupancy	Score	Likelihood of disturbance	Score	Exposure Potential	Score	Maintenance Activity	Score
Main type of activity	1	Location	2	Number of occupants	3	Type of Maintenance	0
		Accessibility	0	Frequency of use	3	Frequency of maintenance	0
		Amount	1	Average Time	3		
Average Score	1	Average Score	1	Average Score	3	Average Score	0
Recommendation	D - No Attention Required, inspect at intervals						
Comments	Enclosed with polycarbonate panels beneath

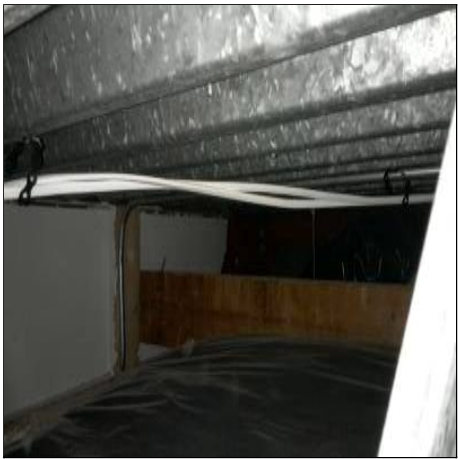
Re-inspection Date:	Lead Surveyor	Survey Type	Floor	Analysis
	9 Jan 2025 to 10 Jan 2025	Tracy Chulk	Reinspection Survey	Ground	Crocidolite (or unknown) (3)
	Building	Room	Item	Quantity	
	Block A	Girls WC A046	Firebreak in ceiling void above wall adj. A045	2m ²	
	Sample No (S,SP,P,As)	Product Type	Surface Treatment	Condition	Accessibility
	Visual (P)	Asbestos Insulating Board (2)	Surface Sealed (1)	Good Condition (0)	Usually inaccessible or unlikely to be disturbed (0)

Normal Occupancy	Score	Likelihood of disturbance	Score	Exposure Potential	Score	Maintenance Activity	Score
Main type of activity	0	Location	3	Number of occupants	2	Type of Maintenance	0
		Accessibility	0	Frequency of use	0	Frequency of maintenance	1
		Amount	1	Average Time	0		
Average Score	0	Average Score	2	Average Score	1	Average Score	1
Recommendation	D - No Attention Required, inspect at intervals						
Comments	Unable to access due to weight of insulation on upper surface of ceiling tiles
