ASBESTOS RE-INSPECTION SURVEY REPORT

Site Name and Address	Stoberry Park Primary School, North Road, Wells, BA5 2TJ	
Client Name and Address	Somerset Council, Strategic Asset Management, County Hall, Taunton, Somerset, TA1 4DY	
Client Contact & Phone No.	Oliver Woodhams 07977400667	
Job No.	J006176	
Date of Re-inspection	9th January 2025 to 10th January 2025	
Next Inspection due	09/01/2026	
Report Date	27 Feb 2025	
Report Revision No.	1	
Inspector/Surveyor	Name: Tracy Chulk	Signature:

Report Issue Date	27 Feb 2025

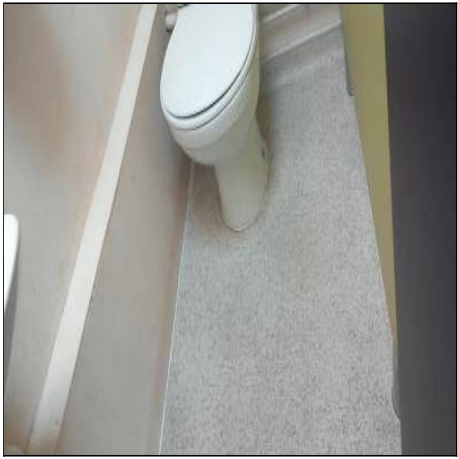
Re-inspection Date:	Lead Surveyor	Survey Type	Floor	Analysis
	9 Jan 2025 to 10 Jan 2025	Tracy Chulk	Reinspection Survey	Ground	N/A
	Building	Room	Item	Quantity	
	Block A	Girls WC A046	Void where pipe enters floor construction	N/A	
	Sample No (S,SP,P,As)	Product Type	Surface Treatment	Condition	Accessibility
	Visual (P)	N/A	N/A	N/A	N/A

Normal Occupancy	Score	Likelihood of disturbance	Score	Exposure Potential	Score	Maintenance Activity	Score
Main type of activity	N/A	Location	N/A	Number of occupants	N/A	Type of Maintenance	N/A
		Accessibility	N/A	Frequency of use	N/A	Frequency of maintenance	N/A
		Amount	N/A	Average Time	N/A		
Average Score	N/A	Average Score	N/A	Average Score	N/A	Average Score	N/A
Recommendation	Inspection Required						
Comments	Unable to access without causing excessive damage

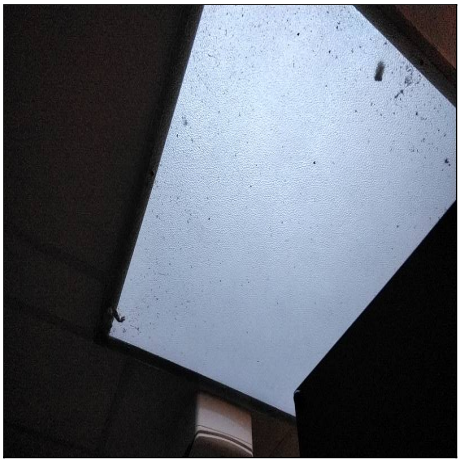
Re-inspection Date:	Lead Surveyor	Survey Type	Floor	Analysis
	9 Jan 2025 to 10 Jan 2025	Tracy Chulk	Reinspection Survey	Ground	Amosite (2)
	Building	Room	Item	Quantity	
	Block A	Girls WC A046	Skylight cheeks (sealed both sides)	2m ²	
	Sample No (S,SP,P,As)	Product Type	Surface Treatment	Condition	Accessibility
	As 20761322 {AB000271}* (SP)	Asbestos Insulating Board (2)	Surface Sealed (1)	Good Condition (0)	Usually inaccessible or unlikely to be disturbed (0)

Normal Occupancy	Score	Likelihood of disturbance	Score	Exposure Potential	Score	Maintenance Activity	Score
Main type of activity	0	Location	2	Number of occupants	2	Type of Maintenance	0
		Accessibility	0	Frequency of use	0	Frequency of maintenance	0
		Amount	1	Average Time	0		
Average Score	0	Average Score	1	Average Score	1	Average Score	0
Recommendation	D - No Attention Required, inspect at intervals						
Comments	Enclosed with polycarbonate panels beneath

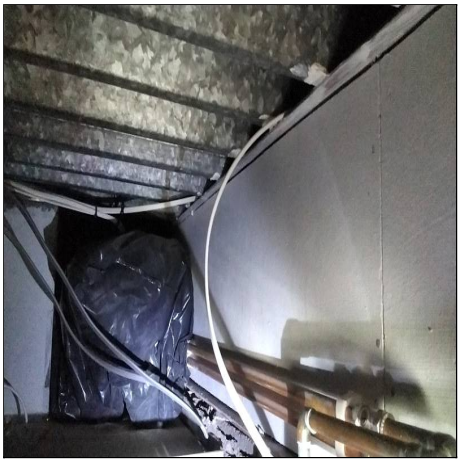
Re-inspection Date:	Lead Surveyor	Survey Type	Floor	Analysis
	9 Jan 2025 to 10 Jan 2025	Tracy Chulk	Reinspection Survey	Ground	Crocidolite (or unknown) (3)
	Building	Room	Item	Quantity	
	Block A	Boys WC A047	Firebreak in ceiling void above wall adj. A051	1m ²	
	Sample No (S,SP,P,As)	Product Type	Surface Treatment	Condition	Accessibility
	Visual (P)	Asbestos Insulating Board (2)	Surface Sealed (1)	Good Condition (0)	Usually inaccessible or unlikely to be disturbed (0)

Normal Occupancy	Score	Likelihood of disturbance	Score	Exposure Potential	Score	Maintenance Activity	Score
Main type of activity	0	Location	2	Number of occupants	2	Type of Maintenance	0
		Accessibility	0	Frequency of use	0	Frequency of maintenance	1
		Amount	1	Average Time	0		
Average Score	0	Average Score	1	Average Score	1	Average Score	1
Recommendation	D - No Attention Required, inspect at intervals						
Comments	Unable to access due to weight of insulation on upper surface of ceiling tiles

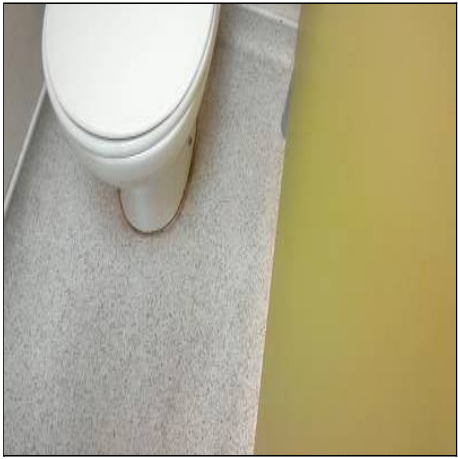
Re-inspection Date:	Lead Surveyor	Survey Type	Floor	Analysis
	9 Jan 2025 to 10 Jan 2025	Tracy Chulk	Reinspection Survey	Ground	N/A
	Building	Room	Item	Quantity	
	Block A	Boys WC A047	Void where pipe enters floor construction	N/A	
	Sample No (S,SP,P,As)	Product Type	Surface Treatment	Condition	Accessibility
	Visual (P)	N/A	N/A	N/A	N/A

Normal Occupancy	Score	Likelihood of disturbance	Score	Exposure Potential	Score	Maintenance Activity	Score
Main type of activity	N/A	Location	N/A	Number of occupants	N/A	Type of Maintenance	N/A
		Accessibility	N/A	Frequency of use	N/A	Frequency of maintenance	N/A
		Amount	N/A	Average Time	N/A		
Average Score	N/A	Average Score	N/A	Average Score	N/A	Average Score	N/A
Recommendation	Inspection Required						
Comments	Unable to access without causing excessive damage

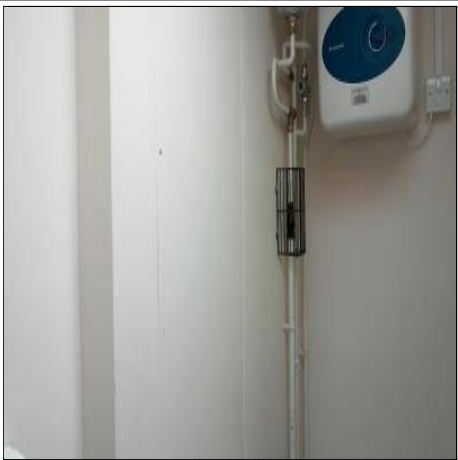
Re-inspection Date:	Lead Surveyor	Survey Type	Floor	Analysis
	9 Jan 2025 to 10 Jan 2025	Tracy Chulk	Reinspection Survey	Ground	N/A
	Building	Room	Item	Quantity	
	Block A	Boys WC A047	Wall void South wall adj A046	N/A	
	Sample No (S,SP,P,As)	Product Type	Surface Treatment	Condition	Accessibility
	Visual (P)	N/A	N/A	N/A	N/A

Normal Occupancy	Score	Likelihood of disturbance	Score	Exposure Potential	Score	Maintenance Activity	Score
Main type of activity	N/A	Location	N/A	Number of occupants	N/A	Type of Maintenance	N/A
		Accessibility	N/A	Frequency of use	N/A	Frequency of maintenance	N/A
		Amount	N/A	Average Time	N/A		
Average Score	N/A	Average Score	N/A	Average Score	N/A	Average Score	N/A
Recommendation	Inspection Required						
Comments	Unable to access without causing excessive damage

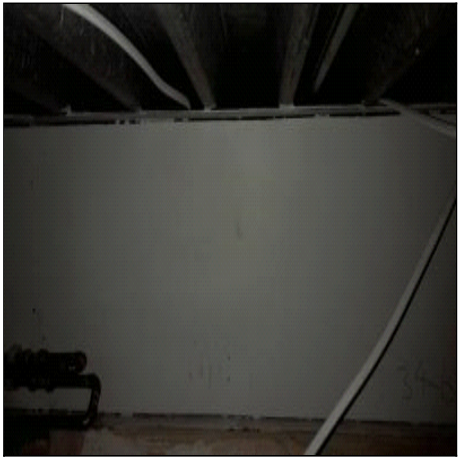
Re-inspection Date:	Lead Surveyor	Survey Type	Floor	Analysis
	9 Jan 2025 to 10 Jan 2025	Tracy Chulk	Reinspection Survey	Ground	Crocidolite (or unknown) (3)
	Building	Room	Item	Quantity	
	Block A	Circulation A048	Firebreak in ceiling void above door to A045 Classroom	1m ²	
	Sample No (S,SP,P,As)	Product Type	Surface Treatment	Condition	Accessibility
	Visual (P)	Asbestos Insulating Board (2)	Surface Sealed (1)	Good Condition (0)	Usually inaccessible or unlikely to be disturbed (0)

Normal Occupancy	Score	Likelihood of disturbance	Score	Exposure Potential	Score	Maintenance Activity	Score
Main type of activity	0	Location	2	Number of occupants	2	Type of Maintenance	0
		Accessibility	0	Frequency of use	3	Frequency of maintenance	1
		Amount	1	Average Time	0		
Average Score	0	Average Score	1	Average Score	2	Average Score	1
Recommendation	D - No Attention Required, inspect at intervals						
Comments	Not accessed due to weight of insulation above ceiling tiles

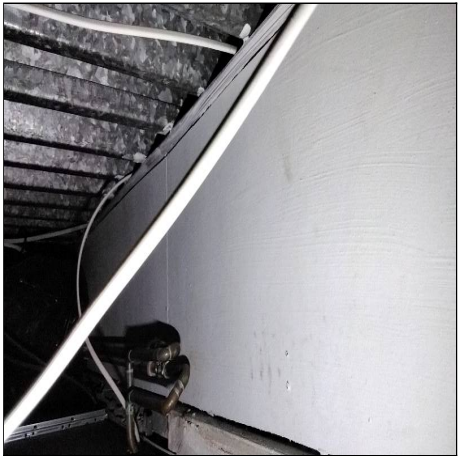
Re-inspection Date:	Lead Surveyor	Survey Type	Floor	Analysis
	9 Jan 2025 to 10 Jan 2025	Tracy Chulk	Reinspection Survey	Ground	Crocidolite (or unknown) (3)
	Building	Room	Item	Quantity	
	Block A	Circulation A048	Firebreak in ceiling void above wall adj. A051 Classroom	1m ²	
	Sample No (S,SP,P,As)	Product Type	Surface Treatment	Condition	Accessibility
	Visual (P)	Asbestos Insulating Board (2)	Surface Sealed (1)	Good Condition (0)	Usually inaccessible or unlikely to be disturbed (0)

Normal Occupancy	Score	Likelihood of disturbance	Score	Exposure Potential	Score	Maintenance Activity	Score
Main type of activity	0	Location	2	Number of occupants	2	Type of Maintenance	0
		Accessibility	0	Frequency of use	3	Frequency of maintenance	1
		Amount	1	Average Time	0		
Average Score	0	Average Score	1	Average Score	2	Average Score	1
Recommendation	D - No Attention Required, inspect at intervals						
Comments	N/A

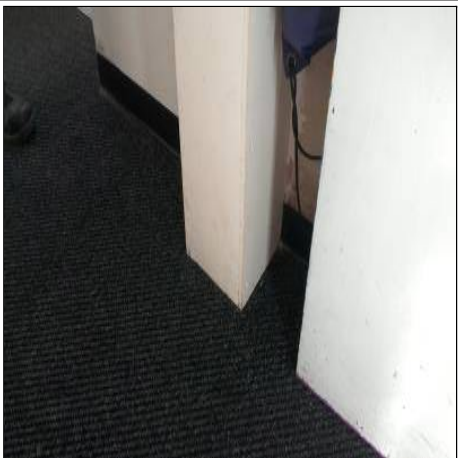
Re-inspection Date:	Lead Surveyor	Survey Type	Floor	Analysis
	9 Jan 2025 to 10 Jan 2025	Tracy Chulk	Reinspection Survey	Ground	N/A
	Building	Room	Item	Quantity	
	Block A	Circulation A048	Floor void	N/A	
	Sample No (S,SP,P,As)	Product Type	Surface Treatment	Condition	Accessibility
	Visual (P)	N/A	N/A	N/A	N/A

Normal Occupancy	Score	Likelihood of disturbance	Score	Exposure Potential	Score	Maintenance Activity	Score
Main type of activity	N/A	Location	N/A	Number of occupants	N/A	Type of Maintenance	N/A
		Accessibility	N/A	Frequency of use	N/A	Frequency of maintenance	N/A
		Amount	N/A	Average Time	N/A		
Average Score	N/A	Average Score	N/A	Average Score	N/A	Average Score	N/A
Recommendation	Inspection Required						
Comments	Unable to access without causing excessive damage

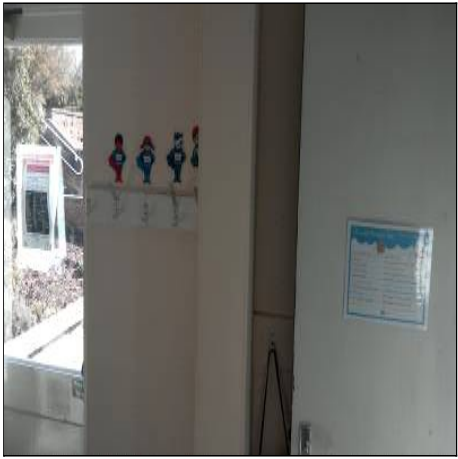
Re-inspection Date:	Lead Surveyor	Survey Type	Floor	Analysis
	9 Jan 2025 to 10 Jan 2025	Tracy Chulk	Reinspection Survey	Ground	N/A
	Building	Room	Item	Quantity	
	Block A	Circulation A048	Vertical wooden boxing East wall	N/A	
	Sample No (S,SP,P,As)	Product Type	Surface Treatment	Condition	Accessibility
	Visual (P)	N/A	N/A	N/A	N/A

Normal Occupancy	Score	Likelihood of disturbance	Score	Exposure Potential	Score	Maintenance Activity	Score
Main type of activity	N/A	Location	N/A	Number of occupants	N/A	Type of Maintenance	N/A
		Accessibility	N/A	Frequency of use	N/A	Frequency of maintenance	N/A
		Amount	N/A	Average Time	N/A		
Average Score	N/A	Average Score	N/A	Average Score	N/A	Average Score	N/A
Recommendation	Inspection Required						
Comments	Unable to access without causing excessive damage

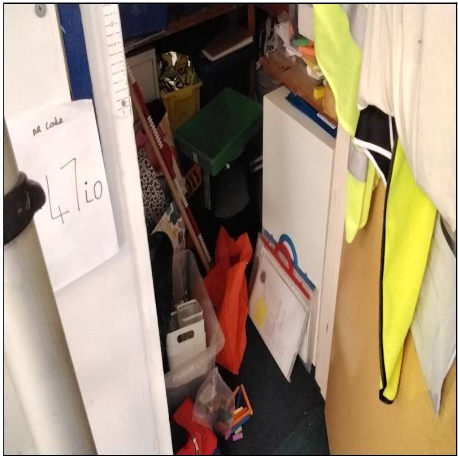
Re-inspection Date:	Lead Surveyor	Survey Type	Floor	Analysis
	9 Jan 2025 to 10 Jan 2025	Tracy Chulk	Reinspection Survey	Ground	Chrysotile + Amosite (2)
	Building	Room	Item	Quantity	
	Block A	Store A050	Firebreak in ceiling void above wall adj. A051 Classroom	1m ²	
	Sample No (S,SP,P,As)	Product Type	Surface Treatment	Condition	Accessibility
	As DD000842 (SP)	Asbestos Insulating Board (2)	Surface Sealed (1)	Good Condition (0)	Usually inaccessible or unlikely to be disturbed (0)

Normal Occupancy	Score	Likelihood of disturbance	Score	Exposure Potential	Score	Maintenance Activity	Score
Main type of activity	0	Location	2	Number of occupants	1	Type of Maintenance	0
		Accessibility	0	Frequency of use	0	Frequency of maintenance	0
		Amount	1	Average Time	0		
Average Score	0	Average Score	1	Average Score	1	Average Score	0
Recommendation	D - No Attention Required, inspect at intervals						
Comments	Unable to access due to stored items

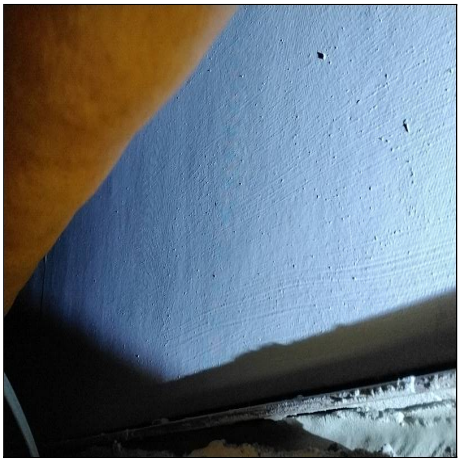
Re-inspection Date:	Lead Surveyor	Survey Type	Floor	Analysis
	9 Jan 2025 to 10 Jan 2025	Tracy Chulk	Reinspection Survey	Ground	Chrysotile + Amosite (2)
	Building	Room	Item	Quantity	
	Block A	Classroom A051	Firebreak in ceiling void above wall adj. A047, A048 and A050	3m	
	Sample No (S,SP,P,As)	Product Type	Surface Treatment	Condition	Accessibility
	DD000842 (S)	Asbestos Insulating Board (2)	Surface Sealed (1)	Good Condition (0)	Usually inaccessible or unlikely to be disturbed (0)

Normal Occupancy	Score	Likelihood of disturbance	Score	Exposure Potential	Score	Maintenance Activity	Score
Main type of activity	1	Location	2	Number of occupants	3	Type of Maintenance	0
		Accessibility	0	Frequency of use	3	Frequency of maintenance	0
		Amount	1	Average Time	3		
Average Score	1	Average Score	1	Average Score	3	Average Score	0
Recommendation	D - No Attention Required, inspect at intervals						
Comments	N/A

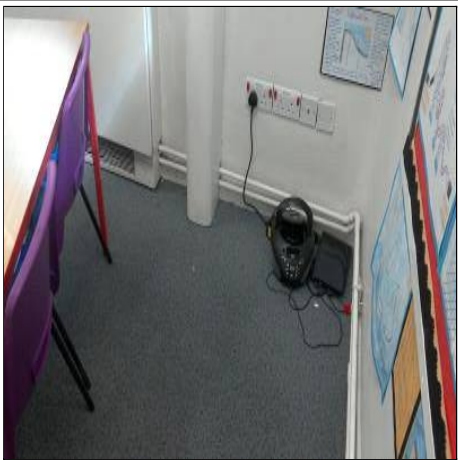
Re-inspection Date:	Lead Surveyor	Survey Type	Floor	Analysis
	9 Jan 2025 to 10 Jan 2025	Tracy Chulk	Reinspection Survey	Ground	N/A
	Building	Room	Item	Quantity	
	Block A	Classroom A054	Floor void	N/A	
	Sample No (S,SP,P,As)	Product Type	Surface Treatment	Condition	Accessibility
	Visual (P)	N/A	N/A	N/A	N/A

Normal Occupancy	Score	Likelihood of disturbance	Score	Exposure Potential	Score	Maintenance Activity	Score
Main type of activity	N/A	Location	N/A	Number of occupants	N/A	Type of Maintenance	N/A
		Accessibility	N/A	Frequency of use	N/A	Frequency of maintenance	N/A
		Amount	N/A	Average Time	N/A		
Average Score	N/A	Average Score	N/A	Average Score	N/A	Average Score	N/A
Recommendation	Inspection Required						
Comments	Unable to access without causing excessive damage

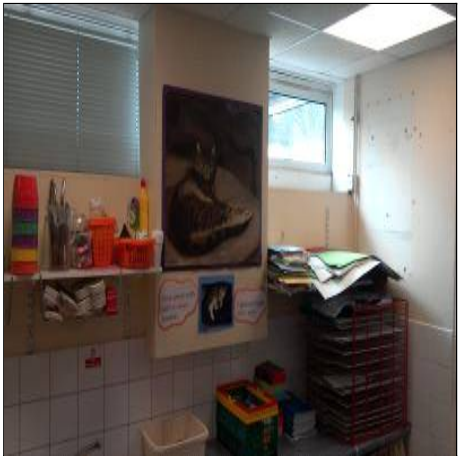
Re-inspection Date:	Lead Surveyor	Survey Type	Floor	Analysis
	9 Jan 2025 to 10 Jan 2025	Tracy Chulk	Reinspection Survey	Ground	N/A
	Building	Room	Item	Quantity	
	Block A	Classroom A054	Vertical wooden boxing South and East walls	N/A	
	Sample No (S,SP,P,As)	Product Type	Surface Treatment	Condition	Accessibility
	Visual (P)	N/A	N/A	N/A	N/A

Normal Occupancy	Score	Likelihood of disturbance	Score	Exposure Potential	Score	Maintenance Activity	Score
Main type of activity	N/A	Location	N/A	Number of occupants	N/A	Type of Maintenance	N/A
		Accessibility	N/A	Frequency of use	N/A	Frequency of maintenance	N/A
		Amount	N/A	Average Time	N/A		
Average Score	N/A	Average Score	N/A	Average Score	N/A	Average Score	N/A
Recommendation	Inspection Required						
Comments	Unable to access without causing excessive damage

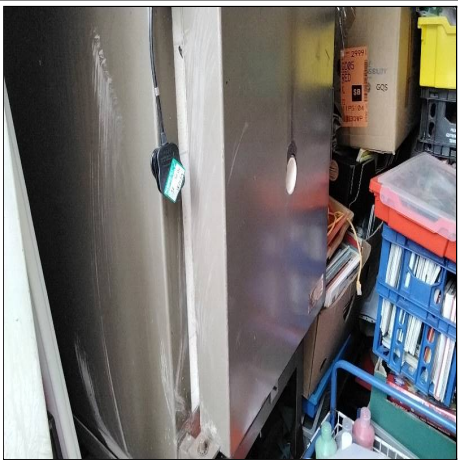
Re-inspection Date:	Lead Surveyor	Survey Type	Floor	Analysis
	9 Jan 2025 to 10 Jan 2025	Tracy Chulk	Reinspection Survey	Ground	N/A
	Building	Room	Item	Quantity	
	Block A	Kiln A056	Wenger kiln	N/A	
	Sample No (S,SP,P,As)	Product Type	Surface Treatment	Condition	Accessibility
	Visual (P)	N/A	N/A	N/A	N/A

Normal Occupancy	Score	Likelihood of disturbance	Score	Exposure Potential	Score	Maintenance Activity	Score
Main type of activity	N/A	Location	N/A	Number of occupants	N/A	Type of Maintenance	N/A
		Accessibility	N/A	Frequency of use	N/A	Frequency of maintenance	N/A
		Amount	N/A	Average Time	N/A		
Average Score	N/A	Average Score	N/A	Average Score	N/A	Average Score	N/A
Recommendation	Inspection Required						
Comments	Unable to access, live at time of survey

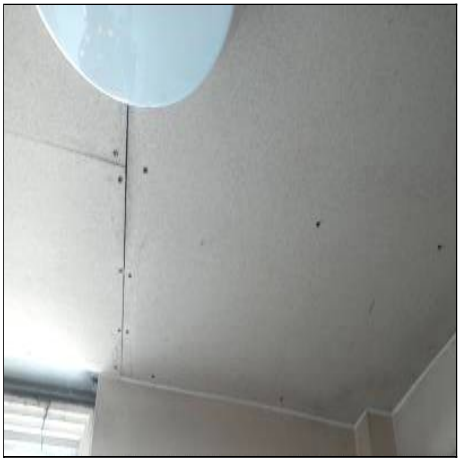
Re-inspection Date:	Lead Surveyor	Survey Type	Floor	Analysis
	9 Jan 2025 to 10 Jan 2025	Tracy Chulk	Reinspection Survey	Ground	No Asbestos Detected (0)
	Building	Room	Item	Quantity	
	Block A	Kiln A056	Fixed ceiling panels	3m ²	
	Sample No (S,SP,P,As)	Product Type	Surface Treatment	Condition	Accessibility
	20761328 {AB000291}* (S)	Not applicable (No asbestos detected) (0)	Completely Sealed (0)	Good Condition (0)	Usually inaccessible or unlikely to be disturbed (0)

Normal Occupancy	Score	Likelihood of disturbance	Score	Exposure Potential	Score	Maintenance Activity	Score
Main type of activity	N/A	Location	N/A	Number of occupants	N/A	Type of Maintenance	N/A
		Accessibility	N/A	Frequency of use	N/A	Frequency of maintenance	N/A
		Amount	N/A	Average Time	N/A		
Average Score	N/A	Average Score	N/A	Average Score	N/A	Average Score	N/A
Recommendation	No further action required						
Comments	N/A

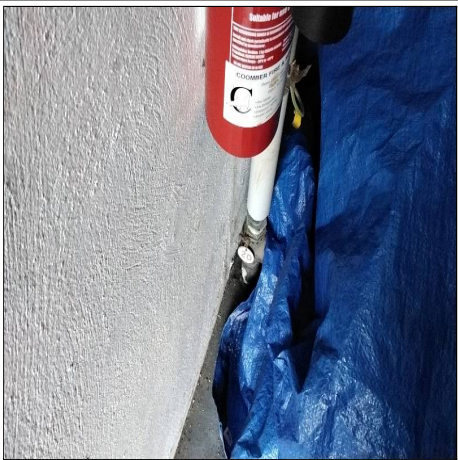
Re-inspection Date:	Lead Surveyor	Survey Type	Floor	Analysis
	9 Jan 2025 to 10 Jan 2025	Tracy Chulk	Reinspection Survey	Ground	N/A
	Building	Room	Item	Quantity	
	Block A	Boiler A057	Floor void; water main inlet	N/A	
	Sample No (S,SP,P,As)	Product Type	Surface Treatment	Condition	Accessibility
	Visual (P)	N/A	N/A	N/A	N/A

Normal Occupancy	Score	Likelihood of disturbance	Score	Exposure Potential	Score	Maintenance Activity	Score
Main type of activity	N/A	Location	N/A	Number of occupants	N/A	Type of Maintenance	N/A
		Accessibility	N/A	Frequency of use	N/A	Frequency of maintenance	N/A
		Amount	N/A	Average Time	N/A		
Average Score	N/A	Average Score	N/A	Average Score	N/A	Average Score	N/A
Recommendation	Inspection Required						
Comments	Unable to access without causing excessive damage

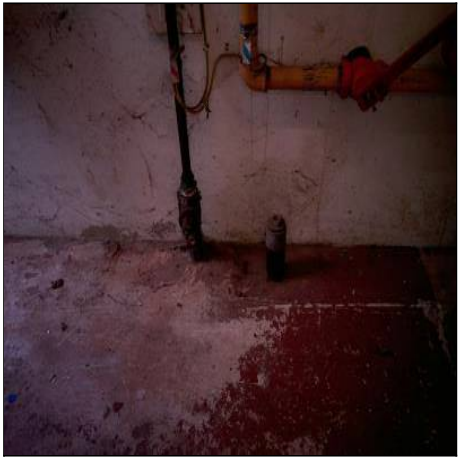
Re-inspection Date:	Lead Surveyor	Survey Type	Floor	Analysis
	9 Jan 2025 to 10 Jan 2025	Tracy Chulk	Reinspection Survey	Ground	N/A
	Building	Room	Item	Quantity	
	Block A	Boiler A057	Where supply pipes enter floor construction	N/A	
	Sample No (S,SP,P,As)	Product Type	Surface Treatment	Condition	Accessibility
	Visual (P)	N/A	N/A	N/A	N/A

Normal Occupancy	Score	Likelihood of disturbance	Score	Exposure Potential	Score	Maintenance Activity	Score
Main type of activity	N/A	Location	N/A	Number of occupants	N/A	Type of Maintenance	N/A
		Accessibility	N/A	Frequency of use	N/A	Frequency of maintenance	N/A
		Amount	N/A	Average Time	N/A		
Average Score	N/A	Average Score	N/A	Average Score	N/A	Average Score	N/A
Recommendation	Inspection Required						
Comments	Unable to access without causing excessive damage

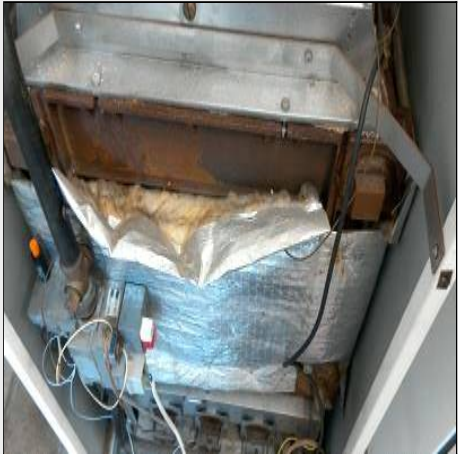
Re-inspection Date:	Lead Surveyor	Survey Type	Floor	Analysis
	9 Jan 2025 to 10 Jan 2025	Tracy Chulk	Reinspection Survey	Ground	No Asbestos Detected (0)
	Building	Room	Item	Quantity	
	Block A	Boiler A057	Insulation (foil covered) around boilers within casing of Concord CX boilers (3 no.)	0 - 1m ²	
	Sample No (S,SP,P,As)	Product Type	Surface Treatment	Condition	Accessibility
	AK000474* (S)	Non Asbestos Insulation (0)	Unsealed lagging and sprays (3)	Low Damage (1)	Occasionally likely to be disturbed (1)

Normal Occupancy	Score	Likelihood of disturbance	Score	Exposure Potential	Score	Maintenance Activity	Score
Main type of activity	N/A	Location	N/A	Number of occupants	N/A	Type of Maintenance	N/A
		Accessibility	N/A	Frequency of use	N/A	Frequency of maintenance	N/A
		Amount	N/A	Average Time	N/A		
Average Score	N/A	Average Score	N/A	Average Score	N/A	Average Score	N/A
Recommendation	No further action required						
Comments	N/A

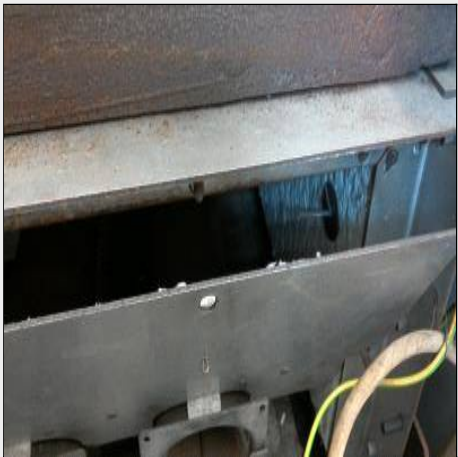
Re-inspection Date:	Lead Surveyor	Survey Type	Floor	Analysis
	9 Jan 2025 to 10 Jan 2025	Tracy Chulk	Reinspection Survey	Ground	No Asbestos Detected (0)
	Building	Room	Item	Quantity	
	Block A	Boiler A057	Insulation at sides/base of burner chamber within boilers Concord CX boilers (3 no.)	<0 - 1m ²	
	Sample No (S,SP,P,As)	Product Type	Surface Treatment	Condition	Accessibility
	AK000476* (S)	Non Asbestos Insulation (0)	Unsealed lagging and sprays (3)	Good Condition (0)	Occasionally likely to be disturbed (1)

Normal Occupancy	Score	Likelihood of disturbance	Score	Exposure Potential	Score	Maintenance Activity	Score
Main type of activity	N/A	Location	N/A	Number of occupants	N/A	Type of Maintenance	N/A
		Accessibility	N/A	Frequency of use	N/A	Frequency of maintenance	N/A
		Amount	N/A	Average Time	N/A		
Average Score	N/A	Average Score	N/A	Average Score	N/A	Average Score	N/A
Recommendation	No further action required						
Comments	N/A

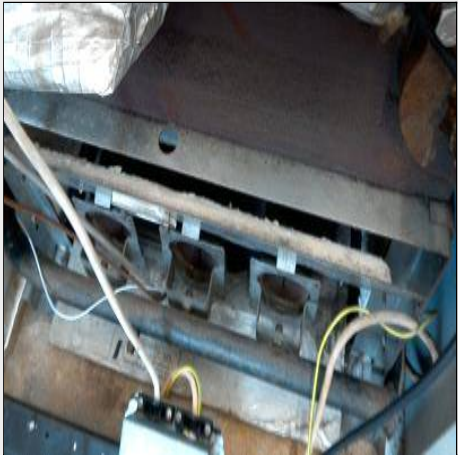
Re-inspection Date:	Lead Surveyor	Survey Type	Floor	Analysis
	9 Jan 2025 to 10 Jan 2025	Tracy Chulk	Reinspection Survey	Ground	No Asbestos Detected (0)
	Building	Room	Item	Quantity	
	Block A	Boiler A057	Insulation to sight glass and behind plate above gas burner tubes Concord CX boilers (3 no.)	<1m	Occasionally likely to be disturbed (1)
	Sample No (S,SP,P,As)	Product Type	Surface Treatment	Condition	
	AK000477* (S)	Non Asbestos Insulation (0)	Unsealed lagging and sprays (3)	Good Condition (0)

Normal Occupancy	Score	Likelihood of disturbance	Score	Exposure Potential	Score	Maintenance Activity	Score
Main type of activity	N/A	Location	N/A	Number of occupants	N/A	Type of Maintenance	N/A
		Accessibility	N/A	Frequency of use	N/A	Frequency of maintenance	N/A
		Amount	N/A	Average Time	N/A		
Average Score	N/A	Average Score	N/A	Average Score	N/A	Average Score	N/A
Recommendation	No further action required						
Comments	N/A

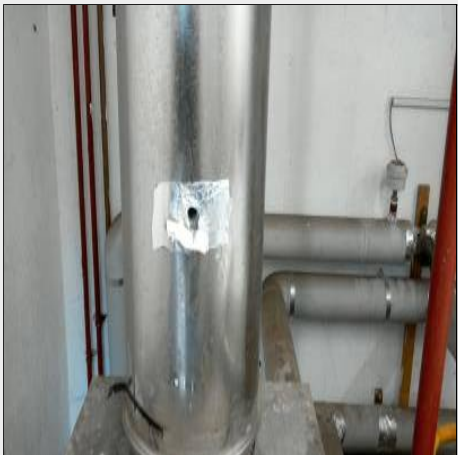
Re-inspection Date:	Lead Surveyor	Survey Type	Floor	Analysis
	9 Jan 2025 to 10 Jan 2025	Tracy Chulk	Reinspection Survey	Ground	No Asbestos Detected (0)
	Building	Room	Item	Quantity	
	Block A	Boiler A057	Insulation within flues to boilers 5 and 6	1 - 2m	
	Sample No (S,SP,P,As)	Product Type	Surface Treatment	Condition	Accessibility
	AK000478* (S)	Non Asbestos Insulation (0)	Surface Sealed (1)	Good Condition (0)	Usually inaccessible or unlikely to be disturbed (0)

Normal Occupancy	Score	Likelihood of disturbance	Score	Exposure Potential	Score	Maintenance Activity	Score
Main type of activity	N/A	Location	N/A	Number of occupants	N/A	Type of Maintenance	N/A
		Accessibility	N/A	Frequency of use	N/A	Frequency of maintenance	N/A
		Amount	N/A	Average Time	N/A		
Average Score	N/A	Average Score	N/A	Average Score	N/A	Average Score	N/A
Recommendation	No further action required						
Comments	N/A

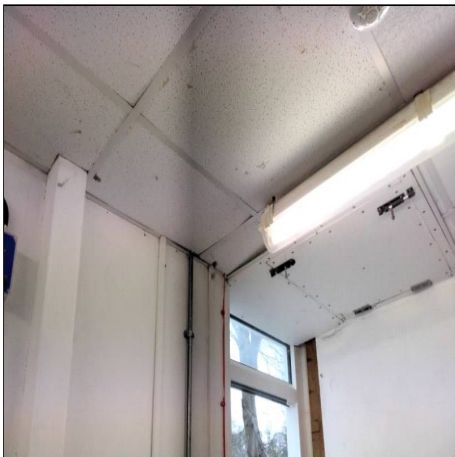
9 Jan 2025 to 10 Jan 2025	Tracy Chulk	Reinspection Survey	Ground	No Asbestos Detected (0)
	Building	Room	Item	Quantity	
	Block A	Boiler A057	Bitumen builders paper to metal wall in ceiling/roof void	12m ²	
	Sample No (S,SP,P,As)	Product Type	Surface Treatment	Condition	Accessibility
	BF000354* (S)	Reinforced Composite (1)	Completely Sealed (0)	Good Condition (0)	Usually inaccessible or unlikely to be disturbed (0)

Normal Occupancy	Score	Likelihood of disturbance	Score	Exposure Potential	Score	Maintenance Activity	Score
Main type of activity	N/A	Location	N/A	Number of occupants	N/A	Type of Maintenance	N/A
		Accessibility	N/A	Frequency of use	N/A	Frequency of maintenance	N/A
		Amount	N/A	Average Time	N/A		
Average Score	N/A	Average Score	N/A	Average Score	N/A	Average Score	N/A
Recommendation	No further action required						
Comments	N/A

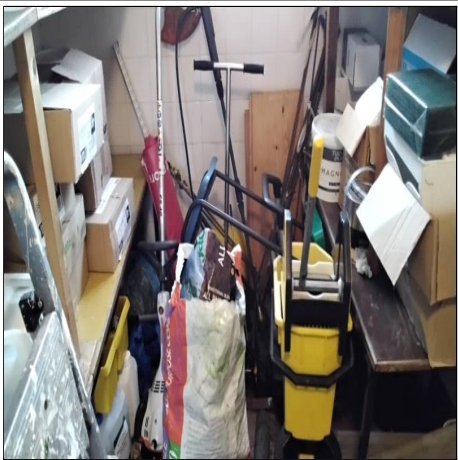
Re-inspection Date:	Lead Surveyor	Survey Type	Floor	Analysis
	9 Jan 2025 to 10 Jan 2025	Tracy Chulk	Reinspection Survey	Ground	N/A
	Building	Room	Item	Quantity	
	Block A	Store A059	Limited access	N/A	
	Sample No (S,SP,P,As)	Product Type	Surface Treatment	Condition	Accessibility
	Visual (P)	N/A	N/A	N/A	N/A

Normal Occupancy	Score	Likelihood of disturbance	Score	Exposure Potential	Score	Maintenance Activity	Score
Main type of activity	N/A	Location	N/A	Number of occupants	N/A	Type of Maintenance	N/A
		Accessibility	N/A	Frequency of use	N/A	Frequency of maintenance	N/A
		Amount	N/A	Average Time	N/A		
Average Score	N/A	Average Score	N/A	Average Score	N/A	Average Score	N/A
Recommendation	Inspection Required						
Comments	Access limited due to stored items

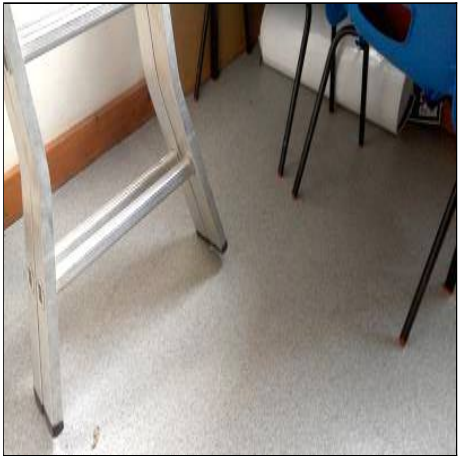
Re-inspection Date:	Lead Surveyor	Survey Type	Floor	Analysis
	9 Jan 2025 to 10 Jan 2025	Tracy Chulk	Reinspection Survey	Ground	No Asbestos Detected (0)
	Building	Room	Item	Quantity	
	Block A	Office A060	Vinyl floor tiles	6m ²	
	Sample No (S,SP,P,As)	Product Type	Surface Treatment	Condition	Accessibility
	20761326 {AB000274}* (S)	Not applicable (No asbestos detected) (0)	Completely Sealed (0)	Good Condition (0)	Usually inaccessible or unlikely to be disturbed (0)

Normal Occupancy	Score	Likelihood of disturbance	Score	Exposure Potential	Score	Maintenance Activity	Score
Main type of activity	N/A	Location	N/A	Number of occupants	N/A	Type of Maintenance	N/A
		Accessibility	N/A	Frequency of use	N/A	Frequency of maintenance	N/A
		Amount	N/A	Average Time	N/A		
Average Score	N/A	Average Score	N/A	Average Score	N/A	Average Score	N/A
Recommendation	No further action required						
Comments	N/A

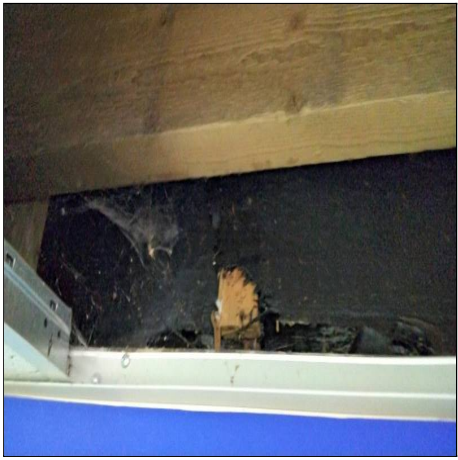
Re-inspection Date:	Lead Surveyor	Survey Type	Floor	Analysis
	9 Jan 2025 to 10 Jan 2025	Tracy Chulk	Reinspection Survey	Ground	No Asbestos Detected (0)
	Building	Room	Item	Quantity	
	Block A	Office A060	Bitumen felt firebreak to A032	3lm	
	Sample No (S,SP,P,As)	Product Type	Surface Treatment	Condition	Accessibility
	BF000355* (S)	Reinforced Composite (1)	Completely Sealed (0)	Low Damage (1)	Occasionally likely to be disturbed (1)

Normal Occupancy	Score	Likelihood of disturbance	Score	Exposure Potential	Score	Maintenance Activity	Score
Main type of activity	N/A	Location	N/A	Number of occupants	N/A	Type of Maintenance	N/A
		Accessibility	N/A	Frequency of use	N/A	Frequency of maintenance	N/A
		Amount	N/A	Average Time	N/A		
Average Score	N/A	Average Score	N/A	Average Score	N/A	Average Score	N/A
Recommendation	No further action required						
Comments	N/A

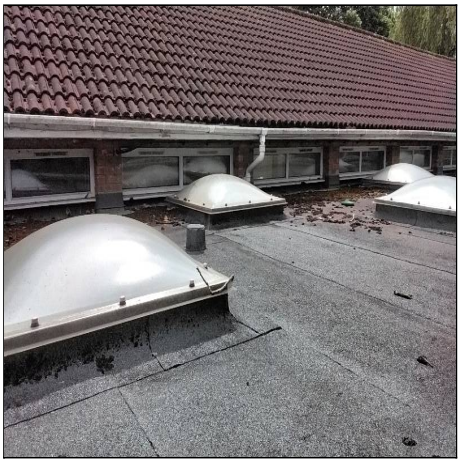
9 Jan 2025 to 10 Jan 2025	Tracy Chulk	Reinspection Survey	External	Crocidolite (or unknown) (3)
	Building	Room	Item	Quantity	
	Block B	External Block B	Capped off flue pipe on roof East end of building above B009 Boys WC	1no.	
	Sample No (S,SP,P,As)	Product Type	Surface Treatment	Condition	Accessibility
	Visual (P)	Asbestos Cement (1)	Surface Sealed (1)	Good Condition (0)	Usually inaccessible or unlikely to be disturbed (0)

Normal Occupancy	Score	Likelihood of disturbance	Score	Exposure Potential	Score	Maintenance Activity	Score
Main type of activity	0	Location	0	Number of occupants	0	Type of Maintenance	0
		Accessibility	0	Frequency of use	0	Frequency of maintenance	0
		Amount	1	Average Time	0		
Average Score	0	Average Score	1	Average Score	0	Average Score	0
Recommendation	D - No Attention Required, inspect at intervals						
Comments	Unable to access due to height

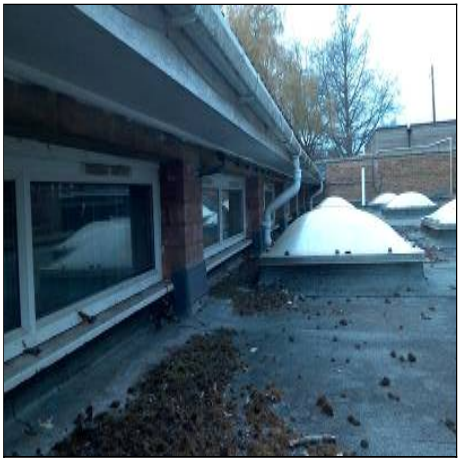
Re-inspection Date:	Lead Surveyor	Survey Type	Floor	Analysis
	9 Jan 2025 to 10 Jan 2025	Tracy Chulk	Reinspection Survey	External	Crocidolite (or unknown) (3)
	Building	Room	Item	Quantity	
	Block B	External Block B	Soffit North elevation B012, B013	50m	
	Sample No (S,SP,P,As)	Product Type	Surface Treatment	Condition	Accessibility
	Visual (P)	Asbestos Insulating Board (2)	Surface Sealed (1)	Low Damage (1)	Usually inaccessible or unlikely to be disturbed (0)

Normal Occupancy	Score	Likelihood of disturbance	Score	Exposure Potential	Score	Maintenance Activity	Score
Main type of activity	0	Location	0	Number of occupants	0	Type of Maintenance	0
		Accessibility	0	Frequency of use	0	Frequency of maintenance	0
		Amount	2	Average Time	0		
Average Score	0	Average Score	1	Average Score	0	Average Score	0
Recommendation	D - No Attention Required, inspect at intervals						
Comments	Unable to access due to height

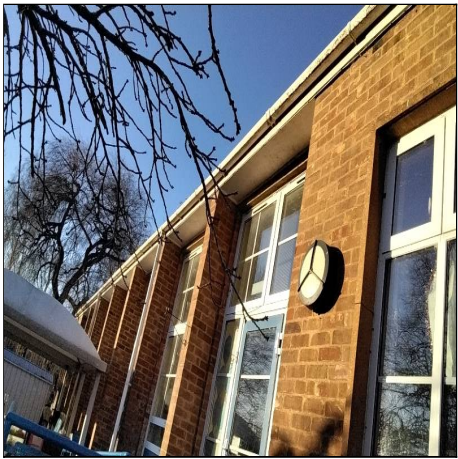
Re-inspection Date:	Lead Surveyor	Survey Type	Floor	Analysis
	9 Jan 2025 to 10 Jan 2025	Tracy Chulk	Reinspection Survey	External	Crocidolite (or unknown) (3)
	Building	Room	Item	Quantity	
	Block B	External Block B	Soffit South elevation B012, B013	50m	
	Sample No (S,SP,P,As)	Product Type	Surface Treatment	Condition	Accessibility
	Visual (P)	Asbestos Insulating Board (2)	Surface Sealed (1)	Good Condition (0)	Usually inaccessible or unlikely to be disturbed (0)

Normal Occupancy	Score	Likelihood of disturbance	Score	Exposure Potential	Score	Maintenance Activity	Score
Main type of activity	0	Location	0	Number of occupants	2	Type of Maintenance	0
		Accessibility	0	Frequency of use	3	Frequency of maintenance	0
		Amount	2	Average Time	2		
Average Score	0	Average Score	1	Average Score	3	Average Score	0
Recommendation	D - No Attention Required, inspect at intervals						
Comments	N/A

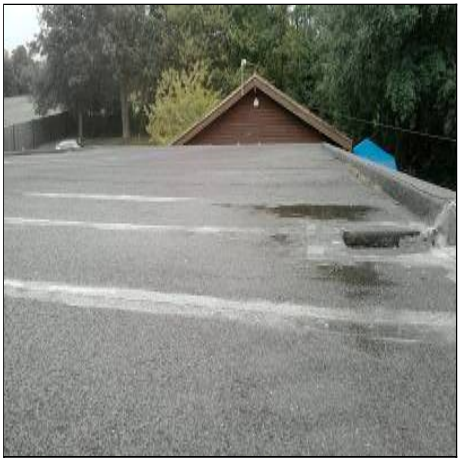
Re-inspection Date:	Lead Surveyor	Survey Type	Floor	Analysis
	9 Jan 2025 to 10 Jan 2025	Tracy Chulk	Reinspection Survey	External	No Asbestos Detected (0)
	Building	Room	Item	Quantity	
	Block B	External Block B	Surface layer of roof felt	80 - 100m ²	
	Sample No (S,SP,P,As)	Product Type	Surface Treatment	Condition	Accessibility
	AA001780* (S)	Well Bound Material (1)	Completely Sealed (0)	Good Condition (0)	Usually inaccessible or unlikely to be disturbed (0)

Normal Occupancy	Score	Likelihood of disturbance	Score	Exposure Potential	Score	Maintenance Activity	Score
Main type of activity	N/A	Location	N/A	Number of occupants	N/A	Type of Maintenance	N/A
		Accessibility	N/A	Frequency of use	N/A	Frequency of maintenance	N/A
		Amount	N/A	Average Time	N/A		
Average Score	N/A	Average Score	N/A	Average Score	N/A	Average Score	N/A
Recommendation	No further action required						
Comments	.

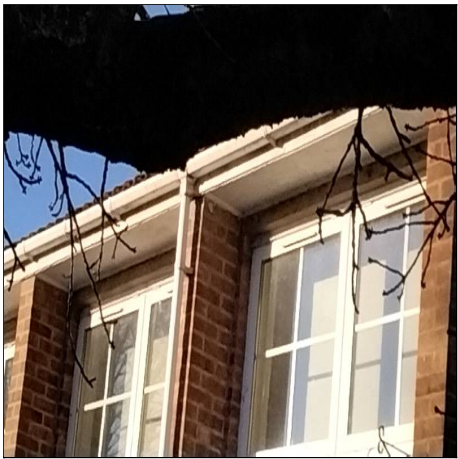
Re-inspection Date:	Lead Surveyor	Survey Type	Floor	Analysis
	9 Jan 2025 to 10 Jan 2025	Tracy Chulk	Reinspection Survey	External	Chrysotile (1)
	Building	Room	Item	Quantity	
	Block B	External Block B	Undertile edging East elevation B014, B015	20m	
	Sample No (S,SP,P,As)	Product Type	Surface Treatment	Condition	Accessibility
	AB000313* (S)	Asbestos Cement (1)	Surface Sealed (1)	Good Condition (0)	Usually inaccessible or unlikely to be disturbed (0)

Normal Occupancy	Score	Likelihood of disturbance	Score	Exposure Potential	Score	Maintenance Activity	Score
Main type of activity	0	Location	0	Number of occupants	2	Type of Maintenance	0
		Accessibility	0	Frequency of use	3	Frequency of maintenance	0
		Amount	2	Average Time	1		
Average Score	0	Average Score	1	Average Score	2	Average Score	0
Recommendation	D - No Attention Required, inspect at intervals						
Comments	N/A

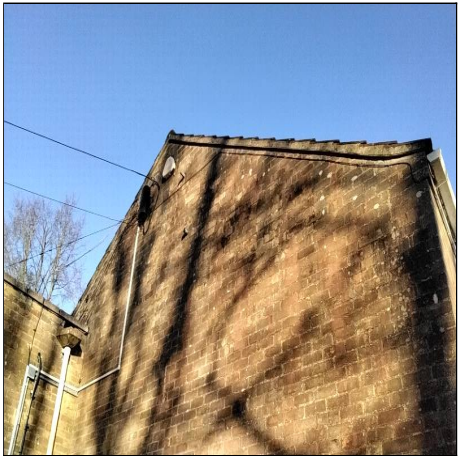
Re-inspection Date:	Lead Surveyor	Survey Type	Floor	Analysis
	9 Jan 2025 to 10 Jan 2025	Tracy Chulk	Reinspection Survey	External	Chrysotile (1)
	Building	Room	Item	Quantity	
	Block B	External Block B	Undertile edging West elevation B010, B010A and B011	20m	
	Sample No (S,SP,P,As)	Product Type	Surface Treatment	Condition	Accessibility
	As AB000313* (SP)	Asbestos Cement (1)	Surface Sealed (1)	Good Condition (0)	Usually inaccessible or unlikely to be disturbed (0)

Normal Occupancy	Score	Likelihood of disturbance	Score	Exposure Potential	Score	Maintenance Activity	Score
Main type of activity	0	Location	0	Number of occupants	0	Type of Maintenance	0
		Accessibility	0	Frequency of use	0	Frequency of maintenance	0
		Amount	2	Average Time	0		
Average Score	0	Average Score	1	Average Score	0	Average Score	0
Recommendation	D - No Attention Required, inspect at intervals						
Comments	N/A

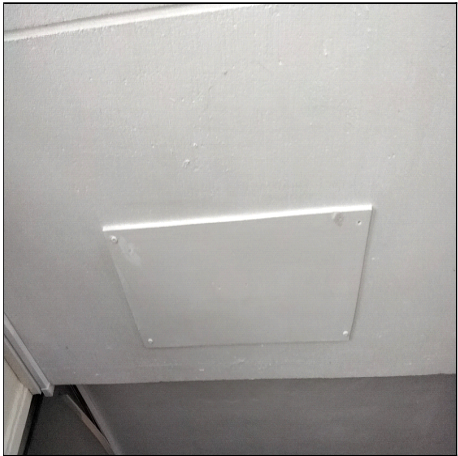
Re-inspection Date:	Lead Surveyor	Survey Type	Floor	Analysis
	9 Jan 2025 to 10 Jan 2025	Tracy Chulk	Reinspection Survey	Ground	Chrysotile + Amosite (2)
	Building	Room	Item	Quantity	
	Block B	Lobby B001	Panel at top of ramp leading to B004	<1m ²	
	Sample No (S,SP,P,As)	Product Type	Surface Treatment	Condition	Accessibility
	20660451 {AB000294}* (S)	Asbestos Insulating Board (2)	Surface Sealed (1)	Good Condition (0)	Occasionally likely to be disturbed (1)

Normal Occupancy	Score	Likelihood of disturbance	Score	Exposure Potential	Score	Maintenance Activity	Score
Main type of activity	1	Location	2	Number of occupants	3	Type of Maintenance	0
		Accessibility	1	Frequency of use	3	Frequency of maintenance	1
		Amount	1	Average Time	0		
Average Score	1	Average Score	2	Average Score	2	Average Score	1
Recommendation	D - No Attention Required, inspect at intervals						
Comments	N/A

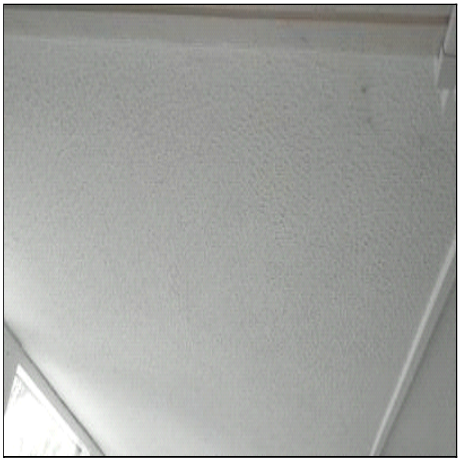
Re-inspection Date:	Lead Surveyor	Survey Type	Floor	Analysis
	9 Jan 2025 to 10 Jan 2025	Tracy Chulk	Reinspection Survey	Ground	No Asbestos Detected (0)
	Building	Room	Item	Quantity	
	Block B	Lobby B001	Textured decorative coating	12m ²	
	Sample No (S,SP,P,As)	Product Type	Surface Treatment	Condition	Accessibility
	20660452 {AB000293}* (S)	Not applicable (No asbestos detected) (0)	Surface Sealed (1)	Good Condition (0)	Usually inaccessible or unlikely to be disturbed (0)

Normal Occupancy	Score	Likelihood of disturbance	Score	Exposure Potential	Score	Maintenance Activity	Score
Main type of activity	N/A	Location	N/A	Number of occupants	N/A	Type of Maintenance	N/A
		Accessibility	N/A	Frequency of use	N/A	Frequency of maintenance	N/A
		Amount	N/A	Average Time	N/A		
Average Score	N/A	Average Score	N/A	Average Score	N/A	Average Score	N/A
Recommendation	No further action required						
Comments	N/A

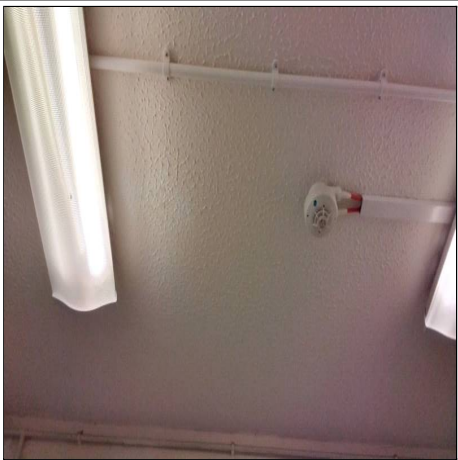
Re-inspection Date:	Lead Surveyor	Survey Type	Floor	Analysis
	9 Jan 2025 to 10 Jan 2025	Tracy Chulk	Reinspection Survey	Ground	N/A
	Building	Room	Item	Quantity	
	Block B	Staff kitchen B002A	Ceiling void	N/A	
	Sample No (S,SP,P,As)	Product Type	Surface Treatment	Condition	Accessibility
	Visual (P)	N/A	N/A	N/A	N/A

Normal Occupancy	Score	Likelihood of disturbance	Score	Exposure Potential	Score	Maintenance Activity	Score
Main type of activity	N/A	Location	N/A	Number of occupants	N/A	Type of Maintenance	N/A
		Accessibility	N/A	Frequency of use	N/A	Frequency of maintenance	N/A
		Amount	N/A	Average Time	N/A		
Average Score	N/A	Average Score	N/A	Average Score	N/A	Average Score	N/A
Recommendation	Inspection Required						
Comments	Unable to access without causing excessive damage

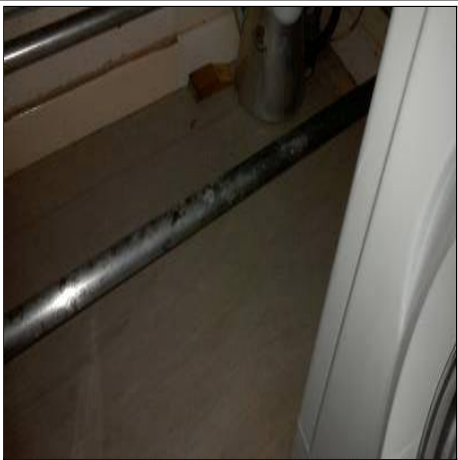
Re-inspection Date:	Lead Surveyor	Survey Type	Floor	Analysis
	9 Jan 2025 to 10 Jan 2025	Tracy Chulk	Reinspection Survey	Ground	N/A
	Building	Room	Item	Quantity	
	Block B	Staff kitchen B002A	Floor void	N/A	
	Sample No (S,SP,P,As)	Product Type	Surface Treatment	Condition	Accessibility
	Visual (P)	N/A	N/A	N/A	N/A

Normal Occupancy	Score	Likelihood of disturbance	Score	Exposure Potential	Score	Maintenance Activity	Score
Main type of activity	N/A	Location	N/A	Number of occupants	N/A	Type of Maintenance	N/A
		Accessibility	N/A	Frequency of use	N/A	Frequency of maintenance	N/A
		Amount	N/A	Average Time	N/A		
Average Score	N/A	Average Score	N/A	Average Score	N/A	Average Score	N/A
Recommendation	Inspection Required						
Comments	Unable to access without causing excessive damage

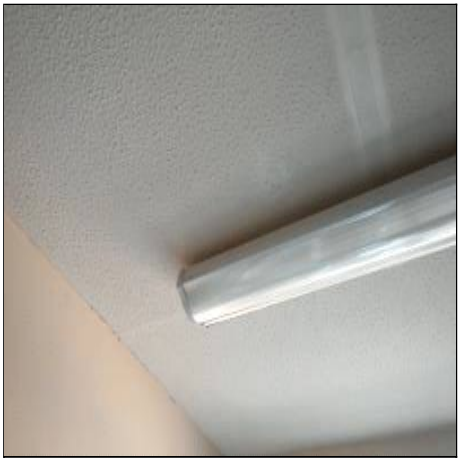
Re-inspection Date:	Lead Surveyor	Survey Type	Floor	Analysis
	9 Jan 2025 to 10 Jan 2025	Tracy Chulk	Reinspection Survey	Ground	No Asbestos Detected (0)
	Building	Room	Item	Quantity	
	Block B	Staff kitchen B002A	Textured decorative coating	8m ²	
	Sample No (S,SP,P,As)	Product Type	Surface Treatment	Condition	Accessibility
	20660449 {AB000295}* (S)	Not applicable (No asbestos detected) (0)	Completely Sealed (0)	Good Condition (0)	Usually inaccessible or unlikely to be disturbed (0)

Normal Occupancy	Score	Likelihood of disturbance	Score	Exposure Potential	Score	Maintenance Activity	Score
Main type of activity	N/A	Location	N/A	Number of occupants	N/A	Type of Maintenance	N/A
		Accessibility	N/A	Frequency of use	N/A	Frequency of maintenance	N/A
		Amount	N/A	Average Time	N/A		
Average Score	N/A	Average Score	N/A	Average Score	N/A	Average Score	N/A
Recommendation	No further action required						
Comments	N/A

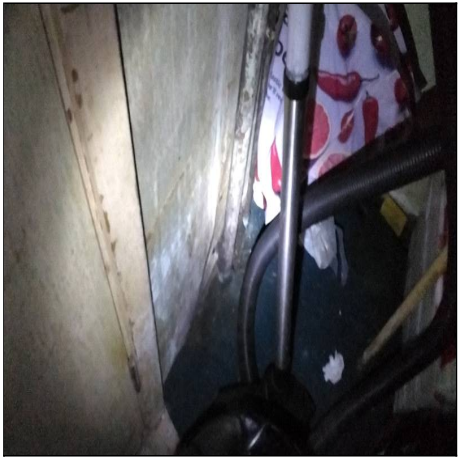
Re-inspection Date:	Lead Surveyor	Survey Type	Floor	Analysis
	9 Jan 2025 to 10 Jan 2025	Tracy Chulk	Reinspection Survey	Ground	N/A
	Building	Room	Item	Quantity	
	Block B	Meters B003	Floor void where pipes enter floor construction	N/A	
	Sample No (S,SP,P,As)	Product Type	Surface Treatment	Condition	Accessibility
	Visual (P)	N/A	N/A	N/A	N/A

Normal Occupancy	Score	Likelihood of disturbance	Score	Exposure Potential	Score	Maintenance Activity	Score
Main type of activity	N/A	Location	N/A	Number of occupants	N/A	Type of Maintenance	N/A
		Accessibility	N/A	Frequency of use	N/A	Frequency of maintenance	N/A
		Amount	N/A	Average Time	N/A		
Average Score	N/A	Average Score	N/A	Average Score	N/A	Average Score	N/A
Recommendation	Inspection Required						
Comments	Unable to access without causing excessive damage

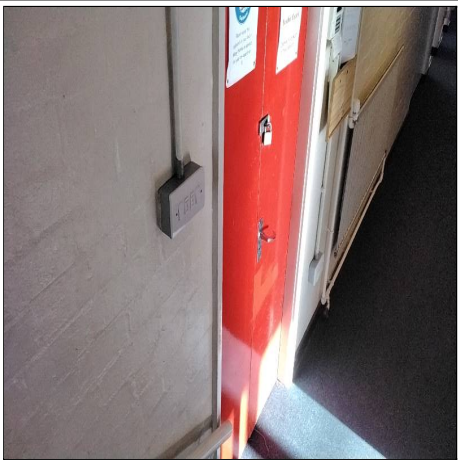
Re-inspection Date:	Lead Surveyor	Survey Type	Floor	Analysis
	9 Jan 2025 to 10 Jan 2025	Tracy Chulk	Reinspection Survey	Ground	N/A
	Building	Room	Item	Quantity	
	Block B	Meters B003	Inaccessible Room	N/A	
	Sample No (S,SP,P,As)	Product Type	Surface Treatment	Condition	Accessibility
	Visual (P)	N/A	N/A	N/A	N/A

Normal Occupancy	Score	Likelihood of disturbance	Score	Exposure Potential	Score	Maintenance Activity	Score
Main type of activity	N/A	Location	N/A	Number of occupants	N/A	Type of Maintenance	N/A
		Accessibility	N/A	Frequency of use	N/A	Frequency of maintenance	N/A
		Amount	N/A	Average Time	N/A		
Average Score	N/A	Average Score	N/A	Average Score	N/A	Average Score	N/A
Recommendation	Inspection Required						
Comments	Locked no key available

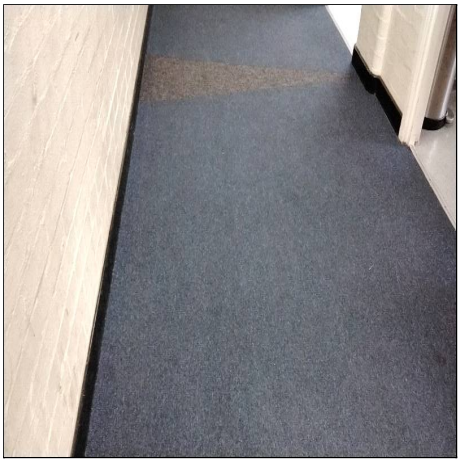
Re-inspection Date:	Lead Surveyor	Survey Type	Floor	Analysis
	9 Jan 2025 to 10 Jan 2025	Tracy Chulk	Reinspection Survey	Ground	Chrysotile (1)
	Building	Room	Item	Quantity	
	Block B	Circulation B004	Vinyl floor tiles beneath carpet and screed	20m ²	
	Sample No (S,SP,P,As)	Product Type	Surface Treatment	Condition	Accessibility
	Visual (P)	Well-bound Material (1)	Completely Sealed (0)	Good Condition (0)	Usually inaccessible or unlikely to be disturbed (0)

Normal Occupancy	Score	Likelihood of disturbance	Score	Exposure Potential	Score	Maintenance Activity	Score
Main type of activity	1	Location	2	Number of occupants	3	Type of Maintenance	0
		Accessibility	0	Frequency of use	3	Frequency of maintenance	1
		Amount	2	Average Time	0		
Average Score	1	Average Score	2	Average Score	2	Average Score	1
Recommendation	D - No Attention Required, inspect at intervals						
Comments	Carpet glued in place - presumed to remain in situ

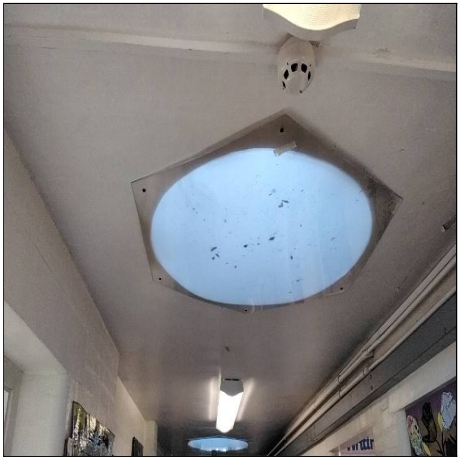
Re-inspection Date:	Lead Surveyor	Survey Type	Floor	Analysis
	9 Jan 2025 to 10 Jan 2025	Tracy Chulk	Reinspection Survey	Ground	N/A
	Building	Room	Item	Quantity	
	Block B	Circulation B004	Above polycarbonate covers beneath skylights	N/A	
	Sample No (S,SP,P,As)	Product Type	Surface Treatment	Condition	Accessibility
	Visual (P)	N/A	N/A	N/A	N/A

Normal Occupancy	Score	Likelihood of disturbance	Score	Exposure Potential	Score	Maintenance Activity	Score
Main type of activity	N/A	Location	N/A	Number of occupants	N/A	Type of Maintenance	N/A
		Accessibility	N/A	Frequency of use	N/A	Frequency of maintenance	N/A
		Amount	N/A	Average Time	N/A		
Average Score	N/A	Average Score	N/A	Average Score	N/A	Average Score	N/A
Recommendation	Inspection Required						
Comments	Unable to access without causing excessive damage

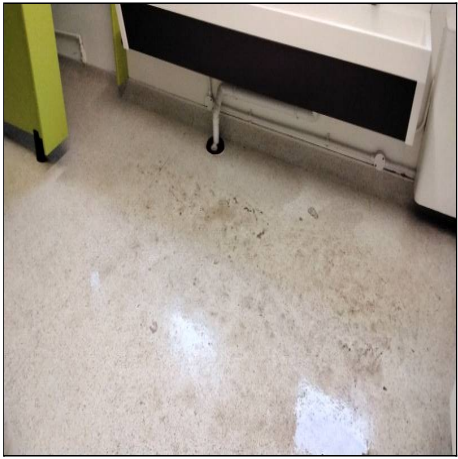
Re-inspection Date:	Lead Surveyor	Survey Type	Floor	Analysis
	9 Jan 2025 to 10 Jan 2025	Tracy Chulk	Reinspection Survey	Ground	N/A
	Building	Room	Item	Quantity	
	Block B	Girls WC B005	Void where pipe enters floor construction	N/A	N/A
	Sample No (S,SP,P,As)	Product Type	Surface Treatment	Condition	Accessibility
	Visual (P)	N/A	N/A	N/A	N/A

Normal Occupancy	Score	Likelihood of disturbance	Score	Exposure Potential	Score	Maintenance Activity	Score
Main type of activity	N/A	Location	N/A	Number of occupants	N/A	Type of Maintenance	N/A
		Accessibility	N/A	Frequency of use	N/A	Frequency of maintenance	N/A
		Amount	N/A	Average Time	N/A		
Average Score	N/A	Average Score	N/A	Average Score	N/A	Average Score	N/A
Recommendation	Inspection Required						
Comments	Unable to access without causing excessive damage

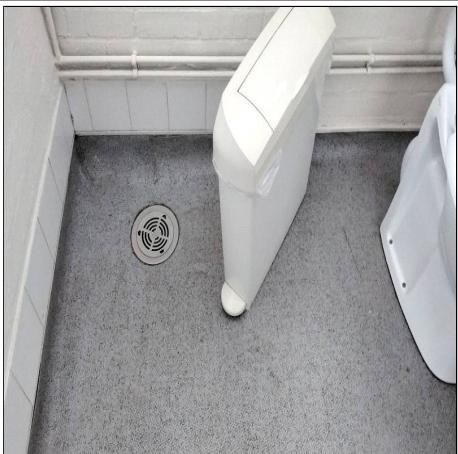
Re-inspection Date:	Lead Surveyor	Survey Type	Floor	Analysis
	9 Jan 2025 to 10 Jan 2025	Tracy Chulk	Reinspection Survey	Ground	N/A
	Building	Room	Item	Quantity	
	Block B	Staff WC B007	Floor voids to drainage and waste	N/A	
	Sample No (S,SP,P,As)	Product Type	Surface Treatment	Condition	Accessibility
	Visual (P)	N/A	N/A	N/A	N/A

Normal Occupancy	Score	Likelihood of disturbance	Score	Exposure Potential	Score	Maintenance Activity	Score
Main type of activity	N/A	Location	N/A	Number of occupants	N/A	Type of Maintenance	N/A
		Accessibility	N/A	Frequency of use	N/A	Frequency of maintenance	N/A
		Amount	N/A	Average Time	N/A		
Average Score	N/A	Average Score	N/A	Average Score	N/A	Average Score	N/A
Recommendation	Inspection Required						
Comments	Unable to access without causing excessive damage

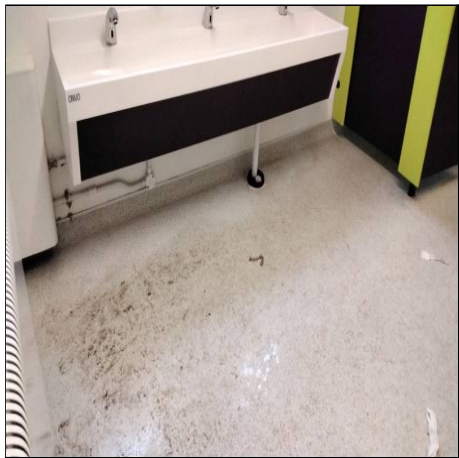
Re-inspection Date:	Lead Surveyor	Survey Type	Floor	Analysis
	9 Jan 2025 to 10 Jan 2025	Tracy Chulk	Reinspection Survey	Ground	N/A
	Building	Room	Item	Quantity	
	Block B	Boys WC B009	Void where pipe enters floor construction	N/A	
	Sample No (S,SP,P,As)	Product Type	Surface Treatment	Condition	Accessibility
	Visual (P)	N/A	N/A	N/A	N/A

Normal Occupancy	Score	Likelihood of disturbance	Score	Exposure Potential	Score	Maintenance Activity	Score
Main type of activity	N/A	Location	N/A	Number of occupants	N/A	Type of Maintenance	N/A
		Accessibility	N/A	Frequency of use	N/A	Frequency of maintenance	N/A
		Amount	N/A	Average Time	N/A		
Average Score	N/A	Average Score	N/A	Average Score	N/A	Average Score	N/A
Recommendation	Inspection Required						
Comments	Unable to access without causing excessive damage

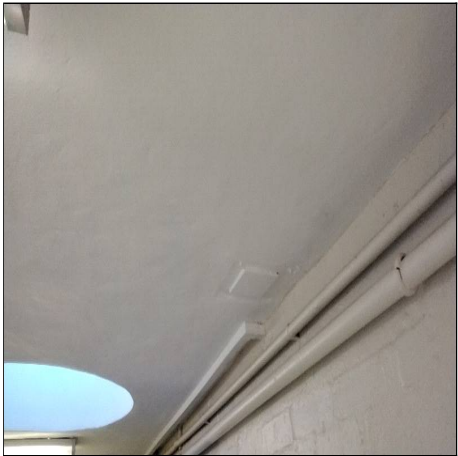
Re-inspection Date:	Lead Surveyor	Survey Type	Floor	Analysis
	9 Jan 2025 to 10 Jan 2025	Tracy Chulk	Reinspection Survey	Ground	Crocidolite (or unknown) (3)
	Building	Room	Item	Quantity	
	Block B	Boys WC B009	Flue pipe through ceiling South side of room	1no.	
	Sample No (S,SP,P,As)	Product Type	Surface Treatment	Condition	Accessibility
	Visual (P)	Asbestos Cement (1)	Surface Sealed (1)	Good Condition (0)	Usually inaccessible or unlikely to be disturbed (0)

Normal Occupancy	Score	Likelihood of disturbance	Score	Exposure Potential	Score	Maintenance Activity	Score
Main type of activity	1	Location	2	Number of occupants	1	Type of Maintenance	0
		Accessibility	0	Frequency of use	3	Frequency of maintenance	0
		Amount	1	Average Time	0		
Average Score	1	Average Score	1	Average Score	2	Average Score	0
Recommendation	D - No Attention Required, inspect at intervals						
Comments	Presumed to be present within ceiling void

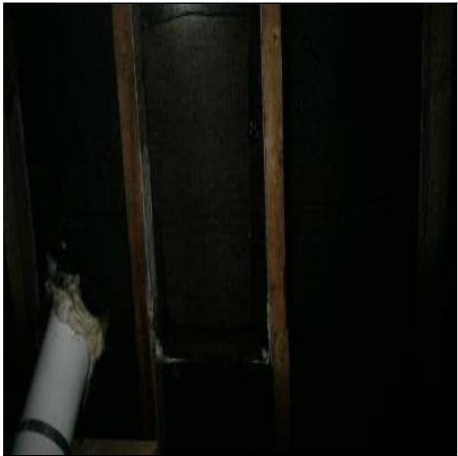
Re-inspection Date:	Lead Surveyor	Survey Type	Floor	Analysis
	9 Jan 2025 to 10 Jan 2025	Tracy Chulk	Reinspection Survey	Ground	Chrysotile (1)
	Building	Room	Item	Quantity	
	Block B	Boiler B010	Redundant Cement flue boxing to sides of rafters	0 - 1m ²	
	Sample No (S,SP,P,As)	Product Type	Surface Treatment	Condition	Accessibility
	20762038 {AA001834}* (S)	Asbestos Cement (1)	Surface Sealed (1)	Medium Damage (2)	Usually inaccessible or unlikely to be disturbed (0)

Normal Occupancy	Score	Likelihood of disturbance	Score	Exposure Potential	Score	Maintenance Activity	Score
Main type of activity	0	Location	2	Number of occupants	1	Type of Maintenance	0
		Accessibility	0	Frequency of use	0	Frequency of maintenance	0
		Amount	1	Average Time	0		
Average Score	0	Average Score	1	Average Score	1	Average Score	0
Recommendation	H - Restrict Access to This Area						
Comments	Unable to access due to height

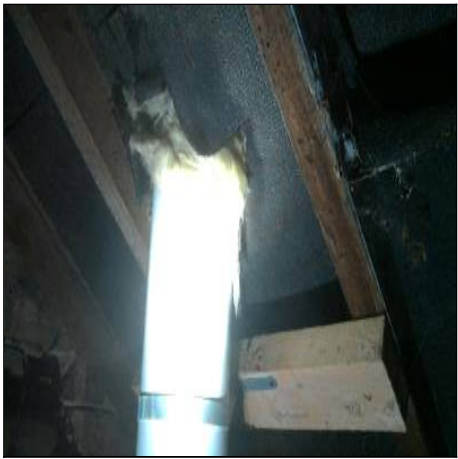
Re-inspection Date:	Lead Surveyor	Survey Type	Floor	Analysis
	9 Jan 2025 to 10 Jan 2025	Tracy Chulk	Reinspection Survey	Ground	No Asbestos Detected (0)
	Building	Room	Item	Quantity	
	Block B	Boiler B010	Felt to underside of roof	Unknown	
	Sample No (S,SP,P,As)	Product Type	Surface Treatment	Condition	Accessibility
	AA001835* (S)	Well Bound Material (1)	Completely Sealed (0)	Low Damage (1)	Usually inaccessible or unlikely to be disturbed (0)

Normal Occupancy	Score	Likelihood of disturbance	Score	Exposure Potential	Score	Maintenance Activity	Score
Main type of activity	N/A	Location	N/A	Number of occupants	N/A	Type of Maintenance	N/A
		Accessibility	N/A	Frequency of use	N/A	Frequency of maintenance	N/A
		Amount	N/A	Average Time	N/A		
Average Score	N/A	Average Score	N/A	Average Score	N/A	Average Score	N/A
Recommendation	No further action required						
Comments	N/A

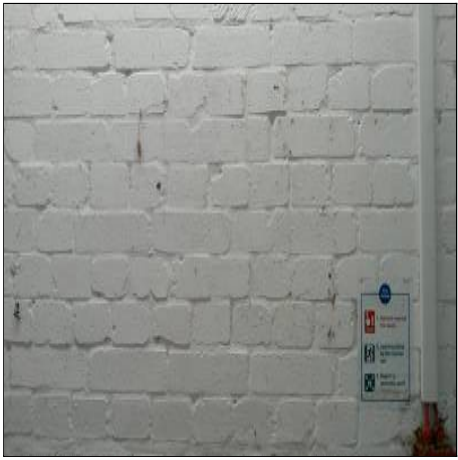
Re-inspection Date:	Lead Surveyor	Survey Type	Floor	Analysis
	9 Jan 2025 to 10 Jan 2025	Tracy Chulk	Reinspection Survey	Ground	No Asbestos Detected (0)
	Building	Room	Item	Quantity	
	Block B	Boiler B010	Residue to walls	Unknown	
	Sample No (S,SP,P,As)	Product Type	Surface Treatment	Condition	Accessibility
	AA001836* (S)	Non Asbestos Insulation (0)	Unsealed lagging and sprays (3)	High Damage (3)	Easily disturbed (2)

Normal Occupancy	Score	Likelihood of disturbance	Score	Exposure Potential	Score	Maintenance Activity	Score
Main type of activity	N/A	Location	N/A	Number of occupants	N/A	Type of Maintenance	N/A
		Accessibility	N/A	Frequency of use	N/A	Frequency of maintenance	N/A
		Amount	N/A	Average Time	N/A		
Average Score	N/A	Average Score	N/A	Average Score	N/A	Average Score	N/A
Recommendation	No further action required						
Comments	N/A

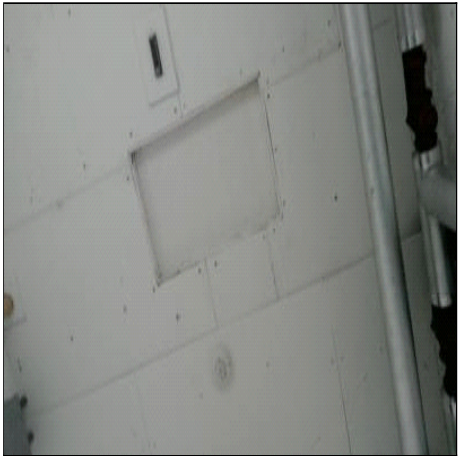
Re-inspection Date:	Lead Surveyor	Survey Type	Floor	Analysis
	9 Jan 2025 to 10 Jan 2025	Tracy Chulk	Reinspection Survey	Ground	No Asbestos Detected (0)
	Building	Room	Item	Quantity	
	Block B	Boiler B010	Fixed ceiling panels	6 - 7m ²	
	Sample No (S,SP,P,As)	Product Type	Surface Treatment	Condition	Accessibility
	AA001837* (S)	Non Asbestos Insulating Board (0)	Unsealed (2)	Low Damage (1)	Occasionally likely to be disturbed (1)

Normal Occupancy	Score	Likelihood of disturbance	Score	Exposure Potential	Score	Maintenance Activity	Score
Main type of activity	N/A	Location	N/A	Number of occupants	N/A	Type of Maintenance	N/A
		Accessibility	N/A	Frequency of use	N/A	Frequency of maintenance	N/A
		Amount	N/A	Average Time	N/A		
Average Score	N/A	Average Score	N/A	Average Score	N/A	Average Score	N/A
Recommendation	No further action required						
Comments	N/A
