ASBESTOS RE-INSPECTION SURVEY REPORT

Site Name and Address	Stoberry Park Primary School, North Road, Wells, BA5 2TJ	
Client Name and Address	Somerset Council, Strategic Asset Management, County Hall, Taunton, Somerset, TA1 4DY	
Client Contact & Phone No.	Oliver Woodhams 07977400667	
Job No.	J006176	
Date of Re-inspection	9th January 2025 to 10th January 2025	
Next Inspection due	09/01/2026	
Report Date	27 Feb 2025	
Report Revision No.	1	
Inspector/Surveyor	Name: Tracy Chulk	Signature:

Report Issue Date	27 Feb 2025

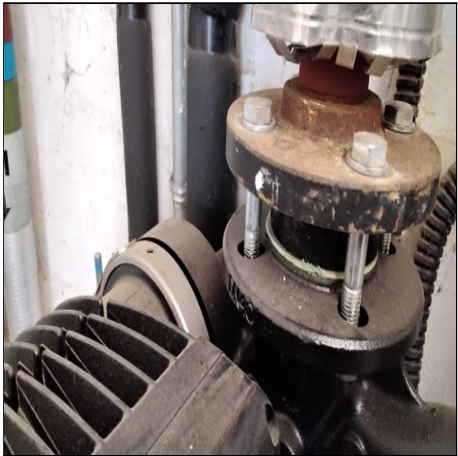
Re-inspection Date:	Lead Surveyor	Survey Type	Floor	Analysis
	9 Jan 2025 to 10 Jan 2025	Tracy Chulk	Reinspection Survey	Ground	No Asbestos Detected (0)
	Building	Room	Item	Quantity	
	Block B	Boiler B010	Gasket to flange	1no.	
	Sample No (S,SP,P,As)	Product Type	Surface Treatment	Condition	Accessibility
	BF000356* (S)	Reinforced Composite (1)	Surface Sealed (1)	Low Damage (1)	Usually inaccessible or unlikely to be disturbed (0)

Normal Occupancy	Score	Likelihood of disturbance	Score	Exposure Potential	Score	Maintenance Activity	Score
Main type of activity	N/A	Location	N/A	Number of occupants	N/A	Type of Maintenance	N/A
		Accessibility	N/A	Frequency of use	N/A	Frequency of maintenance	N/A
		Amount	N/A	Average Time	N/A		
Average Score	N/A	Average Score	N/A	Average Score	N/A	Average Score	N/A
Recommendation	No further action required						
Comments	N/A

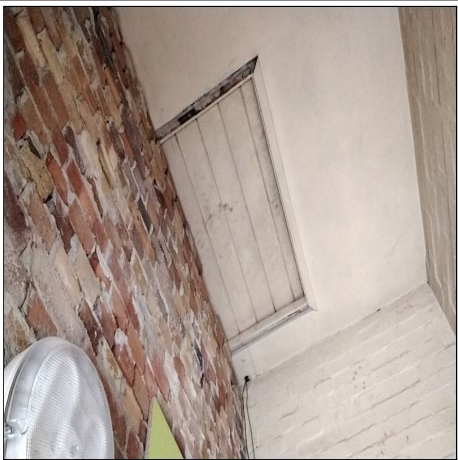
Re-inspection Date:	Lead Surveyor	Survey Type	Floor	Analysis
	9 Jan 2025 to 10 Jan 2025	Tracy Chulk	Reinspection Survey	Ground	N/A
	Building	Room	Item	Quantity	
	Block B	Store B010A	Ceiling void	N/A	
	Sample No (S,SP,P,As)	Product Type	Surface Treatment	Condition	Accessibility
	Visual (P)	N/A	N/A	N/A	N/A

Normal Occupancy	Score	Likelihood of disturbance	Score	Exposure Potential	Score	Maintenance Activity	Score
Main type of activity	N/A	Location	N/A	Number of occupants	N/A	Type of Maintenance	N/A
		Accessibility	N/A	Frequency of use	N/A	Frequency of maintenance	N/A
		Amount	N/A	Average Time	N/A		
Average Score	N/A	Average Score	N/A	Average Score	N/A	Average Score	N/A
Recommendation	Inspection Required						
Comments	Unable to access due to height

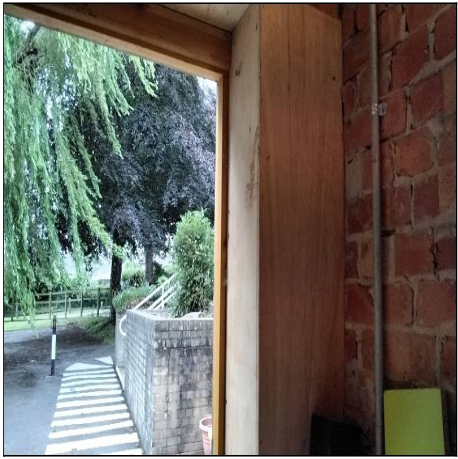
Re-inspection Date:	Lead Surveyor	Survey Type	Floor	Analysis
	9 Jan 2025 to 10 Jan 2025	Tracy Chulk	Reinspection Survey	Ground	N/A
	Building	Room	Item	Quantity	
	Block B	Store B010A	Wooden boxing to either side of door	N/A	
	Sample No (S,SP,P,As)	Product Type	Surface Treatment	Condition	Accessibility
	Visual (P)	N/A	N/A	N/A	N/A

Normal Occupancy	Score	Likelihood of disturbance	Score	Exposure Potential	Score	Maintenance Activity	Score
Main type of activity	N/A	Location	N/A	Number of occupants	N/A	Type of Maintenance	N/A
		Accessibility	N/A	Frequency of use	N/A	Frequency of maintenance	N/A
		Amount	N/A	Average Time	N/A		
Average Score	N/A	Average Score	N/A	Average Score	N/A	Average Score	N/A
Recommendation	Inspection Required						
Comments	Unable to access without causing excessive damage

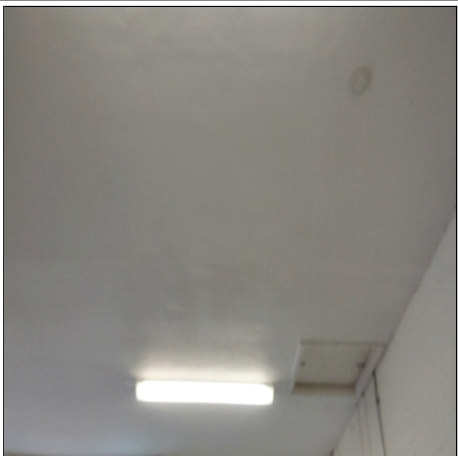
Re-inspection Date:	Lead Surveyor	Survey Type	Floor	Analysis
	9 Jan 2025 to 10 Jan 2025	Tracy Chulk	Reinspection Survey	Ground	N/A
	Building	Room	Item	Quantity	
	Block B	Classroom B012	Ceiling void	N/A	
	Sample No (S,SP,P,As)	Product Type	Surface Treatment	Condition	Accessibility
	Visual (P)	N/A	N/A	N/A	N/A

Normal Occupancy	Score	Likelihood of disturbance	Score	Exposure Potential	Score	Maintenance Activity	Score
Main type of activity	N/A	Location	N/A	Number of occupants	N/A	Type of Maintenance	N/A
		Accessibility	N/A	Frequency of use	N/A	Frequency of maintenance	N/A
		Amount	N/A	Average Time	N/A		
Average Score	N/A	Average Score	N/A	Average Score	N/A	Average Score	N/A
Recommendation	Inspection Required						
Comments	Unable to access, due to height

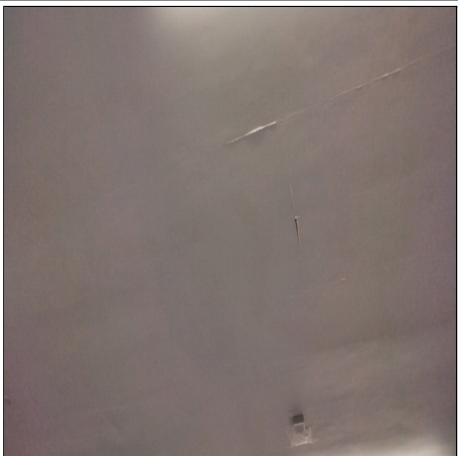
Re-inspection Date:	Lead Surveyor	Survey Type	Floor	Analysis
	9 Jan 2025 to 10 Jan 2025	Tracy Chulk	Reinspection Survey	Ground	N/A
	Building	Room	Item	Quantity	
	Block B	Classroom B013	Ceiling void	N/A	
	Sample No (S,SP,P,As)	Product Type	Surface Treatment	Condition	Accessibility
	Visual (P)	N/A	N/A	N/A	N/A

Normal Occupancy	Score	Likelihood of disturbance	Score	Exposure Potential	Score	Maintenance Activity	Score
Main type of activity	N/A	Location	N/A	Number of occupants	N/A	Type of Maintenance	N/A
		Accessibility	N/A	Frequency of use	N/A	Frequency of maintenance	N/A
		Amount	N/A	Average Time	N/A		
Average Score	N/A	Average Score	N/A	Average Score	N/A	Average Score	N/A
Recommendation	Inspection Required						
Comments	Unable to access without causing excessive damage

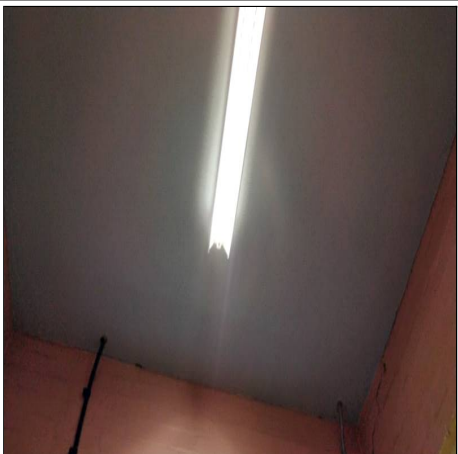
Re-inspection Date:	Lead Surveyor	Survey Type	Floor	Analysis
	9 Jan 2025 to 10 Jan 2025	Tracy Chulk	Reinspection Survey	Ground	N/A
	Building	Room	Item	Quantity	
	Block B	Store B014	Ceiling void	N/A	
	Sample No (S,SP,P,As)	Product Type	Surface Treatment	Condition	Accessibility
	Visual (P)	N/A	N/A	N/A	N/A

Normal Occupancy	Score	Likelihood of disturbance	Score	Exposure Potential	Score	Maintenance Activity	Score
Main type of activity	N/A	Location	N/A	Number of occupants	N/A	Type of Maintenance	N/A
		Accessibility	N/A	Frequency of use	N/A	Frequency of maintenance	N/A
		Amount	N/A	Average Time	N/A		
Average Score	N/A	Average Score	N/A	Average Score	N/A	Average Score	N/A
Recommendation	Inspection Required						
Comments	Unable to access without causing excessive damage

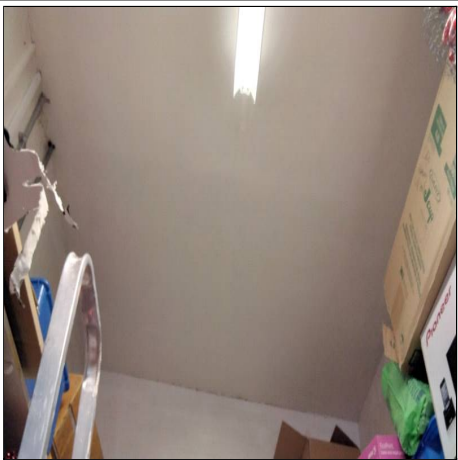
Re-inspection Date:	Lead Surveyor	Survey Type	Floor	Analysis
	9 Jan 2025 to 10 Jan 2025	Tracy Chulk	Reinspection Survey	Ground	N/A
	Building	Room	Item	Quantity	
	Block B	Store B015	Ceiling void	10m ²	
	Sample No (S,SP,P,As)	Product Type	Surface Treatment	Condition	Accessibility
	Visual (P)	N/A	N/A	N/A	N/A

Normal Occupancy	Score	Likelihood of disturbance	Score	Exposure Potential	Score	Maintenance Activity	Score
Main type of activity	N/A	Location	N/A	Number of occupants	N/A	Type of Maintenance	N/A
		Accessibility	N/A	Frequency of use	N/A	Frequency of maintenance	N/A
		Amount	N/A	Average Time	N/A		
Average Score	N/A	Average Score	N/A	Average Score	N/A	Average Score	N/A
Recommendation	Inspection Required						
Comments	Unable to access without causing excessive damage

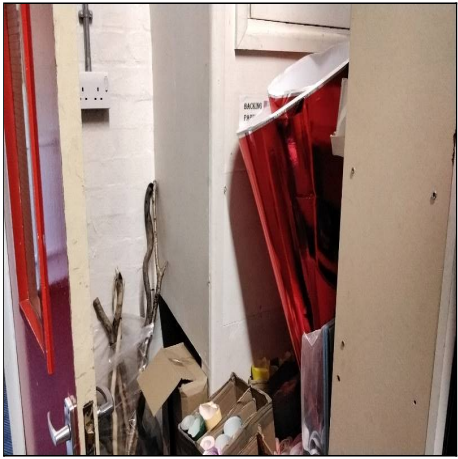
Re-inspection Date:	Lead Surveyor	Survey Type	Floor	Analysis
	9 Jan 2025 to 10 Jan 2025	Tracy Chulk	Reinspection Survey	Ground	N/A
	Building	Room	Item	Quantity	
	Block B	Store B015	Limited access to gas meter cupboard	N/A	
	Sample No (S,SP,P,As)	Product Type	Surface Treatment	Condition	Accessibility
	Visual (P)	N/A	N/A	N/A	N/A

Normal Occupancy	Score	Likelihood of disturbance	Score	Exposure Potential	Score	Maintenance Activity	Score
Main type of activity	N/A	Location	N/A	Number of occupants	N/A	Type of Maintenance	N/A
		Accessibility	N/A	Frequency of use	N/A	Frequency of maintenance	N/A
		Amount	N/A	Average Time	N/A		
Average Score	N/A	Average Score	N/A	Average Score	N/A	Average Score	N/A
Recommendation	Inspection Required						
Comments	Unable to access fully due to stored items

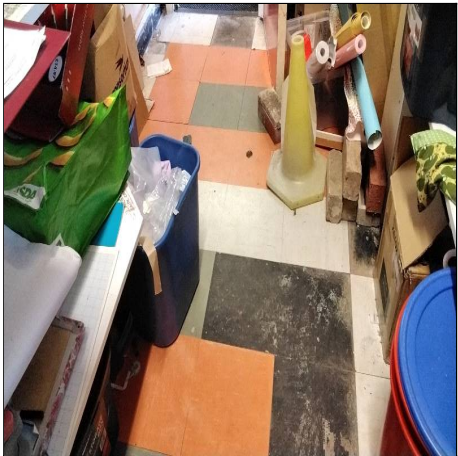
Re-inspection Date:	Lead Surveyor	Survey Type	Floor	Analysis
	9 Jan 2025 to 10 Jan 2025	Tracy Chulk	Reinspection Survey	Ground	Chrysotile (1)
	Building	Room	Item	Quantity	
	Block B	Store B015	Mixed colour vinyl floor tiles	10m ²	
	Sample No (S,SP,P,As)	Product Type	Surface Treatment	Condition	Accessibility
	BF000357* (S)	Reinforced Composite (1)	Completely Sealed (0)	Low Damage (1)	Easily disturbed (2)

Normal Occupancy	Score	Likelihood of disturbance	Score	Exposure Potential	Score	Maintenance Activity	Score
Main type of activity	0	Location	2	Number of occupants	1	Type of Maintenance	0
		Accessibility	2	Frequency of use	0	Frequency of maintenance	1
		Amount	2	Average Time	0		
Average Score	0	Average Score	2	Average Score	1	Average Score	1
Recommendation	Inspection Required						
Comments	Some missing tiles

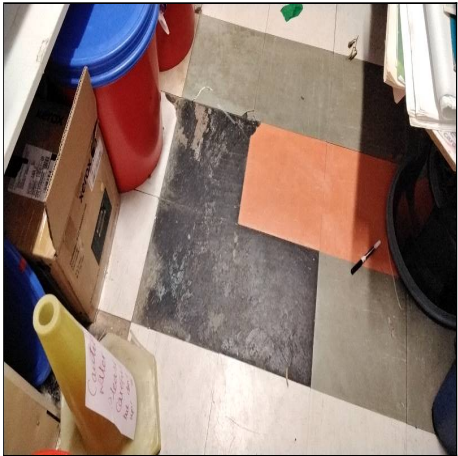
Re-inspection Date:	Lead Surveyor	Survey Type	Floor	Analysis
	9 Jan 2025 to 10 Jan 2025	Tracy Chulk	Reinspection Survey	Ground	Chrysotile (1)
	Building	Room	Item	Quantity	
	Block B	Store B015	Adhesive beneath vinyl tiles to floor	10m ²	
	Sample No (S,SP,P,As)	Product Type	Surface Treatment	Condition	Accessibility
	BF000358* (S)	Reinforced Composite (1)	Surface Sealed (1)	Low Damage (1)	Easily disturbed (2)

Normal Occupancy	Score	Likelihood of disturbance	Score	Exposure Potential	Score	Maintenance Activity	Score
Main type of activity	0	Location	2	Number of occupants	1	Type of Maintenance	1
		Accessibility	2	Frequency of use	0	Frequency of maintenance	0
		Amount	2	Average Time	0		
Average Score	0	Average Score	2	Average Score	1	Average Score	1
Recommendation	Inspection Required						
Comments	Exposed where vinyl tiles are missing

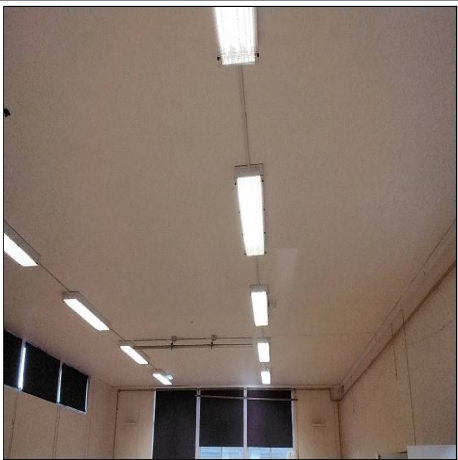
Re-inspection Date:	Lead Surveyor	Survey Type	Floor	Analysis
	9 Jan 2025 to 10 Jan 2025	Tracy Chulk	Reinspection Survey	Ground	N/A
	Building	Room	Item	Quantity	
	Block B	Assembly Hall B016	Ceiling Void	N/A	
	Sample No (S,SP,P,As)	Product Type	Surface Treatment	Condition	Accessibility
	Visual (P)	N/A	N/A	N/A	N/A

Normal Occupancy	Score	Likelihood of disturbance	Score	Exposure Potential	Score	Maintenance Activity	Score
Main type of activity	N/A	Location	N/A	Number of occupants	N/A	Type of Maintenance	N/A
		Accessibility	N/A	Frequency of use	N/A	Frequency of maintenance	N/A
		Amount	N/A	Average Time	N/A		
Average Score	N/A	Average Score	N/A	Average Score	N/A	Average Score	N/A
Recommendation	Inspection Required						
Comments	Unable to access without causing excessive damage

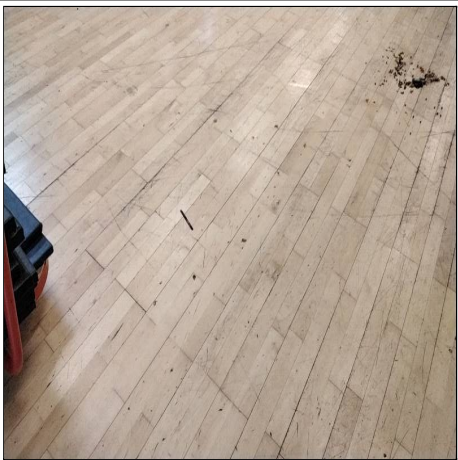
Re-inspection Date:	Lead Surveyor	Survey Type	Floor	Analysis
	9 Jan 2025 to 10 Jan 2025	Tracy Chulk	Reinspection Survey	Ground	N/A
	Building	Room	Item	Quantity	
	Block B	Assembly Hall B016	Floor void to whole floor	N/A	
	Sample No (S,SP,P,As)	Product Type	Surface Treatment	Condition	Accessibility
	Visual (P)	N/A	N/A	N/A	N/A

Normal Occupancy	Score	Likelihood of disturbance	Score	Exposure Potential	Score	Maintenance Activity	Score
Main type of activity	N/A	Location	N/A	Number of occupants	N/A	Type of Maintenance	N/A
		Accessibility	N/A	Frequency of use	N/A	Frequency of maintenance	N/A
		Amount	N/A	Average Time	N/A		
Average Score	N/A	Average Score	N/A	Average Score	N/A	Average Score	N/A
Recommendation	Inspection Required						
Comments	Unable to access without causing excessive damage

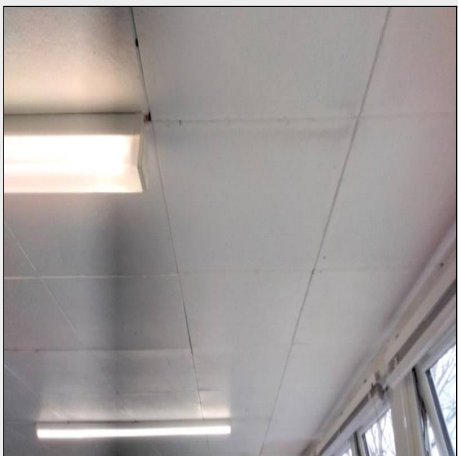
Re-inspection Date:	Lead Surveyor	Survey Type	Floor	Analysis
	9 Jan 2025 to 10 Jan 2025	Tracy Chulk	Reinspection Survey	Ground	N/A
	Building	Room	Item	Quantity	
	Block TB	Classroom TB001	Ceiling void	N/A	
	Sample No (S,SP,P,As)	Product Type	Surface Treatment	Condition	Accessibility
	Visual (P)	N/A	N/A	N/A	N/A

Normal Occupancy	Score	Likelihood of disturbance	Score	Exposure Potential	Score	Maintenance Activity	Score
Main type of activity	N/A	Location	N/A	Number of occupants	N/A	Type of Maintenance	N/A
		Accessibility	N/A	Frequency of use	N/A	Frequency of maintenance	N/A
		Amount	N/A	Average Time	N/A		
Average Score	N/A	Average Score	N/A	Average Score	N/A	Average Score	N/A
Recommendation	Inspection Required						
Comments	N/A

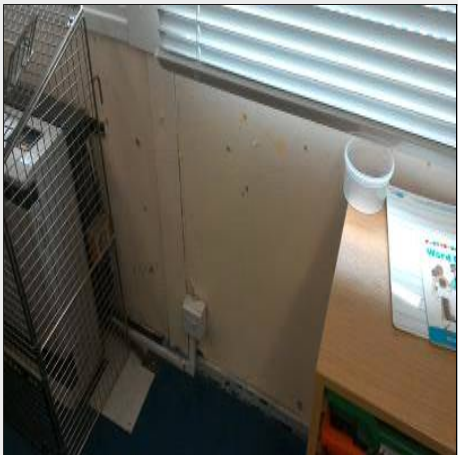
Re-inspection Date:	Lead Surveyor	Survey Type	Floor	Analysis
	9 Jan 2025 to 10 Jan 2025	Tracy Chulk	Reinspection Survey	Ground	No Asbestos Detected (0)
	Building	Room	Item	Quantity	
	Block TB	Classroom TB001	Fixed fibreboard panels to all walls	45m ²	
	Sample No (S,SP,P,As)	Product Type	Surface Treatment	Condition	Accessibility
	21060548 {AB000298} * (S)	Not applicable (No asbestos detected) (0)	Completely Sealed (0)	Good Condition (0)	Usually inaccessible or unlikely to be disturbed (0)

Normal Occupancy	Score	Likelihood of disturbance	Score	Exposure Potential	Score	Maintenance Activity	Score
Main type of activity	N/A	Location	N/A	Number of occupants	N/A	Type of Maintenance	N/A
		Accessibility	N/A	Frequency of use	N/A	Frequency of maintenance	N/A
		Amount	N/A	Average Time	N/A		
Average Score	N/A	Average Score	N/A	Average Score	N/A	Average Score	N/A
Recommendation	No further action required						
Comments	N/A

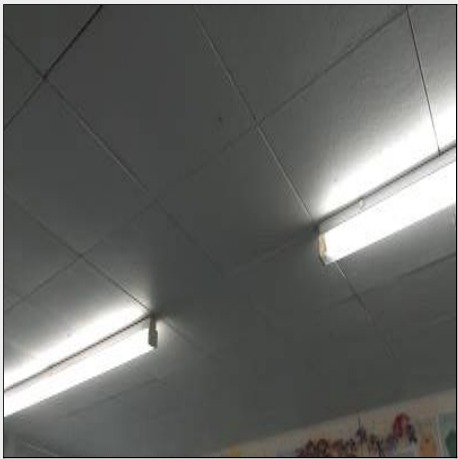
Re-inspection Date:	Lead Surveyor	Survey Type	Floor	Analysis
	9 Jan 2025 to 10 Jan 2025	Tracy Chulk	Reinspection Survey	Ground	No Asbestos Detected (0)
	Building	Room	Item	Quantity	
	Block TB	Classroom TB001	Fixed fibreboard ceiling panels	30m ²	
	Sample No (S,SP,P,As)	Product Type	Surface Treatment	Condition	Accessibility
	AB000300* (S)	Non Asbestos Insulating Board (0)	Surface Sealed (1)	Good Condition (0)	Usually inaccessible or unlikely to be disturbed (0)

Normal Occupancy	Score	Likelihood of disturbance	Score	Exposure Potential	Score	Maintenance Activity	Score
Main type of activity	N/A	Location	N/A	Number of occupants	N/A	Type of Maintenance	N/A
		Accessibility	N/A	Frequency of use	N/A	Frequency of maintenance	N/A
		Amount	N/A	Average Time	N/A		
Average Score	N/A	Average Score	N/A	Average Score	N/A	Average Score	N/A
Recommendation	No further action required						
Comments	N/A

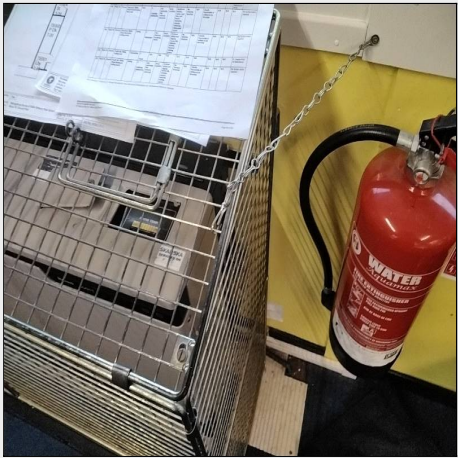
Re-inspection Date:	Lead Surveyor	Survey Type	Floor	Analysis
	9 Jan 2025 to 10 Jan 2025	Tracy Chulk	Reinspection Survey	Ground	No Asbestos Detected (0)
	Building	Room	Item	Quantity	
	Block TB	Classroom TB001	Hardboard panels to West wall	Throughout	
	Sample No (S,SP,P,As)	Product Type	Surface Treatment	Condition	Accessibility
	BD001982* (S)	Non Asbestos Insulating Board (0)	Surface Sealed (1)	Low Damage (1)	Easily disturbed (2)

Normal Occupancy	Score	Likelihood of disturbance	Score	Exposure Potential	Score	Maintenance Activity	Score
Main type of activity	N/A	Location	N/A	Number of occupants	N/A	Type of Maintenance	N/A
		Accessibility	N/A	Frequency of use	N/A	Frequency of maintenance	N/A
		Amount	N/A	Average Time	N/A		
Average Score	N/A	Average Score	N/A	Average Score	N/A	Average Score	N/A
Recommendation	No further action required						
Comments	N/A

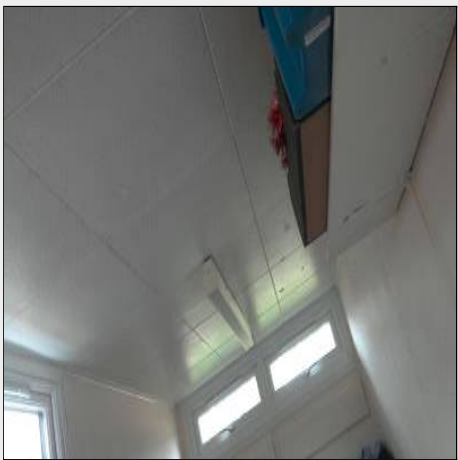
Re-inspection Date:	Lead Surveyor	Survey Type	Floor	Analysis
	9 Jan 2025 to 10 Jan 2025	Tracy Chulk	Reinspection Survey	Ground	N/A
	Building	Room	Item	Quantity	
	Block TB	Pupils WC TB002	Ceiling void	N/A	
	Sample No (S,SP,P,As)	Product Type	Surface Treatment	Condition	Accessibility
	Visual (P)	N/A	N/A	N/A	N/A

Normal Occupancy	Score	Likelihood of disturbance	Score	Exposure Potential	Score	Maintenance Activity	Score
Main type of activity	N/A	Location	N/A	Number of occupants	N/A	Type of Maintenance	N/A
		Accessibility	N/A	Frequency of use	N/A	Frequency of maintenance	N/A
		Amount	N/A	Average Time	N/A		
Average Score	N/A	Average Score	N/A	Average Score	N/A	Average Score	N/A
Recommendation	Inspection Required						
Comments	N/A

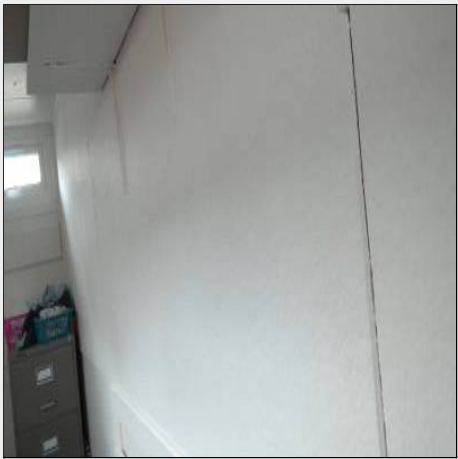
Re-inspection Date:	Lead Surveyor	Survey Type	Floor	Analysis
	9 Jan 2025 to 10 Jan 2025	Tracy Chulk	Reinspection Survey	Ground	No Asbestos Detected (0)
	Building	Room	Item	Quantity	
	Block TB	Pupils WC TB002	Fixed fibreboard panels to all walls	15m ²	
	Sample No (S,SP,P,As)	Product Type	Surface Treatment	Condition	Accessibility
	21060587 {AB000303}* (S)	Not applicable (No asbestos detected) (0)	Completely Sealed (0)	Good Condition (0)	Usually inaccessible or unlikely to be disturbed (0)

Normal Occupancy	Score	Likelihood of disturbance	Score	Exposure Potential	Score	Maintenance Activity	Score
Main type of activity	N/A	Location	N/A	Number of occupants	N/A	Type of Maintenance	N/A
		Accessibility	N/A	Frequency of use	N/A	Frequency of maintenance	N/A
		Amount	N/A	Average Time	N/A		
Average Score	N/A	Average Score	N/A	Average Score	N/A	Average Score	N/A
Recommendation	No further action required						
Comments	N/A

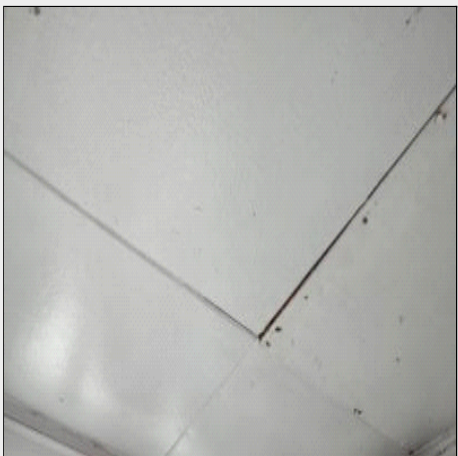
Re-inspection Date:	Lead Surveyor	Survey Type	Floor	Analysis
	9 Jan 2025 to 10 Jan 2025	Tracy Chulk	Reinspection Survey	Ground	N/A
	Building	Room	Item	Quantity	
	Block TB	Lobby TB003	Ceiling void	N/A	
	Sample No (S,SP,P,As)	Product Type	Surface Treatment	Condition	Accessibility
	Visual (P)	N/A	N/A	N/A	N/A

Normal Occupancy	Score	Likelihood of disturbance	Score	Exposure Potential	Score	Maintenance Activity	Score
Main type of activity	N/A	Location	N/A	Number of occupants	N/A	Type of Maintenance	N/A
		Accessibility	N/A	Frequency of use	N/A	Frequency of maintenance	N/A
		Amount	N/A	Average Time	N/A		
Average Score	N/A	Average Score	N/A	Average Score	N/A	Average Score	N/A
Recommendation	Inspection Required						
Comments	N/A

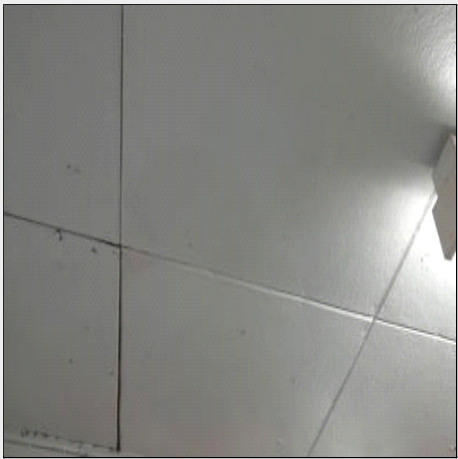
Re-inspection Date:	Lead Surveyor	Survey Type	Floor	Analysis
	9 Jan 2025 to 10 Jan 2025	Tracy Chulk	Reinspection Survey	Ground	No Asbestos Detected (0)
	Building	Room	Item	Quantity	
	Block TB	Lobby TB003	Fixed fibreboard ceiling panels	6m ²	
	Sample No (S,SP,P,As)	Product Type	Surface Treatment	Condition	Accessibility
	21060585 {AB000301}* (S)	Not applicable (No asbestos detected) (0)	Surface Sealed (1)	Good Condition (0)	Usually inaccessible or unlikely to be disturbed (0)

Normal Occupancy	Score	Likelihood of disturbance	Score	Exposure Potential	Score	Maintenance Activity	Score
Main type of activity	N/A	Location	N/A	Number of occupants	N/A	Type of Maintenance	N/A
		Accessibility	N/A	Frequency of use	N/A	Frequency of maintenance	N/A
		Amount	N/A	Average Time	N/A		
Average Score	N/A	Average Score	N/A	Average Score	N/A	Average Score	N/A
Recommendation	No further action required						
Comments	N/A

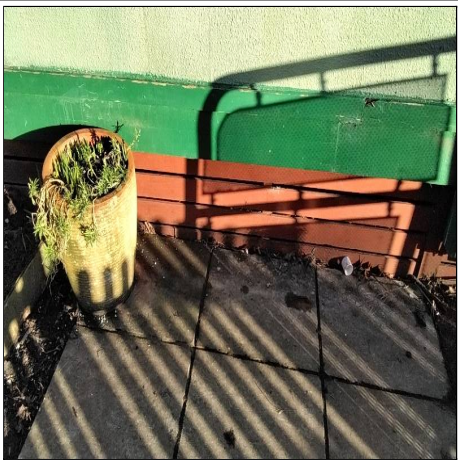
Re-inspection Date:	Lead Surveyor	Survey Type	Floor	Analysis
	9 Jan 2025 to 10 Jan 2025	Tracy Chulk	Reinspection Survey	External	N/A
	Building	Room	Item	Quantity	
	Block TC	External Block TC	Beneath unit	N/A	
	Sample No (S,SP,P,As)	Product Type	Surface Treatment	Condition	Accessibility
	Visual (P)	N/A	N/A	N/A	N/A

Normal Occupancy	Score	Likelihood of disturbance	Score	Exposure Potential	Score	Maintenance Activity	Score
Main type of activity	N/A	Location	N/A	Number of occupants	N/A	Type of Maintenance	N/A
		Accessibility	N/A	Frequency of use	N/A	Frequency of maintenance	N/A
		Amount	N/A	Average Time	N/A		
Average Score	N/A	Average Score	N/A	Average Score	N/A	Average Score	N/A
Recommendation	Inspection Required						
Comments	Unable to access without causing excessive damage

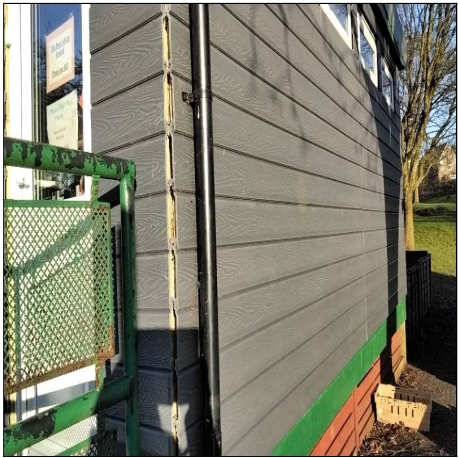
Re-inspection Date:	Lead Surveyor	Survey Type	Floor	Analysis
	9 Jan 2025 to 10 Jan 2025	Tracy Chulk	Reinspection Survey	External	N/A
	Building	Room	Item	Quantity	
	Block TC	External Block TC	Beneath plastic cladding to entrance end of unit	N/A	
	Sample No (S,SP,P,As)	Product Type	Surface Treatment	Condition	Accessibility
	Visual (P)	N/A	N/A	N/A	N/A

Normal Occupancy	Score	Likelihood of disturbance	Score	Exposure Potential	Score	Maintenance Activity	Score
Main type of activity	N/A	Location	N/A	Number of occupants	N/A	Type of Maintenance	N/A
		Accessibility	N/A	Frequency of use	N/A	Frequency of maintenance	N/A
		Amount	N/A	Average Time	N/A		
Average Score	N/A	Average Score	N/A	Average Score	N/A	Average Score	N/A
Recommendation	Inspection Required						
Comments	Unable to access without causing excessive damage

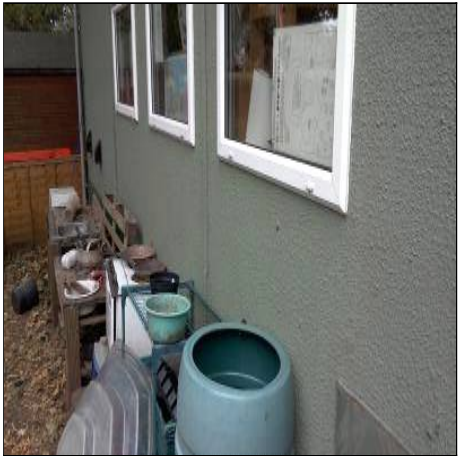
Re-inspection Date:	Lead Surveyor	Survey Type	Floor	Analysis
	9 Jan 2025 to 10 Jan 2025	Tracy Chulk	Reinspection Survey	External	No Asbestos Detected (0)
	Building	Room	Item	Quantity	
	Block TC	External Block TC	Render to all elevations	200m ²	
	Sample No (S,SP,P,As)	Product Type	Surface Treatment	Condition	Accessibility
	AO000112* (S)	Textured Coating + Well Bound Material (1)	Surface Sealed (1)	Good Condition (0)	Usually inaccessible or unlikely to be disturbed (0)

Normal Occupancy	Score	Likelihood of disturbance	Score	Exposure Potential	Score	Maintenance Activity	Score
Main type of activity	N/A	Location	N/A	Number of occupants	N/A	Type of Maintenance	N/A
		Accessibility	N/A	Frequency of use	N/A	Frequency of maintenance	N/A
		Amount	N/A	Average Time	N/A		
Average Score	N/A	Average Score	N/A	Average Score	N/A	Average Score	N/A
Recommendation	No further action required						
Comments	N/A

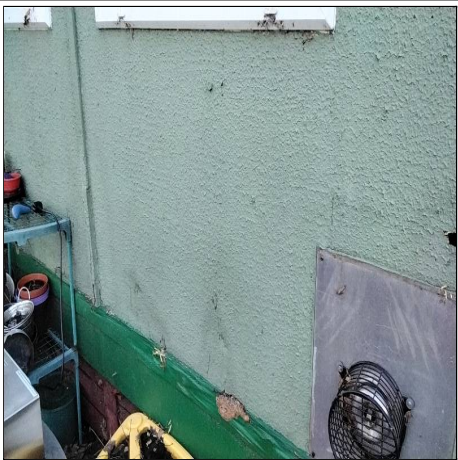
Re-inspection Date:	Lead Surveyor	Survey Type	Floor	Analysis
	9 Jan 2025 to 10 Jan 2025	Tracy Chulk	Reinspection Survey	External	No Asbestos Detected (0)
	Building	Room	Item	Quantity	
	Block TC	External Block TC	Render	Throughout	
	Sample No (S,SP,P,As)	Product Type	Surface Treatment	Condition	Accessibility
	DD000422* (S)	Textured Coating (1)	Surface Sealed (1)	Medium Damage (2)	Easily disturbed (2)

Normal Occupancy	Score	Likelihood of disturbance	Score	Exposure Potential	Score	Maintenance Activity	Score
Main type of activity	N/A	Location	N/A	Number of occupants	N/A	Type of Maintenance	N/A
		Accessibility	N/A	Frequency of use	N/A	Frequency of maintenance	N/A
		Amount	N/A	Average Time	N/A		
Average Score	N/A	Average Score	N/A	Average Score	N/A	Average Score	N/A
Recommendation	No further action required						
Comments	N/A

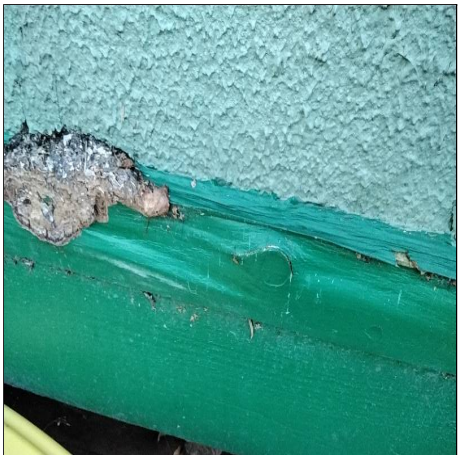
Re-inspection Date:	Lead Surveyor	Survey Type	Floor	Analysis
	9 Jan 2025 to 10 Jan 2025	Tracy Chulk	Reinspection Survey	External	No Asbestos Detected (0)
	Building	Room	Item	Quantity	
	Block TC	External Block TC	Mastic between unit and wooden trim to bottom of unit	80-90lm	
	Sample No (S,SP,P,As)	Product Type	Surface Treatment	Condition	Accessibility
	DD000423* (S)	Well Bound Material (1)	Completely Sealed (0)	Low Damage (1)	Occasionally likely to be disturbed (1)

Normal Occupancy	Score	Likelihood of disturbance	Score	Exposure Potential	Score	Maintenance Activity	Score
Main type of activity	N/A	Location	N/A	Number of occupants	N/A	Type of Maintenance	N/A
		Accessibility	N/A	Frequency of use	N/A	Frequency of maintenance	N/A
		Amount	N/A	Average Time	N/A		
Average Score	N/A	Average Score	N/A	Average Score	N/A	Average Score	N/A
Recommendation	No further action required						
Comments	N/A

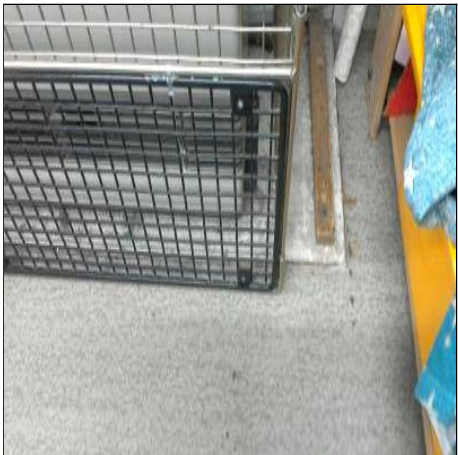
Re-inspection Date:	Lead Surveyor	Survey Type	Floor	Analysis
	9 Jan 2025 to 10 Jan 2025	Tracy Chulk	Reinspection Survey	Ground	No Asbestos Detected (0)
	Building	Room	Item	Quantity	
	Block TC	Play group TC001	Panel beneath heater	2m ²	Usually inaccessible or unlikely to be disturbed (0)
	Sample No (S,SP,P,As)	Product Type	Surface Treatment	Condition	
	20561285 {AO000111}* (S)	Not applicable (No asbestos detected) (0)	Completely Sealed (0)	Good Condition (0)

Normal Occupancy	Score	Likelihood of disturbance	Score	Exposure Potential	Score	Maintenance Activity	Score
Main type of activity	N/A	Location	N/A	Number of occupants	N/A	Type of Maintenance	N/A
		Accessibility	N/A	Frequency of use	N/A	Frequency of maintenance	N/A
		Amount	N/A	Average Time	N/A		
Average Score	N/A	Average Score	N/A	Average Score	N/A	Average Score	N/A
Recommendation	No further action required						
Comments	N/A

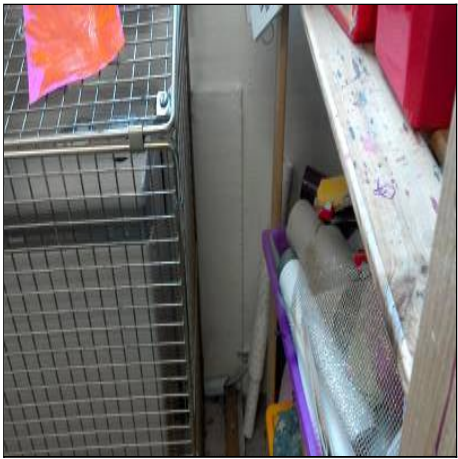
Re-inspection Date:	Lead Surveyor	Survey Type	Floor	Analysis
	9 Jan 2025 to 10 Jan 2025	Tracy Chulk	Reinspection Survey	Ground	No Asbestos Detected (0)
	Building	Room	Item	Quantity	
	Block TC	Play group TC001	Panel behind heater	2m ²	
	Sample No (S,SP,P,As)	Product Type	Surface Treatment	Condition	Accessibility
	20561290 {AO000110}* (S)	Not applicable (No asbestos detected) (0)	Completely Sealed (0)	Good Condition (0)	Usually inaccessible or unlikely to be disturbed (0)

Normal Occupancy	Score	Likelihood of disturbance	Score	Exposure Potential	Score	Maintenance Activity	Score
Main type of activity	N/A	Location	N/A	Number of occupants	N/A	Type of Maintenance	N/A
		Accessibility	N/A	Frequency of use	N/A	Frequency of maintenance	N/A
		Amount	N/A	Average Time	N/A		
Average Score	N/A	Average Score	N/A	Average Score	N/A	Average Score	N/A
Recommendation	No further action required						
Comments	N/A

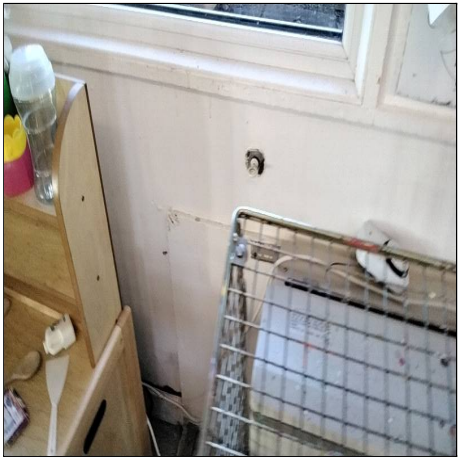
Re-inspection Date:	Lead Surveyor	Survey Type	Floor	Analysis
	9 Jan 2025 to 10 Jan 2025	Tracy Chulk	Reinspection Survey	Ground	No Asbestos Detected (0)
	Building	Room	Item	Quantity	
	Block TC	Play group TC001	Typical plasterboard to walls	Typical	
	Sample No (S,SP,P,As)	Product Type	Surface Treatment	Condition	Accessibility
	DD000420* (S)	Non Asbestos Cement (0)	Surface Sealed (1)	Good Condition (0)	Easily disturbed (2)

Normal Occupancy	Score	Likelihood of disturbance	Score	Exposure Potential	Score	Maintenance Activity	Score
Main type of activity	N/A	Location	N/A	Number of occupants	N/A	Type of Maintenance	N/A
		Accessibility	N/A	Frequency of use	N/A	Frequency of maintenance	N/A
		Amount	N/A	Average Time	N/A		
Average Score	N/A	Average Score	N/A	Average Score	N/A	Average Score	N/A
Recommendation	No further action required						
Comments	N/A

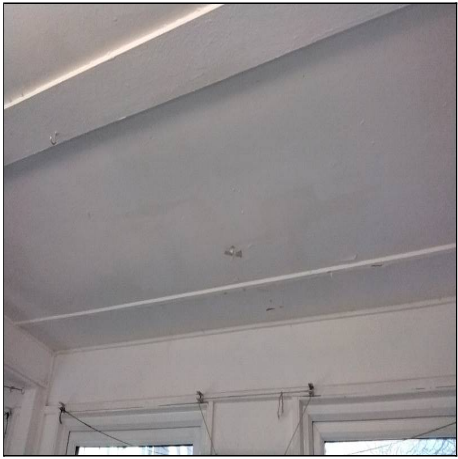
Re-inspection Date:	Lead Surveyor	Survey Type	Floor	Analysis
	9 Jan 2025 to 10 Jan 2025	Tracy Chulk	Reinspection Survey	Ground	No Asbestos Detected (0)
	Building	Room	Item	Quantity	
	Block TC	Play group TC001	Typical plasterboard	Typical	
	Sample No (S,SP,P,As)	Product Type	Surface Treatment	Condition	Accessibility
	DD000421* (S)	Non Asbestos Cement (0)	Surface Sealed (1)	Good Condition (0)	Occasionally likely to be disturbed (1)

Normal Occupancy	Score	Likelihood of disturbance	Score	Exposure Potential	Score	Maintenance Activity	Score
Main type of activity	N/A	Location	N/A	Number of occupants	N/A	Type of Maintenance	N/A
		Accessibility	N/A	Frequency of use	N/A	Frequency of maintenance	N/A
		Amount	N/A	Average Time	N/A		
Average Score	N/A	Average Score	N/A	Average Score	N/A	Average Score	N/A
Recommendation	No further action required						
Comments	N/A

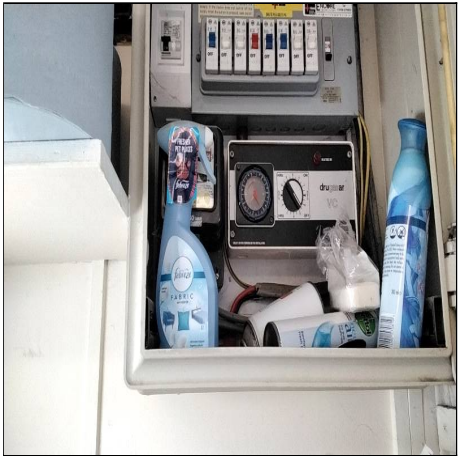
Re-inspection Date:	Lead Surveyor	Survey Type	Floor	Analysis
	9 Jan 2025 to 10 Jan 2025	Tracy Chulk	Reinspection Survey	Ground	N/A
	Building	Room	Item	Quantity	
	Block TC	Pupils WC TC003	Drugasar heating controller in switchgear cupboard, NE wall	N/A	
	Sample No (S,SP,P,As)	Product Type	Surface Treatment	Condition	Accessibility
	Visual (P)	N/A	N/A	N/A	N/A

Normal Occupancy	Score	Likelihood of disturbance	Score	Exposure Potential	Score	Maintenance Activity	Score
Main type of activity	N/A	Location	N/A	Number of occupants	N/A	Type of Maintenance	N/A
		Accessibility	N/A	Frequency of use	N/A	Frequency of maintenance	N/A
		Amount	N/A	Average Time	N/A		
Average Score	N/A	Average Score	N/A	Average Score	N/A	Average Score	N/A
Recommendation	Inspection Required						
Comments	Switchgear and controls are live

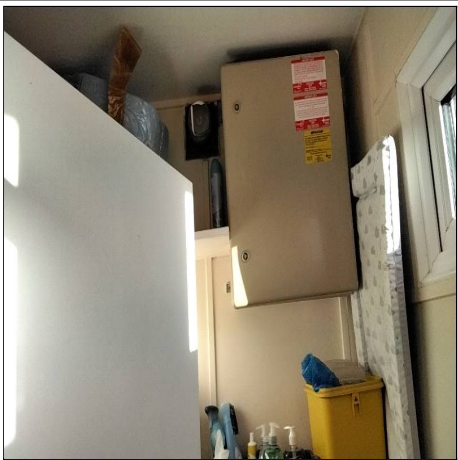
Re-inspection Date:	Lead Surveyor	Survey Type	Floor	Analysis
	9 Jan 2025 to 10 Jan 2025	Tracy Chulk	Reinspection Survey	Ground	N/A
	Building	Room	Item	Quantity	
	Block TC	Pupils WC TC003	Old electric meter	N/A	
	Sample No (S,SP,P,As)	Product Type	Surface Treatment	Condition	Accessibility
	Visual (P)	N/A	N/A	N/A	N/A

Normal Occupancy	Score	Likelihood of disturbance	Score	Exposure Potential	Score	Maintenance Activity	Score
Main type of activity	N/A	Location	N/A	Number of occupants	N/A	Type of Maintenance	N/A
		Accessibility	N/A	Frequency of use	N/A	Frequency of maintenance	N/A
		Amount	N/A	Average Time	N/A		
Average Score	N/A	Average Score	N/A	Average Score	N/A	Average Score	N/A
Recommendation	Inspection Required						
Comments	Unable to access, live at time of survey

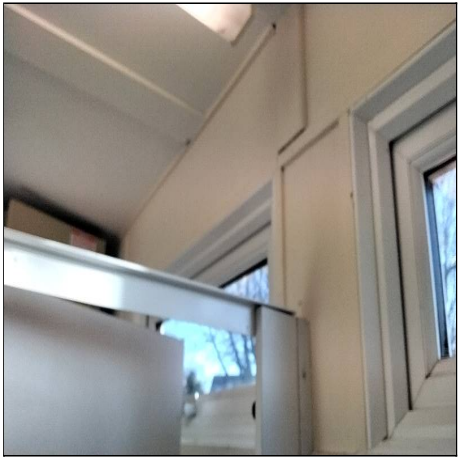
Re-inspection Date:	Lead Surveyor	Survey Type	Floor	Analysis
	9 Jan 2025 to 10 Jan 2025	Tracy Chulk	Reinspection Survey	Ground	No Asbestos Detected (0)
	Building	Room	Item	Quantity	
	Block TC	Pupils WC TC003	Typical plasterboard	Typical	
	Sample No (S,SP,P,As)	Product Type	Surface Treatment	Condition	Accessibility
	As DD000420* (SP)	Non Asbestos Cement (0)	Surface Sealed (1)	Good Condition (0)	Easily disturbed (2)

Normal Occupancy	Score	Likelihood of disturbance	Score	Exposure Potential	Score	Maintenance Activity	Score
Main type of activity	N/A	Location	N/A	Number of occupants	N/A	Type of Maintenance	N/A
		Accessibility	N/A	Frequency of use	N/A	Frequency of maintenance	N/A
		Amount	N/A	Average Time	N/A		
Average Score	N/A	Average Score	N/A	Average Score	N/A	Average Score	N/A
Recommendation	No further action required						
Comments	N/A

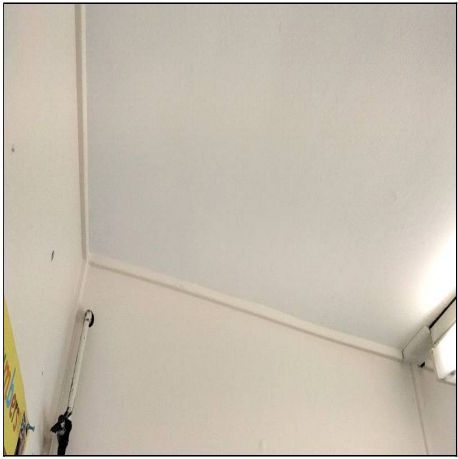
Re-inspection Date:	Lead Surveyor	Survey Type	Floor	Analysis
	9 Jan 2025 to 10 Jan 2025	Tracy Chulk	Reinspection Survey	Ground	No Asbestos Detected (0)
	Building	Room	Item	Quantity	
	Block TC	Pupils WC TC003	Typical plasterboard	Typical	
	Sample No (S,SP,P,As)	Product Type	Surface Treatment	Condition	Accessibility
	As DD000421* (SP)	Non Asbestos Cement (0)	Surface Sealed (1)	Good Condition (0)	Occasionally likely to be disturbed (1)

Normal Occupancy	Score	Likelihood of disturbance	Score	Exposure Potential	Score	Maintenance Activity	Score
Main type of activity	N/A	Location	N/A	Number of occupants	N/A	Type of Maintenance	N/A
		Accessibility	N/A	Frequency of use	N/A	Frequency of maintenance	N/A
		Amount	N/A	Average Time	N/A		
Average Score	N/A	Average Score	N/A	Average Score	N/A	Average Score	N/A
Recommendation	No further action required						
Comments	N/A

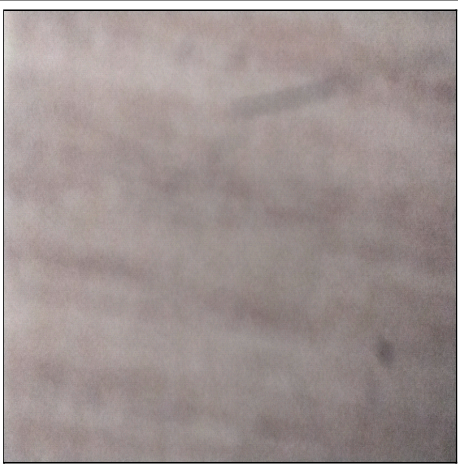
Re-inspection Date:	Lead Surveyor	Survey Type	Floor	Analysis
	9 Jan 2025 to 10 Jan 2025	Tracy Chulk	Reinspection Survey	External	N/A
	Building	Room	Item	Quantity	
	Block TE	External Block TE	Roof deck beneath modern roof felt.	N/A	
	Sample No (S,SP,P,As)	Product Type	Surface Treatment	Condition	Accessibility
	Visual (P)	N/A	N/A	N/A	N/A

Normal Occupancy	Score	Likelihood of disturbance	Score	Exposure Potential	Score	Maintenance Activity	Score
Main type of activity	N/A	Location	N/A	Number of occupants	N/A	Type of Maintenance	N/A
		Accessibility	N/A	Frequency of use	N/A	Frequency of maintenance	N/A
		Amount	N/A	Average Time	N/A		
Average Score	N/A	Average Score	N/A	Average Score	N/A	Average Score	N/A
Recommendation	Inspection Required						
Comments	Unable to access without causing excessive damage

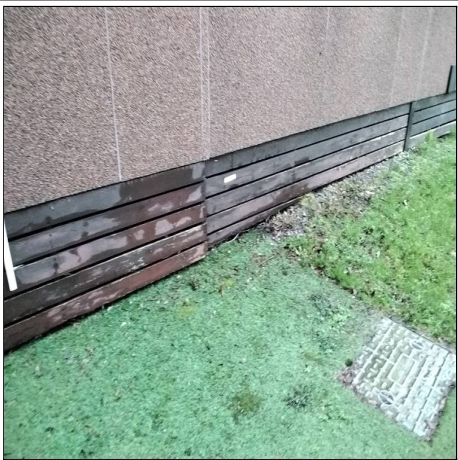
Re-inspection Date:	Lead Surveyor	Survey Type	Floor	Analysis
	9 Jan 2025 to 10 Jan 2025	Tracy Chulk	Reinspection Survey	External	N/A
	Building	Room	Item	Quantity	
	Block TE	External Block TE	Void beneath unit	N/A	
	Sample No (S,SP,P,As)	Product Type	Surface Treatment	Condition	Accessibility
	Visual (P)	N/A	N/A	N/A	N/A

Normal Occupancy	Score	Likelihood of disturbance	Score	Exposure Potential	Score	Maintenance Activity	Score
Main type of activity	N/A	Location	N/A	Number of occupants	N/A	Type of Maintenance	N/A
		Accessibility	N/A	Frequency of use	N/A	Frequency of maintenance	N/A
		Amount	N/A	Average Time	N/A		
Average Score	N/A	Average Score	N/A	Average Score	N/A	Average Score	N/A
Recommendation	Inspection Required						
Comments	Unable to access without causing excessive damage

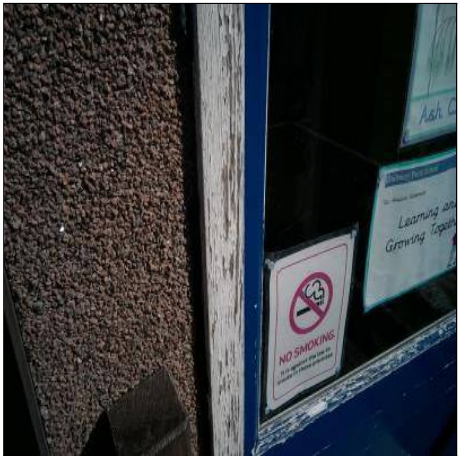
Re-inspection Date:	Lead Surveyor	Survey Type	Floor	Analysis
	9 Jan 2025 to 10 Jan 2025	Tracy Chulk	Reinspection Survey	External	No Asbestos Detected (0)
	Building	Room	Item	Quantity	
	Block TE	External Block TE	Black mastic around door frame	3 - 4m	
	Sample No (S,SP,P,As)	Product Type	Surface Treatment	Condition	Accessibility
	AA000349* (S)	Well Bound Material (1)	Completely Sealed (0)	Good Condition (0)	Occasionally likely to be disturbed (1)

Normal Occupancy	Score	Likelihood of disturbance	Score	Exposure Potential	Score	Maintenance Activity	Score
Main type of activity	N/A	Location	N/A	Number of occupants	N/A	Type of Maintenance	N/A
		Accessibility	N/A	Frequency of use	N/A	Frequency of maintenance	N/A
		Amount	N/A	Average Time	N/A		
Average Score	N/A	Average Score	N/A	Average Score	N/A	Average Score	N/A
Recommendation	No further action required						
Comments	N/A

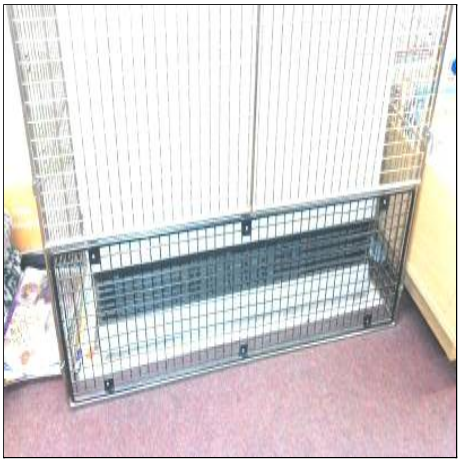
Re-inspection Date:	Lead Surveyor	Survey Type	Floor	Analysis
	9 Jan 2025 to 10 Jan 2025	Tracy Chulk	Reinspection Survey	Ground	No Asbestos Detected (0)
	Building	Room	Item	Quantity	
	Block TE	Classroom TE003	Panel beneath heater North wall	1m ²	
	Sample No (S,SP,P,As)	Product Type	Surface Treatment	Condition	Accessibility
	AB000297* (S)	Non Asbestos Insulating Board (0)	Surface Sealed (1)	Good Condition (0)	Usually inaccessible or unlikely to be disturbed (0)

Normal Occupancy	Score	Likelihood of disturbance	Score	Exposure Potential	Score	Maintenance Activity	Score
Main type of activity	N/A	Location	N/A	Number of occupants	N/A	Type of Maintenance	N/A
		Accessibility	N/A	Frequency of use	N/A	Frequency of maintenance	N/A
		Amount	N/A	Average Time	N/A		
Average Score	N/A	Average Score	N/A	Average Score	N/A	Average Score	N/A
Recommendation	No further action required						
Comments	N/A

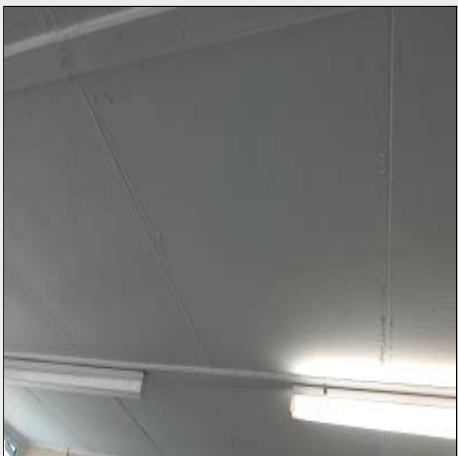
Re-inspection Date:	Lead Surveyor	Survey Type	Floor	Analysis
	9 Jan 2025 to 10 Jan 2025	Tracy Chulk	Reinspection Survey	Ground	N/A
	Building	Room	Item	Quantity	
	Block TF	Classroom TF001	Ceiling void	N/A	
	Sample No (S,SP,P,As)	Product Type	Surface Treatment	Condition	Accessibility
	Visual (P)	N/A	N/A	N/A	N/A

Normal Occupancy	Score	Likelihood of disturbance	Score	Exposure Potential	Score	Maintenance Activity	Score
Main type of activity	N/A	Location	N/A	Number of occupants	N/A	Type of Maintenance	N/A
		Accessibility	N/A	Frequency of use	N/A	Frequency of maintenance	N/A
		Amount	N/A	Average Time	N/A		
Average Score	N/A	Average Score	N/A	Average Score	N/A	Average Score	N/A
Recommendation	Inspection Required						
Comments	Building demolished

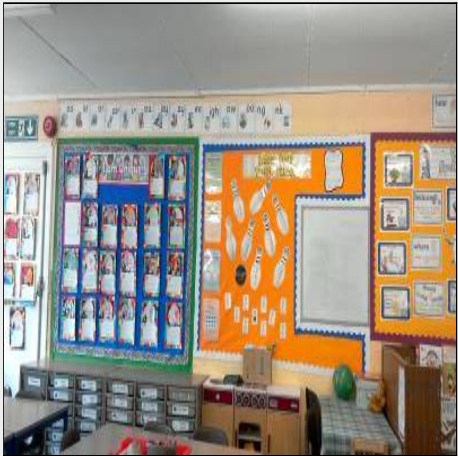
Re-inspection Date:	Lead Surveyor	Survey Type	Floor	Analysis
	9 Jan 2025 to 10 Jan 2025	Tracy Chulk	Reinspection Survey	Ground	No Asbestos Detected (0)
	Building	Room	Item	Quantity	
	Block TF	Classroom TF001	Fibreboard wall panels	50m ²	
	Sample No (S,SP,P,As)	Product Type	Surface Treatment	Condition	Accessibility
	20660454 {AB000308} * (S)	Not applicable (No asbestos detected) (0)	Surface Sealed (1)	Good Condition (0)	Usually inaccessible or unlikely to be disturbed (0)

Normal Occupancy	Score	Likelihood of disturbance	Score	Exposure Potential	Score	Maintenance Activity	Score
Main type of activity	N/A	Location	N/A	Number of occupants	N/A	Type of Maintenance	N/A
		Accessibility	N/A	Frequency of use	N/A	Frequency of maintenance	N/A
		Amount	N/A	Average Time	N/A		
Average Score	N/A	Average Score	N/A	Average Score	N/A	Average Score	N/A
Recommendation	No further action required						
Comments	Building demolished

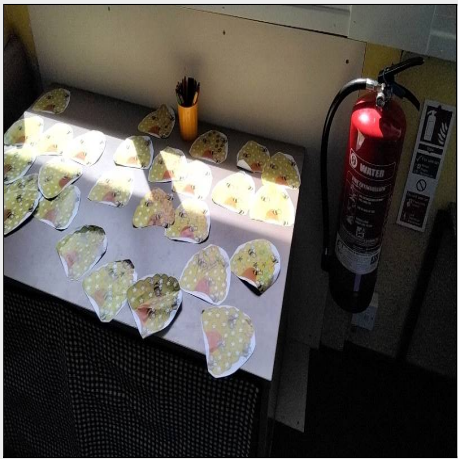
Re-inspection Date:	Lead Surveyor	Survey Type	Floor	Analysis
	9 Jan 2025 to 10 Jan 2025	Tracy Chulk	Reinspection Survey	Ground	Chrysotile + Amosite (2)
	Building	Room	Item	Quantity	
	Block TF	Classroom TF001	Panel behind skirting (behind heater) South wall	<1m ²	
	Sample No (S,SP,P,As)	Product Type	Surface Treatment	Condition	Accessibility
	20660456 {AB000309} * (S)	Asbestos Insulating Board (2)	Surface Sealed (1)	Good Condition (0)	Usually inaccessible or unlikely to be disturbed (0)

Normal Occupancy	Score	Likelihood of disturbance	Score	Exposure Potential	Score	Maintenance Activity	Score
Main type of activity	0	Location	2	Number of occupants	0	Type of Maintenance	0
		Accessibility	0	Frequency of use	0	Frequency of maintenance	0
		Amount	1	Average Time	0		
Average Score	0	Average Score	1	Average Score	0	Average Score	0
Recommendation	D - No Attention Required, inspect at intervals						
Comments	Building demolished

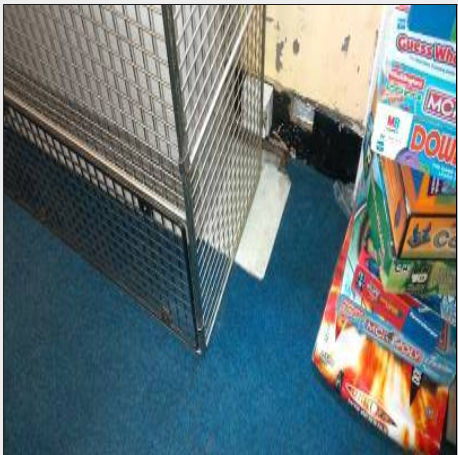
Re-inspection Date:	Lead Surveyor	Survey Type	Floor	Analysis
	9 Jan 2025 to 10 Jan 2025	Tracy Chulk	Reinspection Survey	Ground	No Asbestos Detected (0)
	Building	Room	Item	Quantity	
	Block TF	Classroom TF001	Panel beneath heater South wall	1m ²	
	Sample No (S,SP,P,As)	Product Type	Surface Treatment	Condition	Accessibility
	21060580 {AB000306} * (S)	Not applicable (No asbestos detected) (0)	Completely Sealed (0)	Good Condition (0)	Usually inaccessible or unlikely to be disturbed (0)

Normal Occupancy	Score	Likelihood of disturbance	Score	Exposure Potential	Score	Maintenance Activity	Score
Main type of activity	N/A	Location	N/A	Number of occupants	N/A	Type of Maintenance	N/A
		Accessibility	N/A	Frequency of use	N/A	Frequency of maintenance	N/A
		Amount	N/A	Average Time	N/A		
Average Score	N/A	Average Score	N/A	Average Score	N/A	Average Score	N/A
Recommendation	No further action required						
Comments	Building demolished

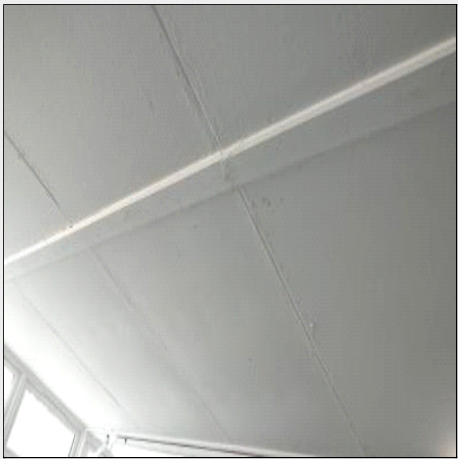
Re-inspection Date:	Lead Surveyor	Survey Type	Floor	Analysis
	9 Jan 2025 to 10 Jan 2025	Tracy Chulk	Reinspection Survey	Ground	No Asbestos Detected (0)
	Building	Room	Item	Quantity	
	Block TF	Classroom TF001	Fixed fibreboard ceiling panels	45m ²	
	Sample No (S,SP,P,As)	Product Type	Surface Treatment	Condition	Accessibility
	21060581 {AB000307} * (S)	Not applicable (No asbestos detected) (0)	Completely Sealed (0)	Good Condition (0)	Usually inaccessible or unlikely to be disturbed (0)

Normal Occupancy	Score	Likelihood of disturbance	Score	Exposure Potential	Score	Maintenance Activity	Score
Main type of activity	N/A	Location	N/A	Number of occupants	N/A	Type of Maintenance	N/A
		Accessibility	N/A	Frequency of use	N/A	Frequency of maintenance	N/A
		Amount	N/A	Average Time	N/A		
Average Score	N/A	Average Score	N/A	Average Score	N/A	Average Score	N/A
Recommendation	No further action required						
Comments	Building demolished

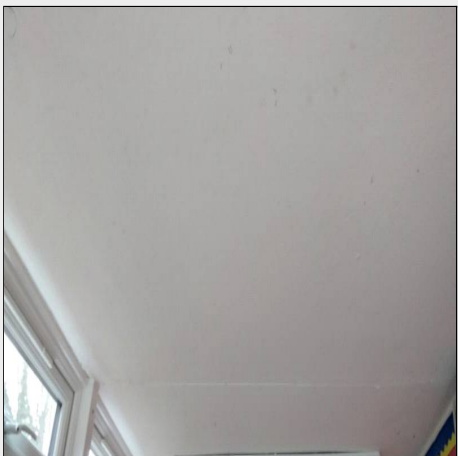
Re-inspection Date:	Lead Surveyor	Survey Type	Floor	Analysis
	9 Jan 2025 to 10 Jan 2025	Tracy Chulk	Reinspection Survey	Ground	N/A
	Building	Room	Item	Quantity	
	Block TF	Pupils cloak TF003	Ceiling void	N/A	
	Sample No (S,SP,P,As)	Product Type	Surface Treatment	Condition	Accessibility
	Visual (P)	N/A	N/A	N/A	N/A

Normal Occupancy	Score	Likelihood of disturbance	Score	Exposure Potential	Score	Maintenance Activity	Score
Main type of activity	N/A	Location	N/A	Number of occupants	N/A	Type of Maintenance	N/A
		Accessibility	N/A	Frequency of use	N/A	Frequency of maintenance	N/A
		Amount	N/A	Average Time	N/A		
Average Score	N/A	Average Score	N/A	Average Score	N/A	Average Score	N/A
Recommendation	Inspection Required						
Comments	Building demolished

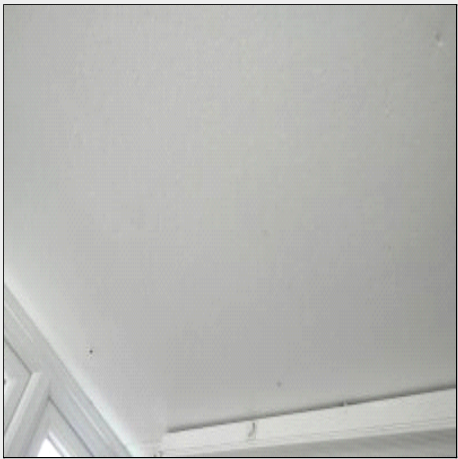
Re-inspection Date:	Lead Surveyor	Survey Type	Floor	Analysis
	9 Jan 2025 to 10 Jan 2025	Tracy Chulk	Reinspection Survey	Ground	No Asbestos Detected (0)
	Building	Room	Item	Quantity	
	Block TF	Pupils cloak TF003	Fixed fibreboard ceiling panels	4m ²	
	Sample No (S,SP,P,As)	Product Type	Surface Treatment	Condition	Accessibility
	20660455 {AB000310}* (S)	Not applicable (No asbestos detected) (0)	Completely Sealed (0)	Good Condition (0)	Usually inaccessible or unlikely to be disturbed (0)

Normal Occupancy	Score	Likelihood of disturbance	Score	Exposure Potential	Score	Maintenance Activity	Score
Main type of activity	N/A	Location	N/A	Number of occupants	N/A	Type of Maintenance	N/A
		Accessibility	N/A	Frequency of use	N/A	Frequency of maintenance	N/A
		Amount	N/A	Average Time	N/A		
Average Score	N/A	Average Score	N/A	Average Score	N/A	Average Score	N/A
Recommendation	No further action required						
Comments	Building demolished
