**ASBESTOS REINSPECTION SURVEY
OF
REDHILLS SCHOOL, LANDHAYES ROAD, EXETER, DEVON, EX4 2BY**

**CLIENT: TORBAY DEVELOPMENT AGENCY
3RD FLOOR, TOR HILL HOUSE, UNION STREET, TORQUAY, TQ2 5QW**

**SITE UPRN NO: N/A
PROJECT NO: J617237
SURVEY START DATE: 22 Jul 2020
NUMBER OF ASBESTOS CONTAINING MATERIALS IDENTIFIED: 82**

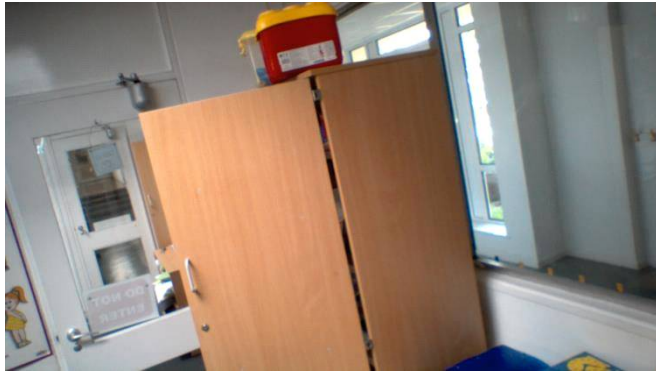
FLOOR/LOCATION:	0008	
DESCRIPTION:	Cement infill panels over door and below glazed wall	
RECOMMENDATIONS:	Manage, monitor and inform maintenance personnel prior to relevant works	
EXTENT:	<10m ² or <10m pipe run	
SAMPLE REF:	SPST EC004654 {GW003840}	
RESULT:	Chrysotile

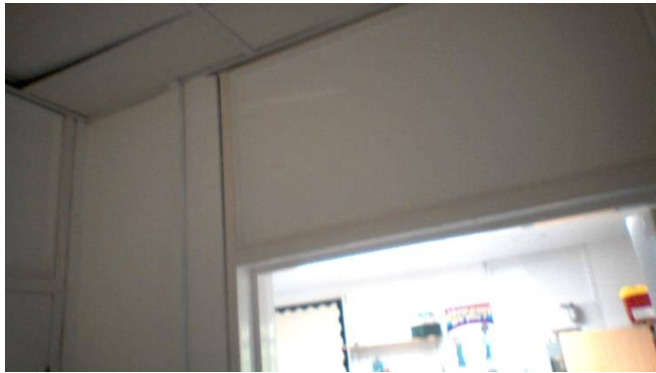
FLOOR/LOCATION:	0009	
DESCRIPTION:	Cement infill panels over door	
RECOMMENDATIONS:	Manage, monitor and inform maintenance personnel prior to relevant works	
EXTENT:	<10m ² or <10m pipe run	
SAMPLE REF:	SPST EC004646 {GW003837}	
RESULT:	Chrysotile

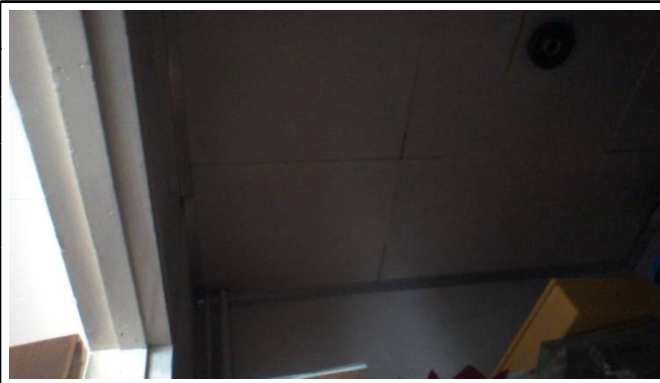
BUILDING NAME:	Redhills School
FLOOR/LOCATION:	0028
DESCRIPTION:	Fixed ceiling tiles
RECOMMENDATIONS:	Manage, monitor and inform maintenance personnel prior to relevant works
EXTENT:	<10m ² or <10m pipe run
SAMPLE REF:	EC004653 {GW003846}
RESULT:	Amosite

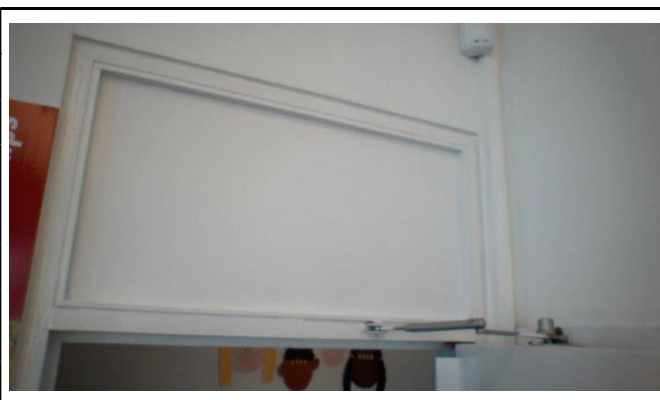
BUILDING NAME:	Redhills School
FLOOR/LOCATION:	0034
DESCRIPTION:	Cement infill panel over door
RECOMMENDATIONS:	Manage, monitor and inform maintenance personnel prior to relevant works
EXTENT:	<10m ² or <10m pipe run
SAMPLE REF:	SPST EC004646 {GW003837}
RESULT:	Chrysotile

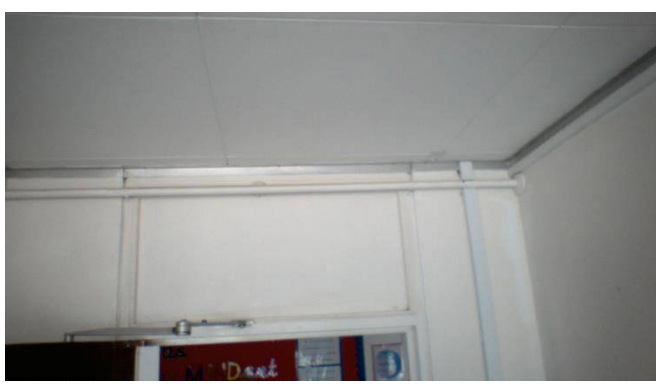
FLOOR/LOCATION:	0047	
DESCRIPTION:	Cement infill panel over door	
RECOMMENDATIONS:	Manage, monitor and inform maintenance personnel prior to relevant works	
EXTENT:	<10m ² or <10m pipe run	
SAMPLE REF:	SPST EC004646 {GW003837}	
RESULT:	Chrysotile

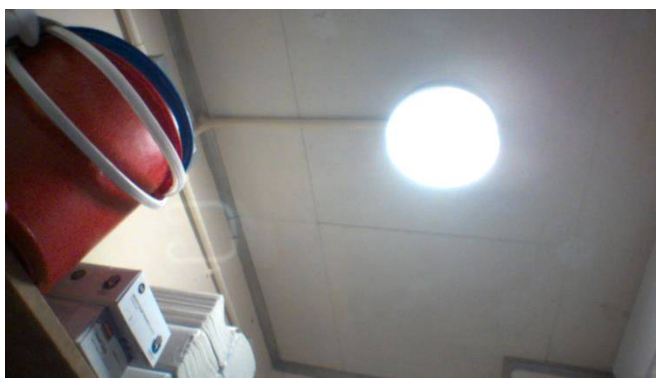
FLOOR/LOCATION:	0048	
DESCRIPTION:	Fixed ceiling tiles	
RECOMMENDATIONS:	Manage, monitor and inform maintenance personnel prior to relevant works	
EXTENT:	<10m ² or <10m pipe run	
SAMPLE REF:	SPST EC004649 {GW003849}	
RESULT:	Amosite

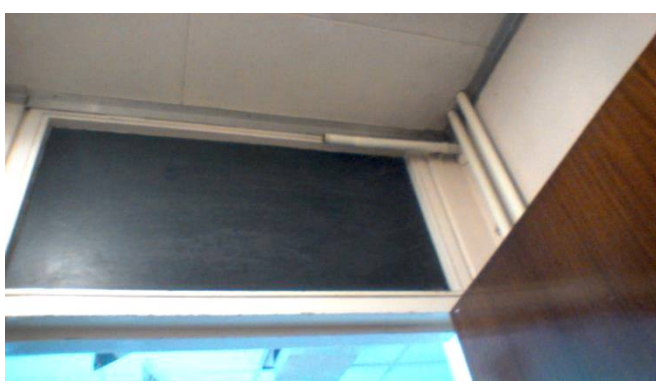
FLOOR/LOCATION:	0048	
DESCRIPTION:	Cement infill panel over door	
RECOMMENDATIONS:	Manage, monitor and inform maintenance personnel prior to relevant works	
EXTENT:	<10m ² or <10m pipe run	
SAMPLE REF:	SPST EC004632 {GW003850}	
RESULT:	Chrysotile

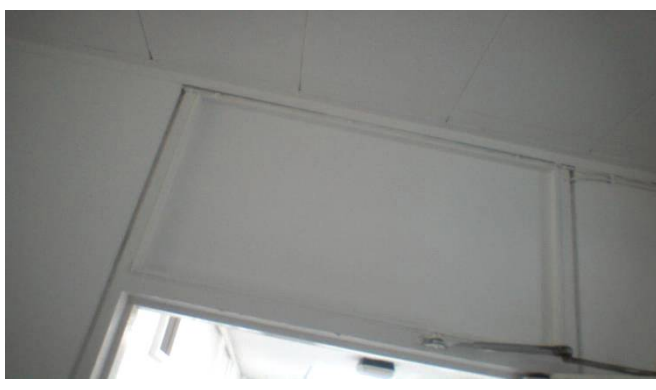
FLOOR/LOCATION:	0050	
DESCRIPTION:	Cement infill panel over door	
RECOMMENDATIONS:	Manage, monitor and inform maintenance personnel prior to relevant works	
EXTENT:	<10m ² or <10m pipe run	
SAMPLE REF:	SPST EC004646 {GW003837}	
RESULT:	Chrysotile

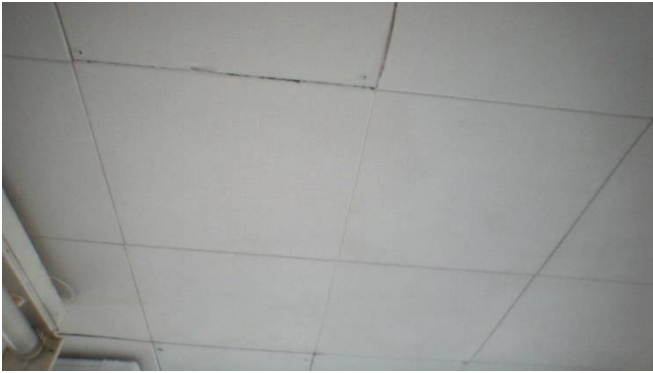
FLOOR/LOCATION:	0050	
DESCRIPTION:	Presumed Insulating board debris within ceiling void, no access to sample as fixed ceiling tiles	
RECOMMENDATIONS:	Restrict access, remove and/or decontaminate area	
EXTENT:	<10m ² or <10m pipe run	
SAMPLE REF:	Presumed	
RESULT:	Presumed Crocidolite (or unknown)

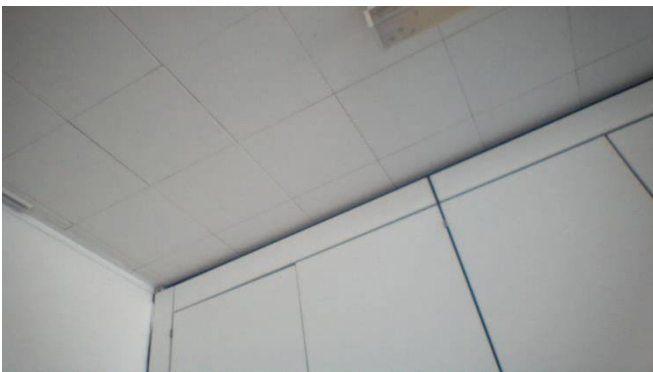
FLOOR/LOCATION:	0050A	
DESCRIPTION:	Presumed Insulating board debris within ceiling void, no access to sample as fixed ceiling tiles,	
RECOMMENDATIONS:	Restrict access, remove and/or decontaminate area	
EXTENT:	<10m ² or <10m pipe run	
SAMPLE REF:	Presumed	
RESULT:	Presumed Crocidolite (or unknown)

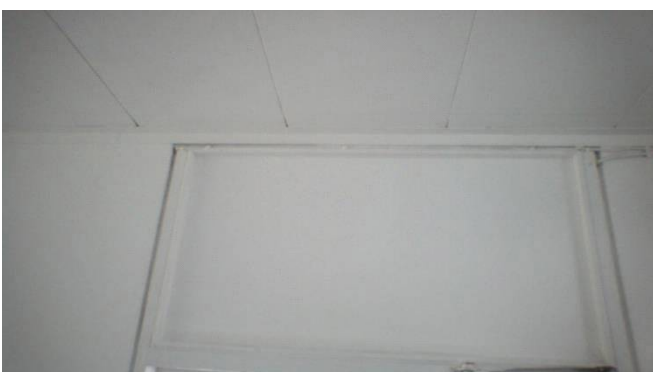
FLOOR/LOCATION:	0050B	
DESCRIPTION:	Cement infill panel over door	
RECOMMENDATIONS:	Manage, monitor and inform maintenance personnel prior to relevant works	
EXTENT:	<10m ² or <10m pipe run	
SAMPLE REF:	SPST EC004646 {GW003837}	
RESULT:	Chrysotile

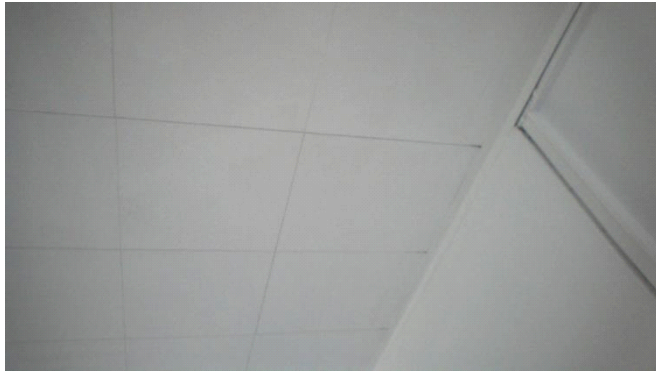
FLOOR/LOCATION:	0050B	
DESCRIPTION:	Presumed Insulating board debris within ceiling void, no access to sample as fixed ceiling tiles	
RECOMMENDATIONS:	Restrict access, remove and/or decontaminate area	
EXTENT:	<10m ² or <10m pipe run	
SAMPLE REF:	Presumed	
RESULT:	Presumed Crocidolite (or unknown)

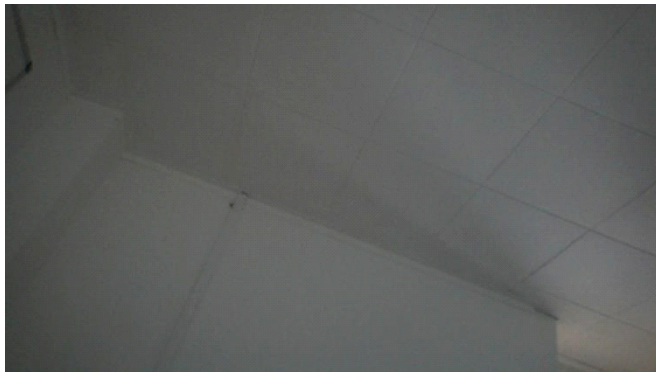
FLOOR/LOCATION:	0050C	
DESCRIPTION:	Presumed Insulating board debris within ceiling void, no access to sample as fixed ceiling tiles	
RECOMMENDATIONS:	Restrict access, remove and/or decontaminate area	
EXTENT:	<10m ² or <10m pipe run	
SAMPLE REF:	Presumed	
RESULT:	Presumed Crocidolite (or unknown)

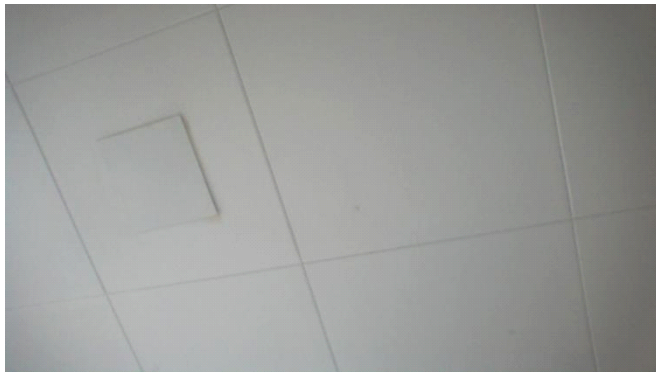
FLOOR/LOCATION:	0052	
DESCRIPTION:	Fixed ceiling tiles	
RECOMMENDATIONS:	Manage, monitor and inform maintenance personnel prior to relevant works	
EXTENT:	<10m ² or <10m pipe run	
SAMPLE REF:	EC004647 {GW003851}	
RESULT:	Amosite

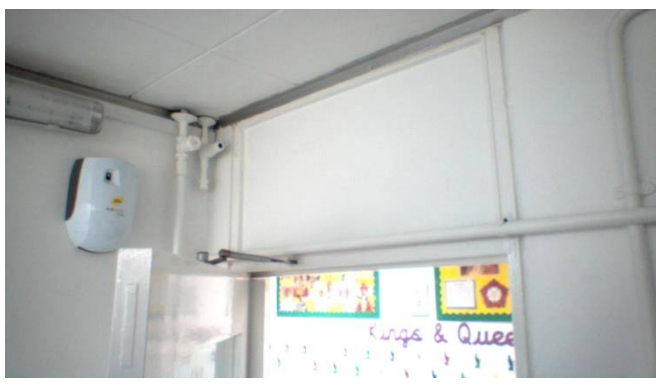
FLOOR/LOCATION:	0052	
DESCRIPTION:	Cement infill panel over door	
RECOMMENDATIONS:	Manage, monitor and inform maintenance personnel prior to relevant works	
EXTENT:	<10m ² or <10m pipe run	
SAMPLE REF:	SPST EC004646 {GW003837}	
RESULT:	Chrysotile

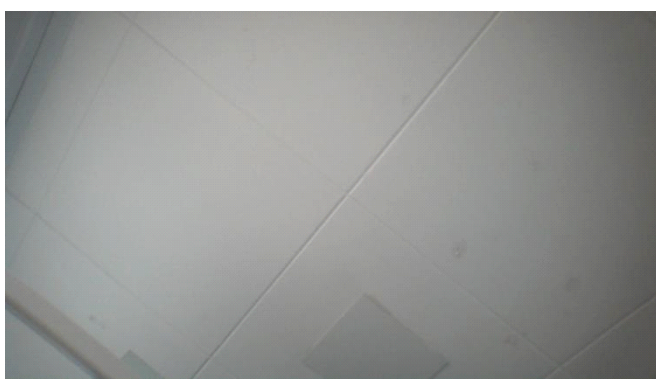
FLOOR/LOCATION:	0053	
DESCRIPTION:	Fixed ceiling tiles	
RECOMMENDATIONS:	Manage, monitor and inform maintenance personnel prior to relevant works	
EXTENT:	<10m ² or <10m pipe run	
SAMPLE REF:	SPST EC004647 {GW003851}	
RESULT:	Amosite

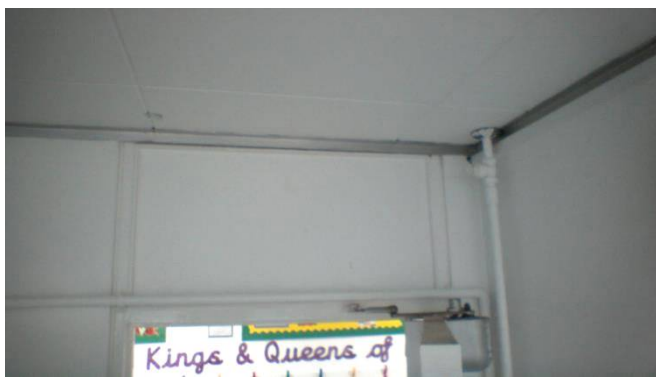
FLOOR/LOCATION:	0053	
DESCRIPTION:	Cement infill panel over door	
RECOMMENDATIONS:	Manage, monitor and inform maintenance personnel prior to relevant works	
EXTENT:	<10m ² or <10m pipe run	
SAMPLE REF:	SPST EC004646 {GW003837}	
RESULT:	Chrysotile

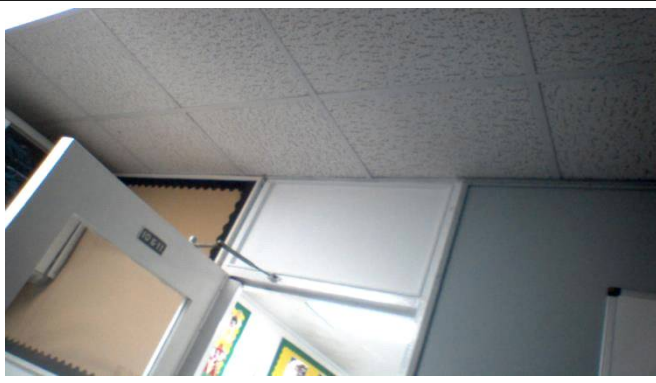
FLOOR/LOCATION:	0054	
DESCRIPTION:	Cement infill panel over door	
RECOMMENDATIONS:	Manage, monitor and inform maintenance personnel prior to relevant works	
EXTENT:	<10m ² or <10m pipe run	
SAMPLE REF:	EC004637 {GW003852}	
RESULT:	Chrysotile

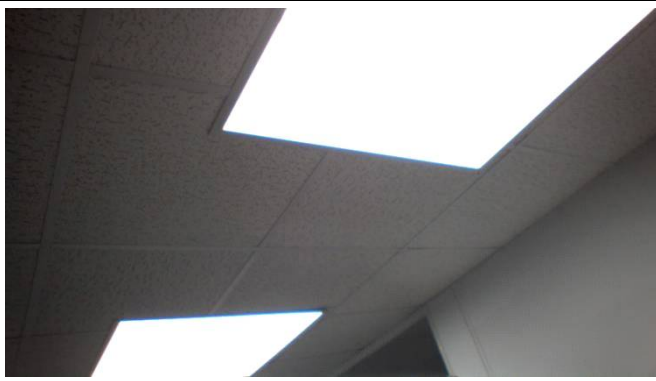
FLOOR/LOCATION:	0054	
DESCRIPTION:	Upstands to skylights	
RECOMMENDATIONS:	Manage, monitor and inform maintenance personnel prior to relevant works	
EXTENT:	<10m ² or <10m pipe run	
SAMPLE REF:	EC004640 {GW003853}	
RESULT:	Amosite

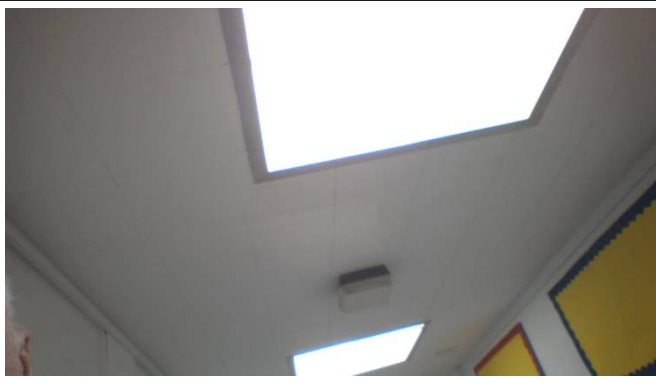
FLOOR/LOCATION:	0055	
DESCRIPTION:	Upstands to skylights	
RECOMMENDATIONS:	Manage, monitor and inform maintenance personnel prior to relevant works	
EXTENT:	<10m ² or <10m pipe run	
SAMPLE REF:	EC004644 {GW003854}	
RESULT:	Amosite

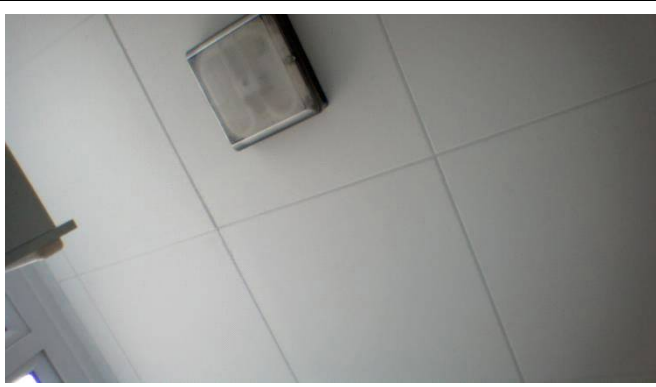
FLOOR/LOCATION:	0056	
DESCRIPTION:	Fixed ceiling tiles	
RECOMMENDATIONS:	Manage, monitor and inform maintenance personnel prior to relevant works	
EXTENT:	10 - 50 m ² or 10 - 50m pipe run	
SAMPLE REF:	EC004645 {GW003855}	
RESULT:	Amosite

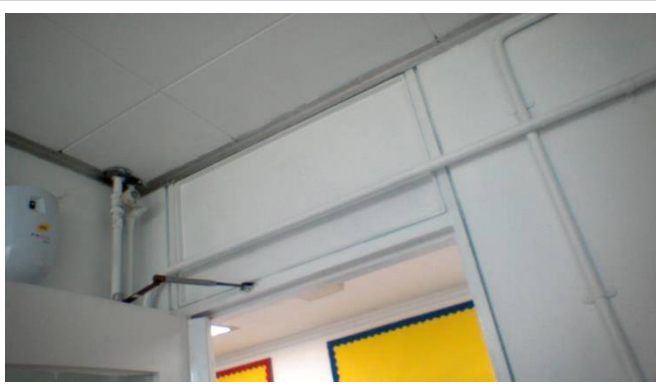
FLOOR/LOCATION:	0056	
DESCRIPTION:	Cement infill panel over door	
RECOMMENDATIONS:	Manage, monitor and inform maintenance personnel prior to relevant works	
EXTENT:	<10m ² or <10m pipe run	
SAMPLE REF:	SPST EC004637 {GW003852}	
RESULT:	Chrysotile

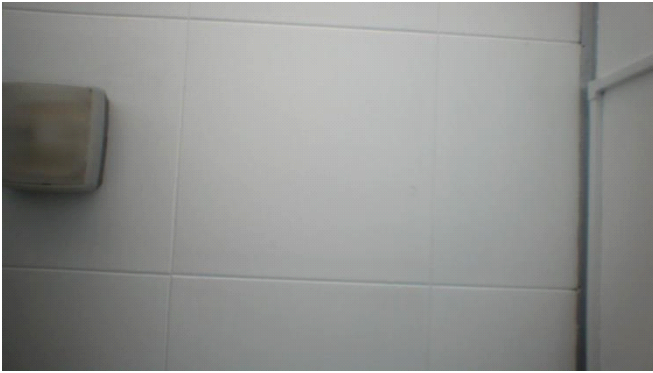
FLOOR/LOCATION:	0057	
DESCRIPTION:	Fixed ceiling tiles	
RECOMMENDATIONS:	Manage, monitor and inform maintenance personnel prior to relevant works	
EXTENT:	10 - 50 m ² or 10 - 50m pipe run	
SAMPLE REF:	SPST EC004645 {GW003855}	
RESULT:	Amosite

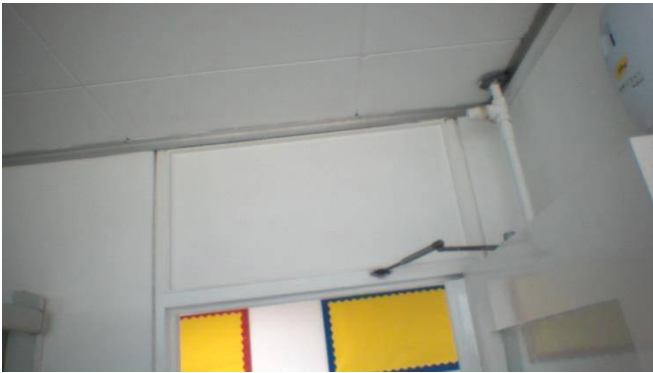
FLOOR/LOCATION:	0057	
DESCRIPTION:	Cement infill panel over door	
RECOMMENDATIONS:	Manage, monitor and inform maintenance personnel prior to relevant works	
EXTENT:	<10m ² or <10m pipe run	
SAMPLE REF:	SPST EC004637 {GW003852}	
RESULT:	Chrysotile

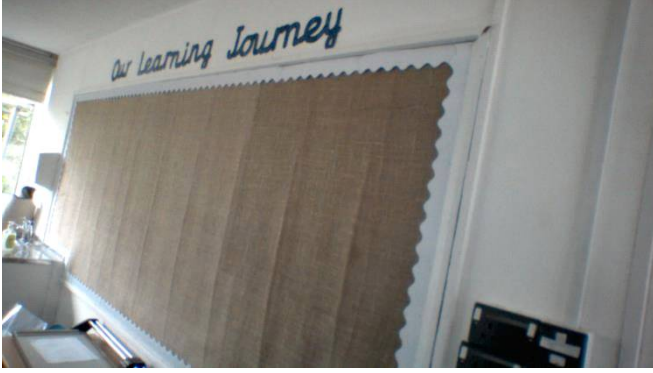
FLOOR/LOCATION:	0058	
DESCRIPTION:	Blackboard (coloured green), covered by new white board.	
RECOMMENDATIONS:	Manage, monitor and inform maintenance personnel prior to relevant works	
EXTENT:	<10m ² or <10m pipe run	
SAMPLE REF:	SPST 124 {GW003841}	
RESULT:	Chrysotile

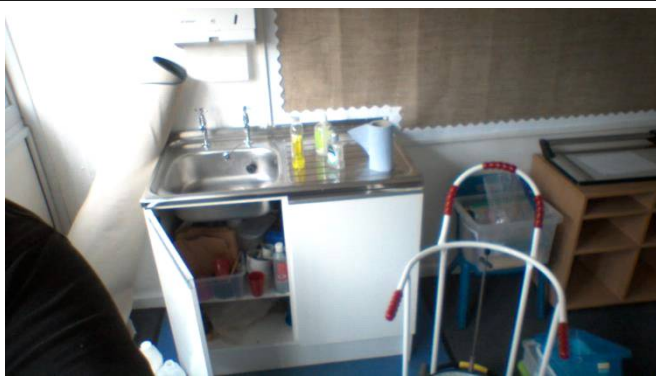
FLOOR/LOCATION:	0058	
DESCRIPTION:	Sink pad	
RECOMMENDATIONS:	Manage, monitor and inform maintenance personnel prior to relevant works	
EXTENT:	<10m² or <10m pipe run	
SAMPLE REF:	126 {GW003856}	
RESULT:	Chrysotile

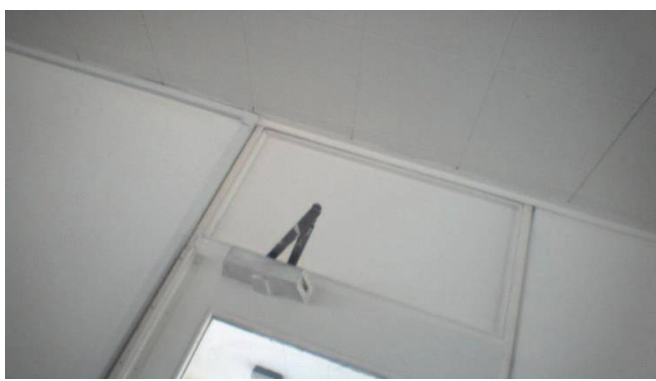
FLOOR/LOCATION:	0058	
DESCRIPTION:	Cement infil panel over door	
RECOMMENDATIONS:	Manage, monitor and inform maintenance personnel prior to relevant works	
EXTENT:	<10m² or <10m pipe run	
SAMPLE REF:	SPST EC004637 {GW003852}	
RESULT:	Chrysotile

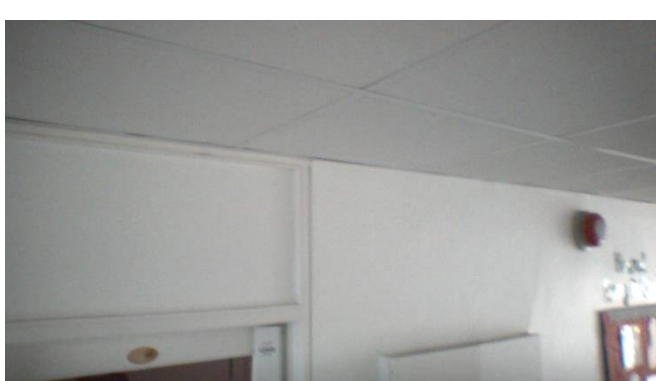
FLOOR/LOCATION:	0061	
DESCRIPTION:	Cement infil panels over doors to 0064, 0065	
RECOMMENDATIONS:	Manage, monitor and inform maintenance personnel prior to relevant works	
EXTENT:	<10m² or <10m pipe run	
SAMPLE REF:	SPST EC004637 {GW003852}	
RESULT:	Chrysotile

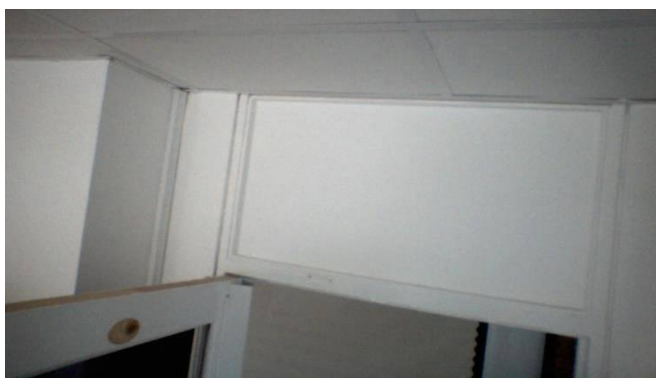
FLOOR/LOCATION:	0064	
DESCRIPTION:	Cement infill panel over door	
RECOMMENDATIONS:	Manage, monitor and inform maintenance personnel prior to relevant works	
EXTENT:	<10m ² or <10m pipe run	
SAMPLE REF:	SPST EC004637 {GW003852}	
RESULT:	Chrysotile

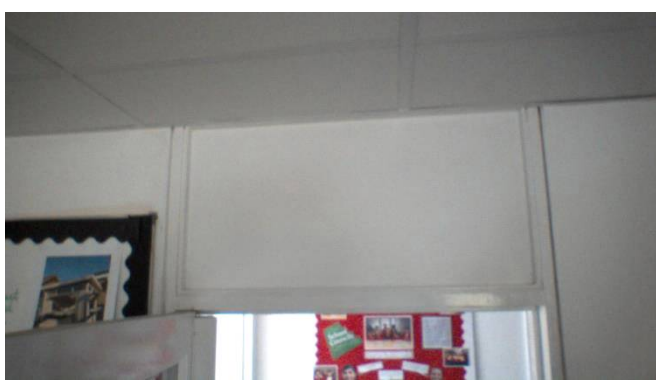
FLOOR/LOCATION:	0065	
DESCRIPTION:	Cement infill panel over door	
RECOMMENDATIONS:	Manage, monitor and inform maintenance personnel prior to relevant works	
EXTENT:	<10m ² or <10m pipe run	
SAMPLE REF:	SPST EC004637 {GW003852}	
RESULT:	Chrysotile

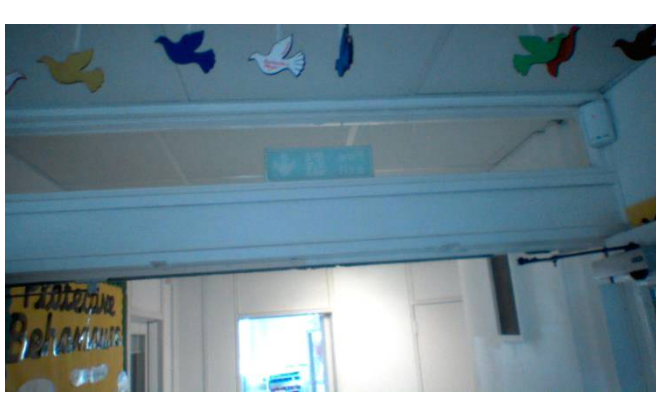
FLOOR/LOCATION:	0086	
DESCRIPTION:	Cement infill panel above doorway to 0009	
RECOMMENDATIONS:	Manage, monitor and inform maintenance personnel prior to relevant works	
EXTENT:	<10m ² or <10m pipe run	
SAMPLE REF:	SPST EC004632 {GW003850}	
RESULT:	Chrysotile

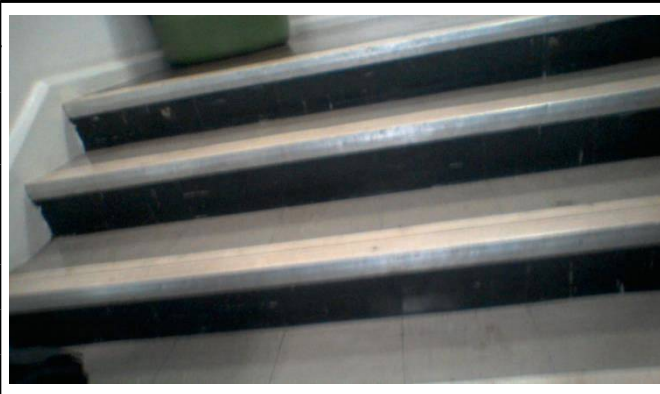
BUILDING NAME:	Redhills School
FLOOR/LOCATION:	0087
DESCRIPTION:	Black and grey vinyl floor tiles and adhesive to steps
RECOMMENDATIONS:	Manage, monitor and inform maintenance personnel prior to relevant works
EXTENT:	<10m ² or <10m pipe run
SAMPLE REF:	ED007251 {GW003860}
RESULT:	Chrysotile
